Geotechnical Investigation September 2003

GEOTECHNICAL INVESTIGATION
Heavy Duty Boardwalk Improvements
Tuntutuliak, Alaska

DM&A Job No. 4149.019

September 30, 2003

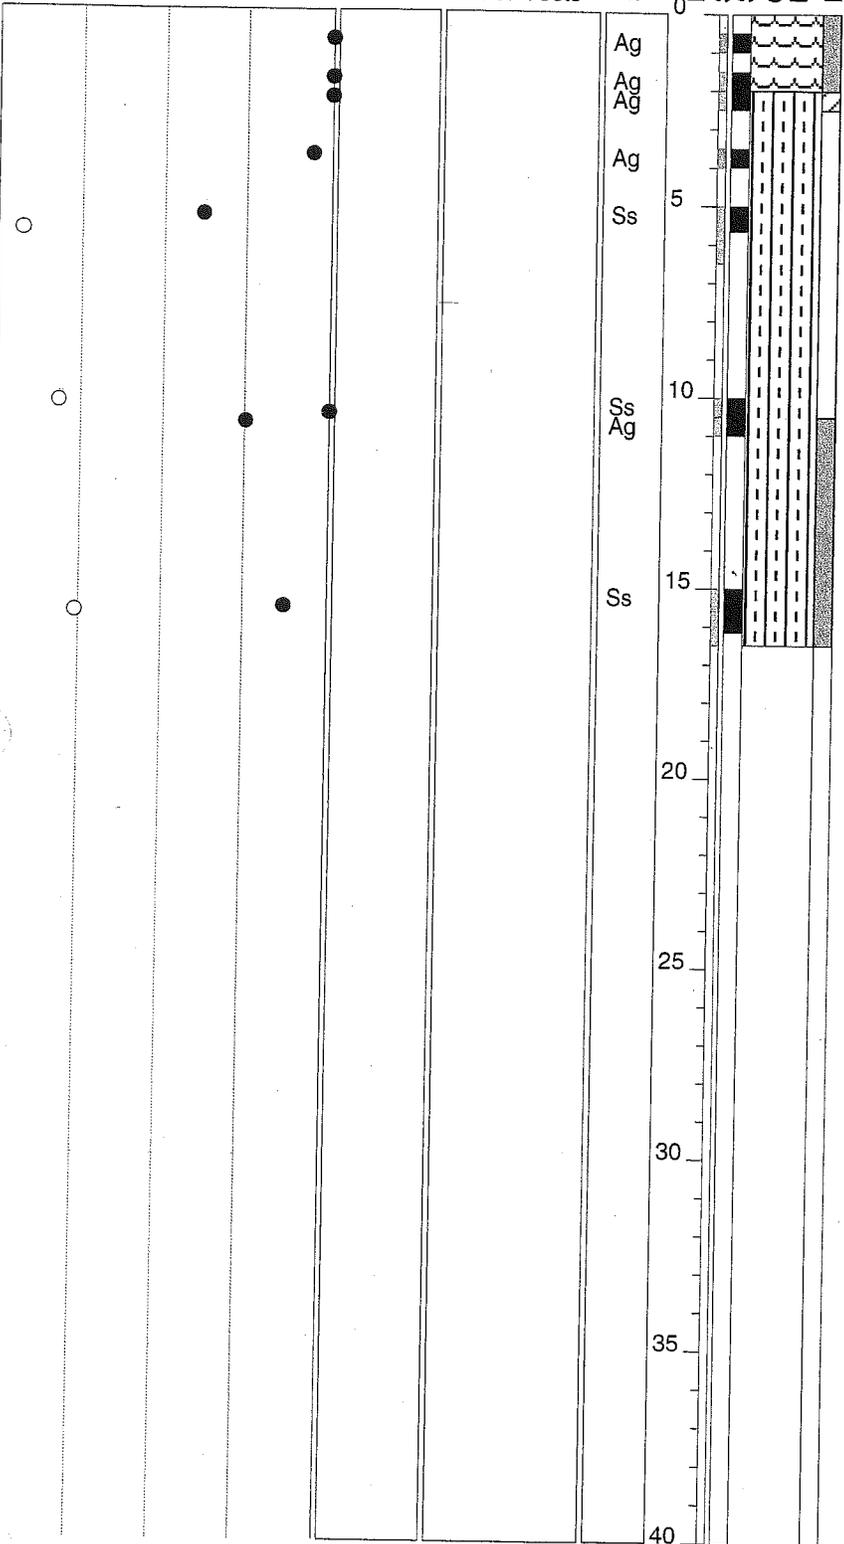
Boardwalk Section 'F'

Boring F encountered 3 feet of peat and organic silt over mixed silt and organic silt with occasional layers of firm organics to the base of the borehole at a depth of 16.5 feet. Seasonal frost was present to 2.5 feet, and icy permafrost was encountered below a depth of 10.5 feet.

The soil above the permafrost is highly compressible and settlement of the timber cribbing will continue to occur with time. A positive, long-term solution would be to replace the timber cribbing with helical anchors. Alternatively, the boardwalk could be releveled periodically and shims placed on the settling cribs. Any floats that might be present should be removed and be replaced with either cribbing or helical anchors to be consistent with the rest of the support.

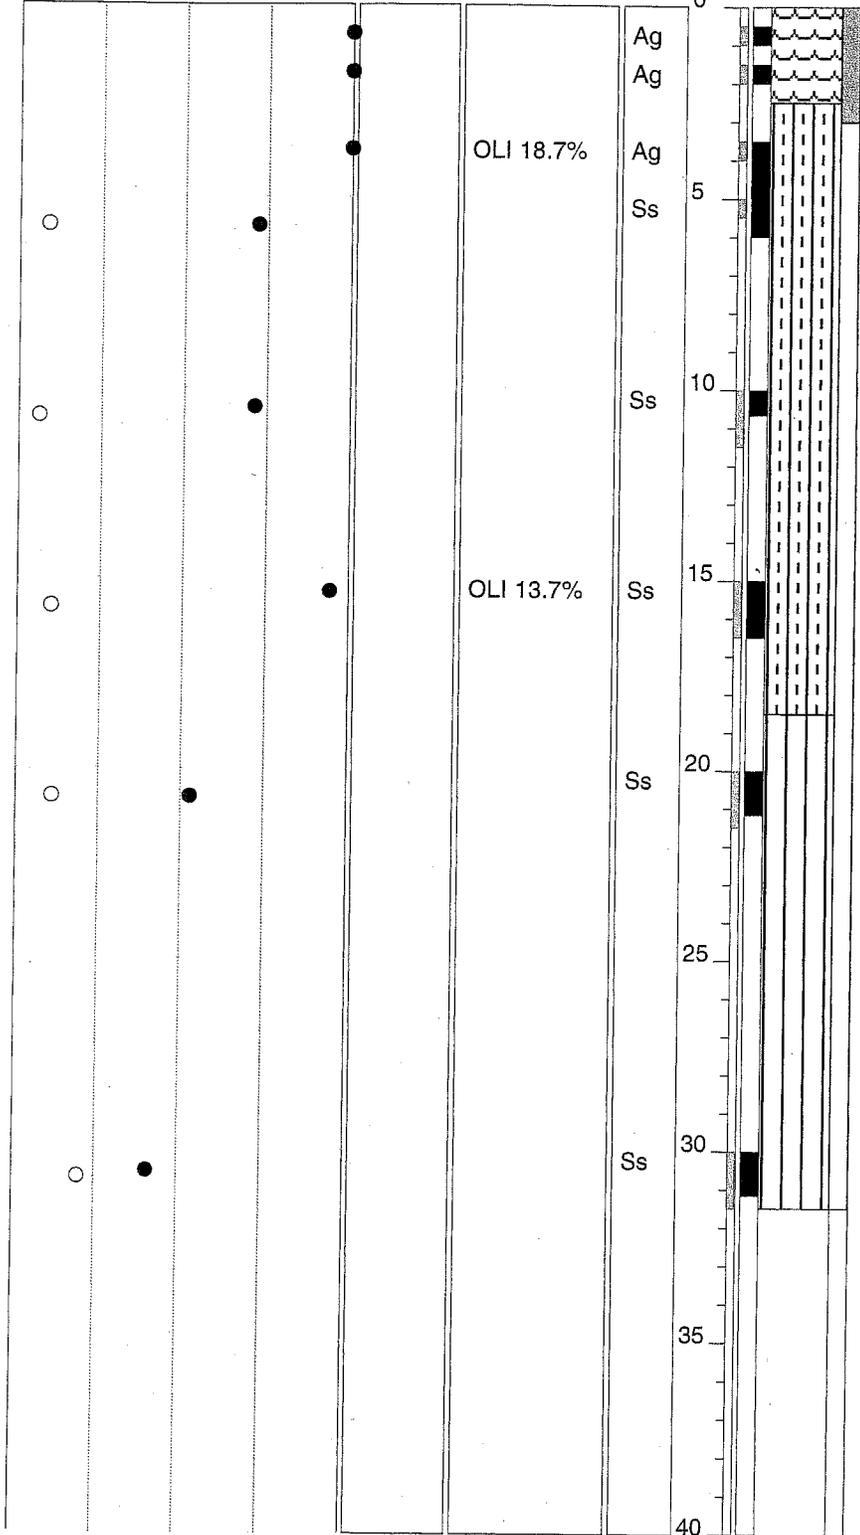
Boardwalk Section 'G'

Boring G was drilled to a depth of 31.5 feet near the center of this section, where displacement was most severe. The soils encountered include 2.5 feet of peat over organic silt to a depth of 18.5 feet. Beneath the organic silt, gray silt was present to the base of the boring. The soils were unfrozen below 3 feet of seasonal frost.

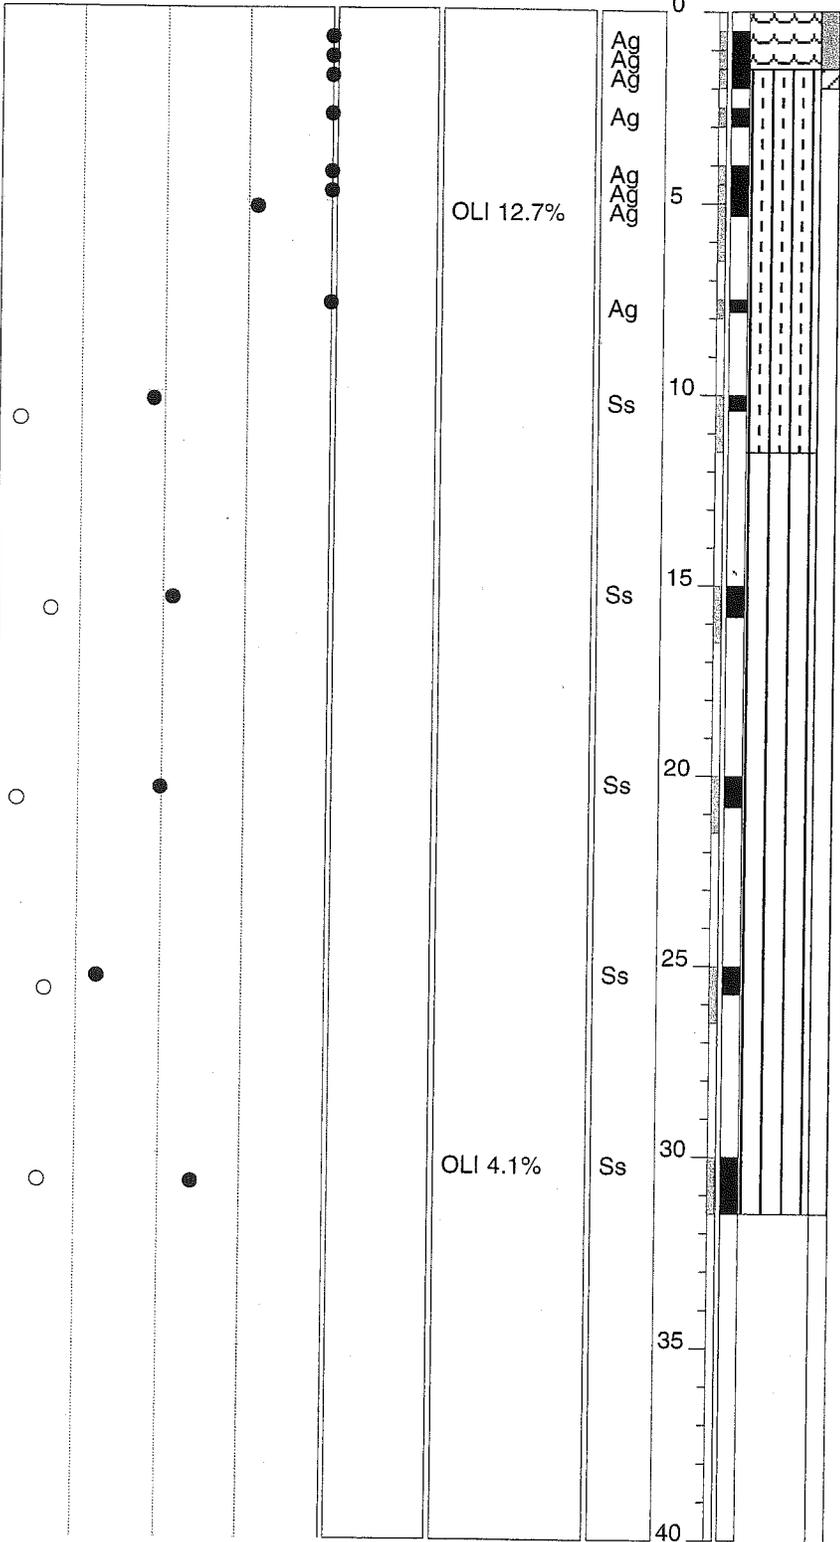
Boardwalk Section 'H'

Section H includes a bridge crossing a neck of the lake and the transitions at each end. The bridge section is supported on Chance anchors. The transitions at each end are on floats with Duckbill anchors. Movement has been considerable as evident from the excessive cribbing and displacement of floats. The floats have lifted the bridge almost completely off the Chance anchor at the southeast end. The movement has caused the side planks to break off and has resulted in a slight dip in bridge near west end.

Boring H shows peat and organic silt to 10.5 feet and then medium stiff silt to the depth explored, 31.5 feet. The only frozen soil was a thin layer of seasonal frost.

The soils are highly compressible to a depth of 10.5 feet. The major distress to the transitions appears to be caused by uplift of the floats during flooding. The cribbing and floats should be removed and replaced with helical anchors gaining support in the silt below 10.5 feet.
