# HAINES BOROUGH STORMWATER INFRASTRUCTURE REPORT

February 2019

ACWA Grant # 18-09

Takshanuk Watershed Council

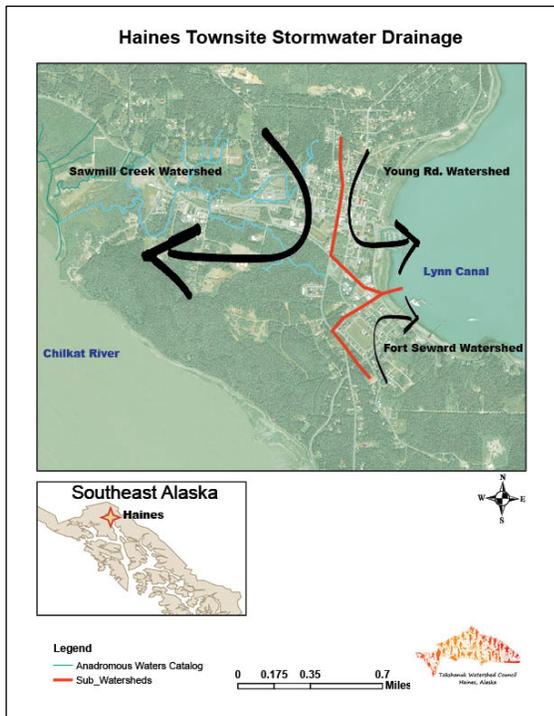
**Figure 1: The approximate sub-watersheds and direction of stormwater flow in the Haines townsite.**

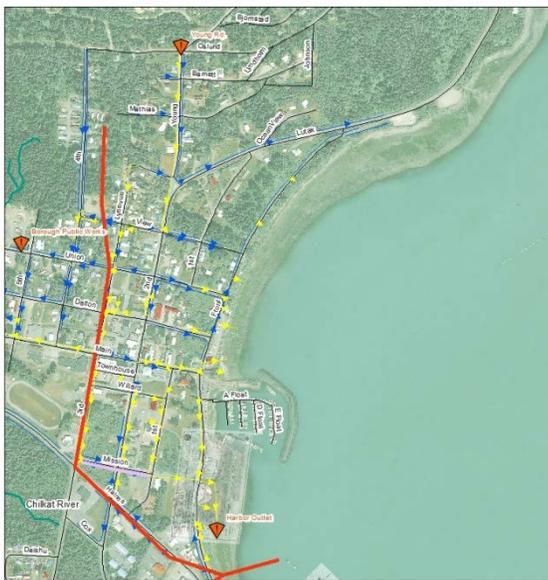
The Young Road sub-watershed is approximately 150 acres and is bound by Mt. Ripinski to the north and Lynn Canal to the east. The main direction of flow in this sub-watershed is south and then east with a final discharge into Lynn Canal. This sub-watershed includes the downtown business district of Haines and contains the majority of impervious surface within the Haines townsite (Fig 2).

There are two identified locations where stormwater best management practices (BMP's) could be utilized.

1. Top of Young Road: Most of the roads above Young Rd. are not paved and contribute sediment into the Young Rd. drainage system. Additionally, the location of a gravel

extraction pit at the head of Young Rd. could pose as a potential sediment source area.

- The ditches and culverts that contribute stormwater into Young Rd. should be evaluated for the potential of a bioswale or similar green infrastructure technique that would allow sediment and pollutants to settle out before entering the Young Rd. drainage system.

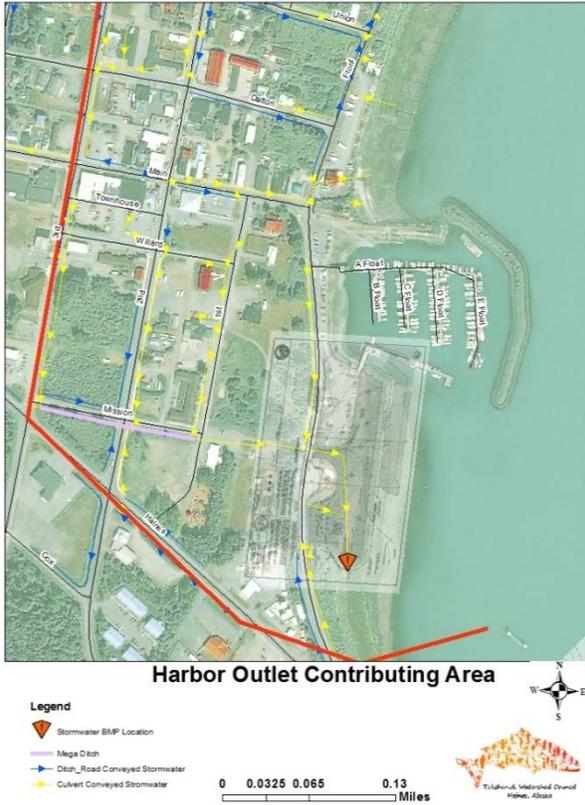
Figure 3: Harbor Outlet Contributing Area.

1). This culvert drains the majority of stormwater flowing from downtown Haines bound by 3<sup>rd</sup> Ave and Willard St. This area encompasses approximately 55 acres. Stormwater is conveyed into a single “mega ditch” that flows along Mission St. and connects with the new Harbor drainage system (Fig. 3). BMP’s that are already in place in this system include a grate in the ditch at the southern corner of Mission St. and 1<sup>st</sup> Ave to collect large debris and an oil-water separator within the new Harbor drainage system that filters stormwater before it outlets onto the beach. The oil-water separator, however, does not trap sediment from the stormwater.

- Explore options for dispersing stormwater from the outlet of the harbor culvert into adjacent tidelands. The intact tidelands in this area could act as a sediment and pollutant retention area that would reduce these inputs into Lynn Canal. See Image 2 that shows a stitched-together panorama of the outlet. Currently the flow is not dispersing and is directed back into the
