ALASKA DEPARTMENT OF ENVIRONMENTAL CONSERVATION
Division of Spill Prevention and Response
Prevention Preparedness and Response Program
SITUATION REPORT (SITREP)

Aero Air Plane Crash in Unalaska Bay

SITREP #: 2 and FINAL

SPILL #: 20259901601

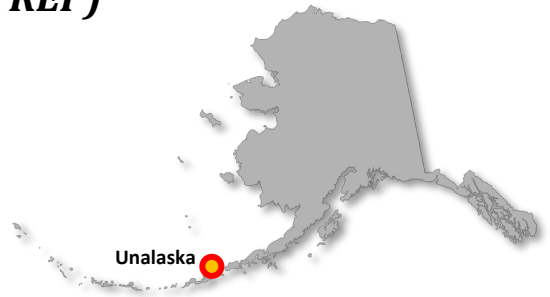
An overflight was conducted at 2:00 pm on January 16. The USCG took pictures of the sheen and estimated the size of the sheen visible on the surface of the water.
