ALASKA DEPARTMENT OF ENVIRONMENTAL CONSERVATION  
Division of Spill Prevention and Response  
Prevention Preparedness and Response Program  
**SITUATION REPORT (SITREP)**

## 2020 VMT Sump Oily Water Spill

**SITREP #:** 5

**INCIDENT LOCATION:** 58-SU-3 Admin Sump, Valdez Marine Terminal

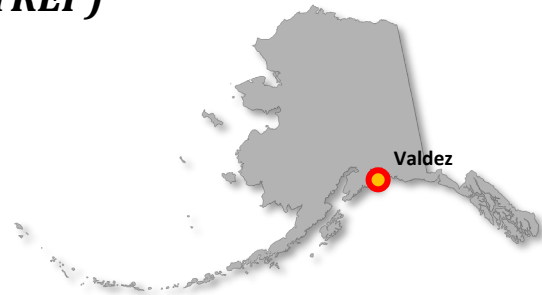
An outflow location has been identified on the shoreline where oily water was entering into Port Valdez. The outflow location is from a culvert that ends at the shoreline within the primary containment boom. The outflow is currently discharging high volumes of snow melt and rain water with a minor sheen. **An outflow water management apparatus that includes collection boxes was constructed to collect oily water from the outflow before it discharges into Port Valdez. This apparatus was installed on April 24 and is successfully collecting oil from the outflow discharge. A vac truck and sorbents have been used to recover oil from the collection boxes.**
