PHASE I ENVIRONMENTAL SITE ASSESSMENT

**CAREY PROPERTY
3130, 3142, & 3150 MOUNTAIN VIEW DRIVE**

ANCHORAGE, ALASKA

MAY 2005

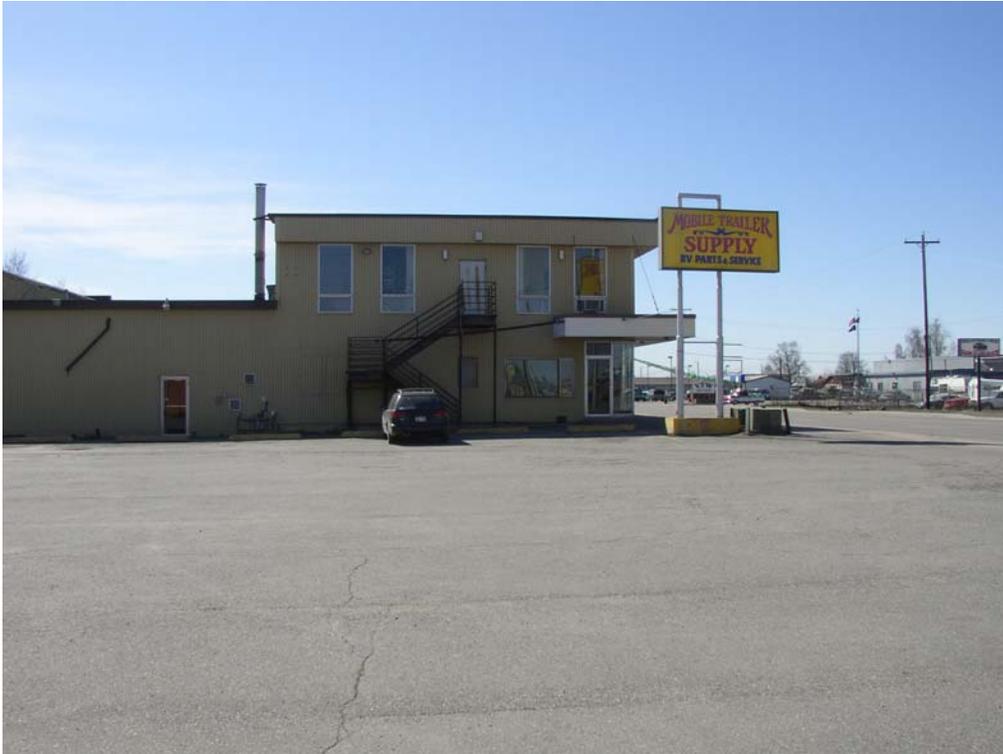
The Carey property is located in an industrial area of Anchorage, approximately 0.6 miles southeast of Ship Creek and 1.5 miles north of Chester Creek. The west Mountain View area is located on a ridge, dropping down toward the Ship Creek basin to the north and the Campbell Creek basin to the south. The site is accessed via Mountain View Drive, which borders the northwest edge of the property (Photos 1 and 2).

**Photo 1. Northeast side of the building and sign (facing southwest).
Mountain View Drive is on the right.**

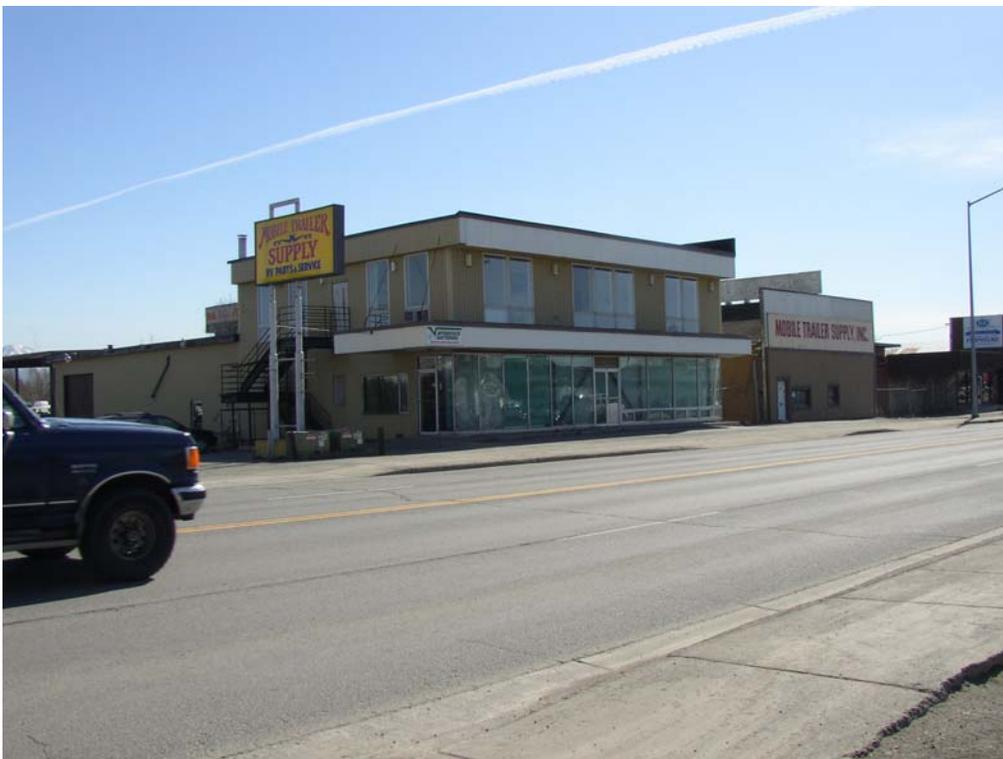
Photo 2. Front of Carey property from across Mountain View Drive (facing south).

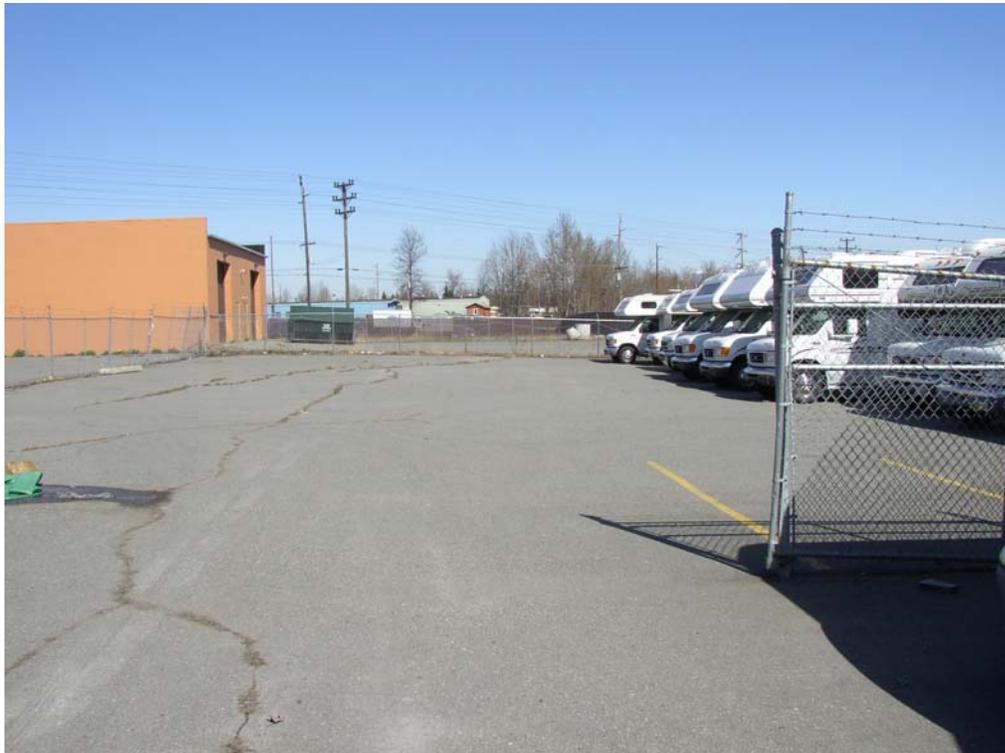
The rear portion of the property is enclosed by a chain link fence (see Figure 2-1), and late-model RVs are parked within the fenced area along the back of the property (Photo 6). There are also two storage containers located behind the RVs, against the fence; these are visible in the 2004 aerial photo in Appendix B. Several vehicles and a forklift were parked beneath the metal canopy at the time of the inspection (Photo 7). There are five automotive repair/maintenance bays in Building 2, with bay doors opening to the back of the property (Photo 8). There is a small area surrounded by the three buildings and the enclosed corridor that has broken pavement and an oil-stained patch of ground (Photo 9).

Photo 6. RVs parked behind building, with Alutiiq RV building on left side of photo (facing northeast).

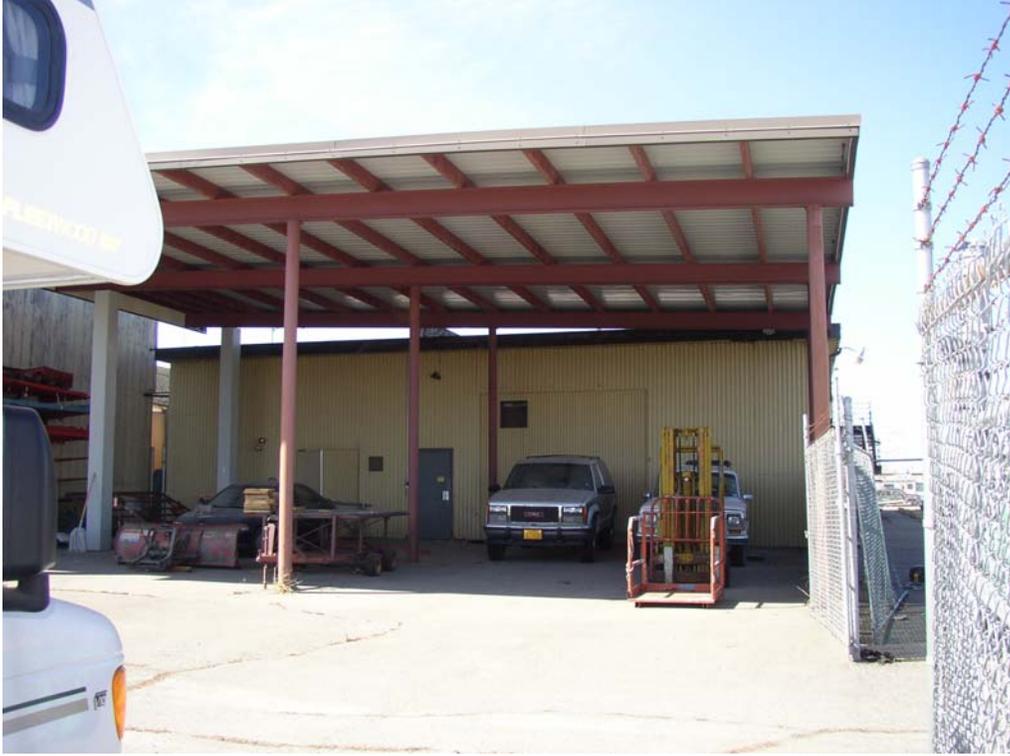
Photo 7. Covered area at the rear of Building 3, taken from the southeast end of the property (facing northwest).

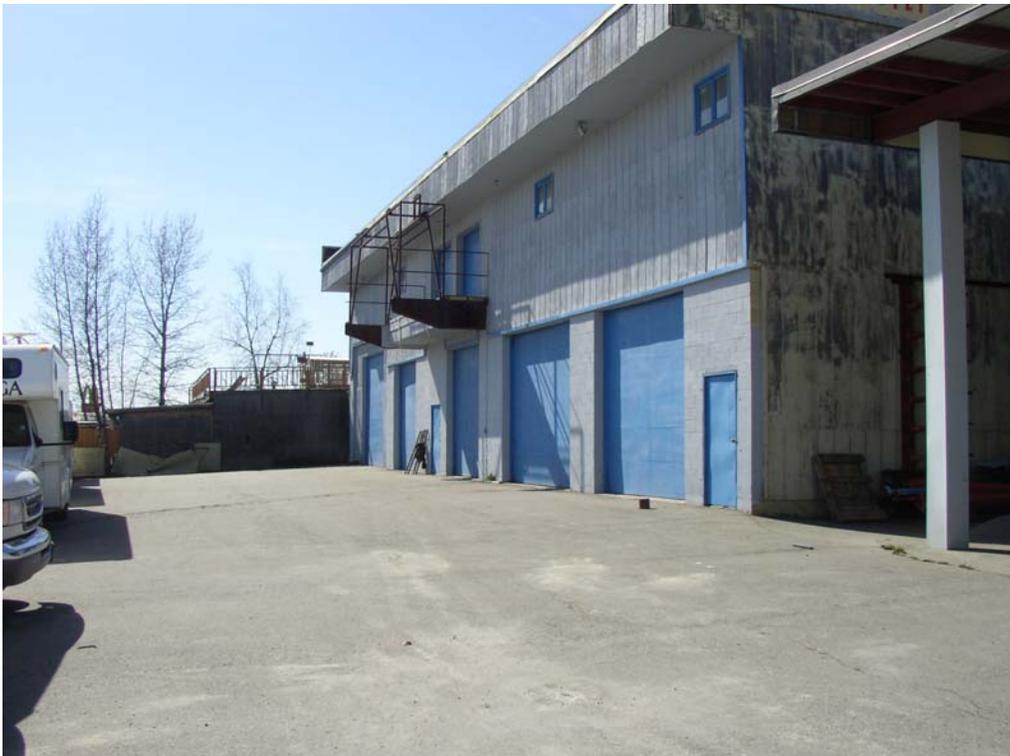
Photo 8. Bay doors at the rear of the building (Building 2, facing west).

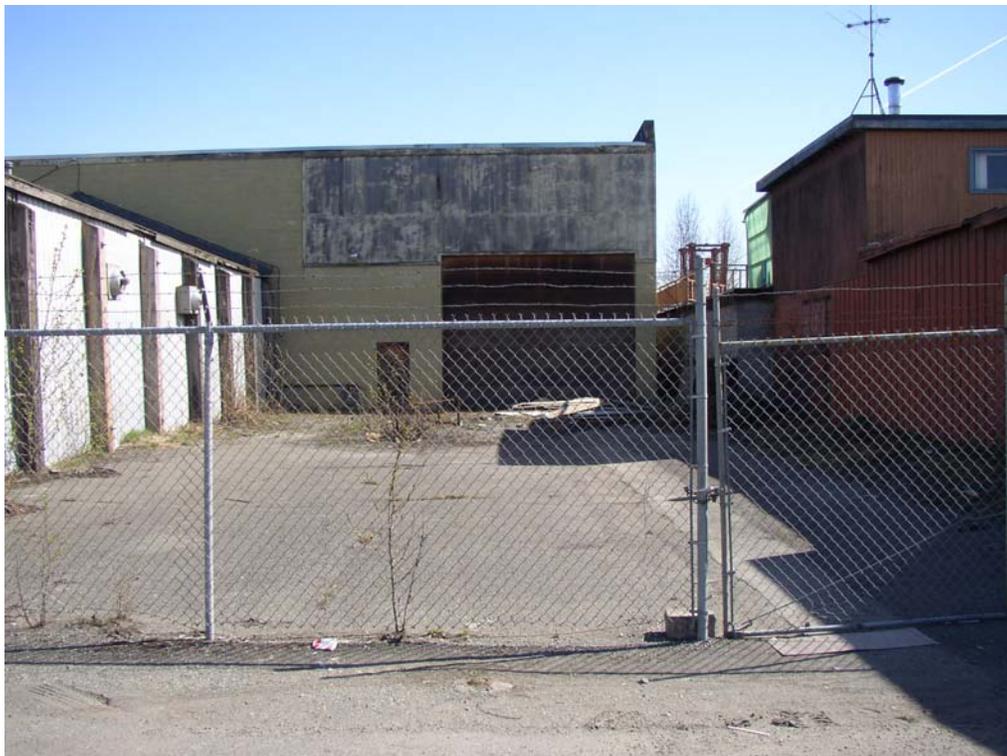
The front of the property is free of debris. The areas at the front of the property between Buildings 1 and 3 and at the southwestern edge of the property are fenced (Photo 10). There are two transformers owned by Municipal Light and Power located at the base of the sign at the north corner of the Building 3 (Photo 11). The transformers are labeled as having been tested and free of PCBs.

Photo 10. Southwestern-most edge of property; RK Unfinished Furniture building is on right side of photo (facing southeast).

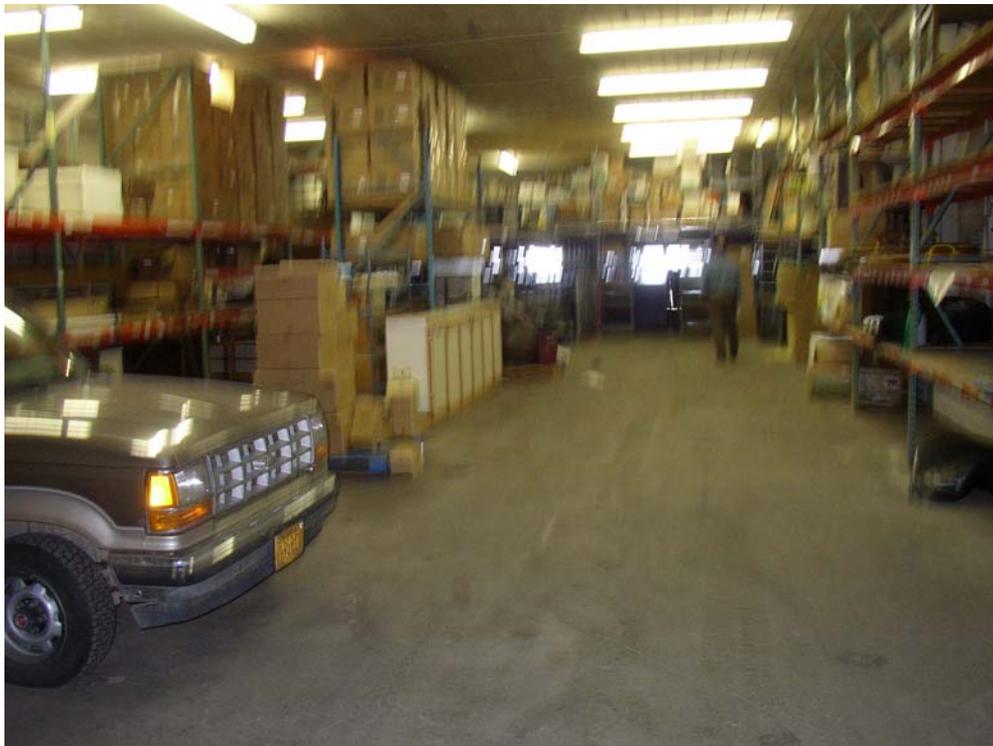
Building 1 is the original Duke Lumber building, which is currently used for storage (Photo 12). Some of the items noted in the building include tires, boxes of new products, a truck, mattresses, fluorescent light bulbs, propane tanks (Photo 13), fire extinguishers, oxygen tanks, and an air compressor. What appears to be a plugged floor drain was also observed in the building (Photo 14).

Photo 12. Original Duke Lumber building (Building 1), which currently has shelving for storage, facing toward front of building (northwest).

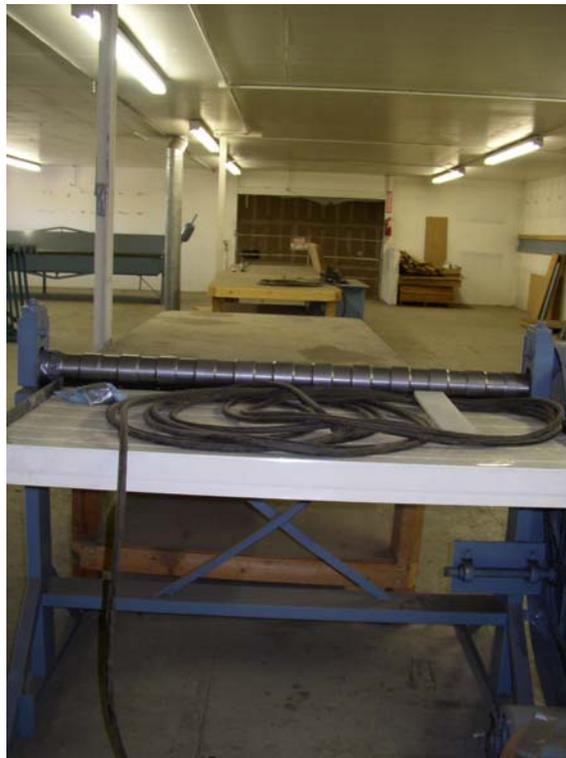
The second story of Building 2 appears to have been used as a machine shop, as it contains several large pieces of machinery, including a break press (Photo 20). No chemicals, paints, etc., are stored in the upstairs area of Building 2.

Photo 20. Machine shop space in second story above the maintenance bays (rear portion Building 2), facing toward southwest end of building.

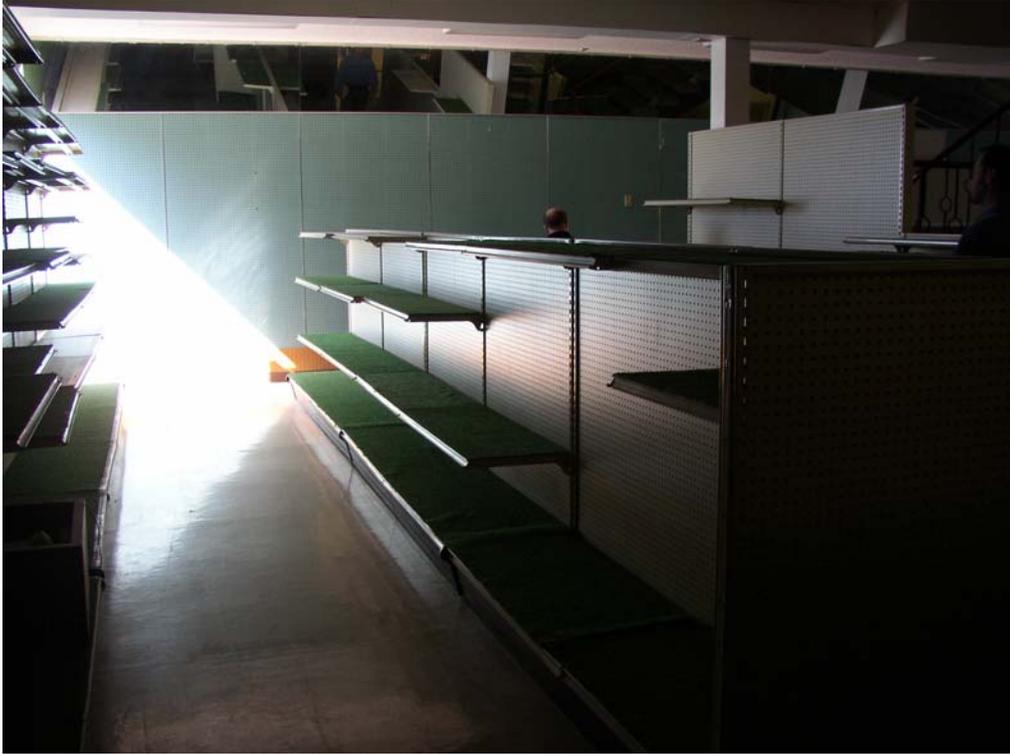
Building 3 is used primarily for office and retail space, though there is an automotive repair/maintenance bay along the back of the first floor. The first floor of the front of the building has shelving for retail items (Photo 21). Currently the shelving is empty. The boiler system is located in a closet along the northeast wall of the building and appears to be in good condition (Photo 22). There is some welding equipment located in an area in front of the maintenance bay (Photo 23), and a bathroom on the northeast side of the building. The second story of Building 3 houses office space and two bathrooms.

Photo 21. Retail area on first floor in Building 3, facing toward front of building (northwest).

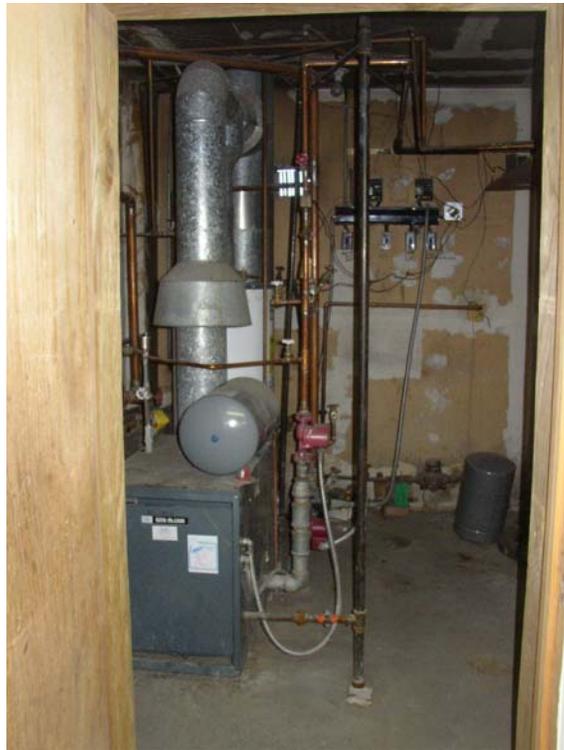
Photo 22. Boiler system located in closet along the northeast wall of Building 3 (facing northeast).

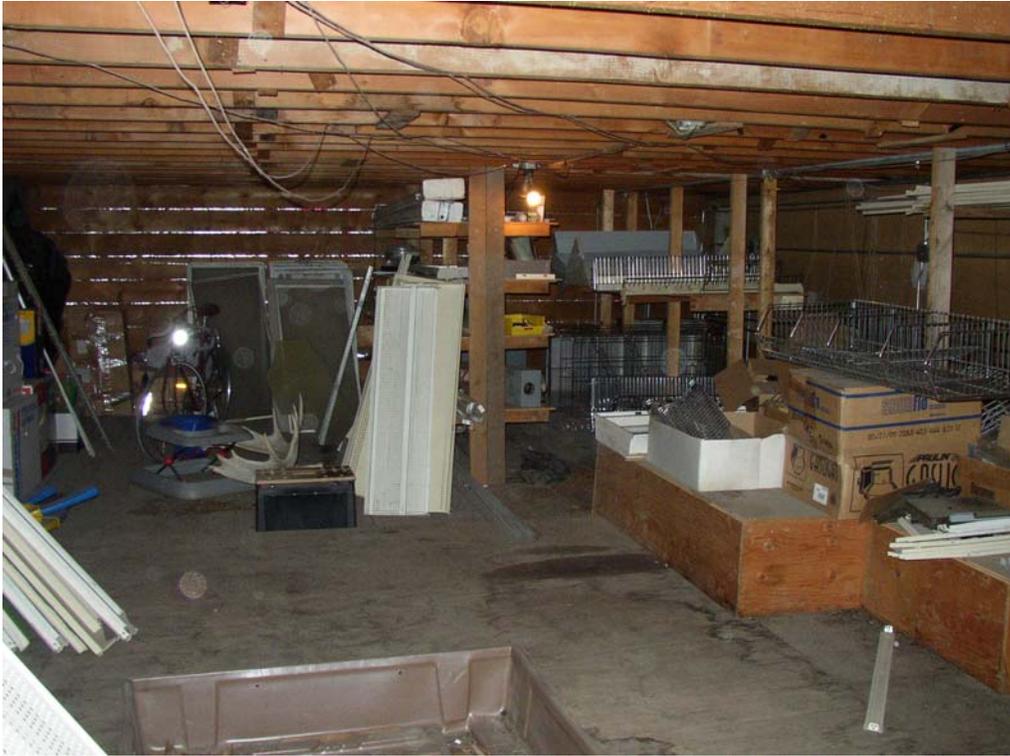
The maintenance bay in Building 3 contains a forklift, a truck, cans of paint, and mechanical equipment (Photo 24). A door in this bay opens out onto the back of the property, beneath the metal canopy. No floor drain was evident in this area. A loft area is accessed from the bay, which is used for storage (Photo 25). A 5-gallon can of Stoddard solvent was observed in the loft area (Photo 26).

Photo 25. Loft area over the auto maintenance bay located to the rear of Building 3, used for storage of various items.

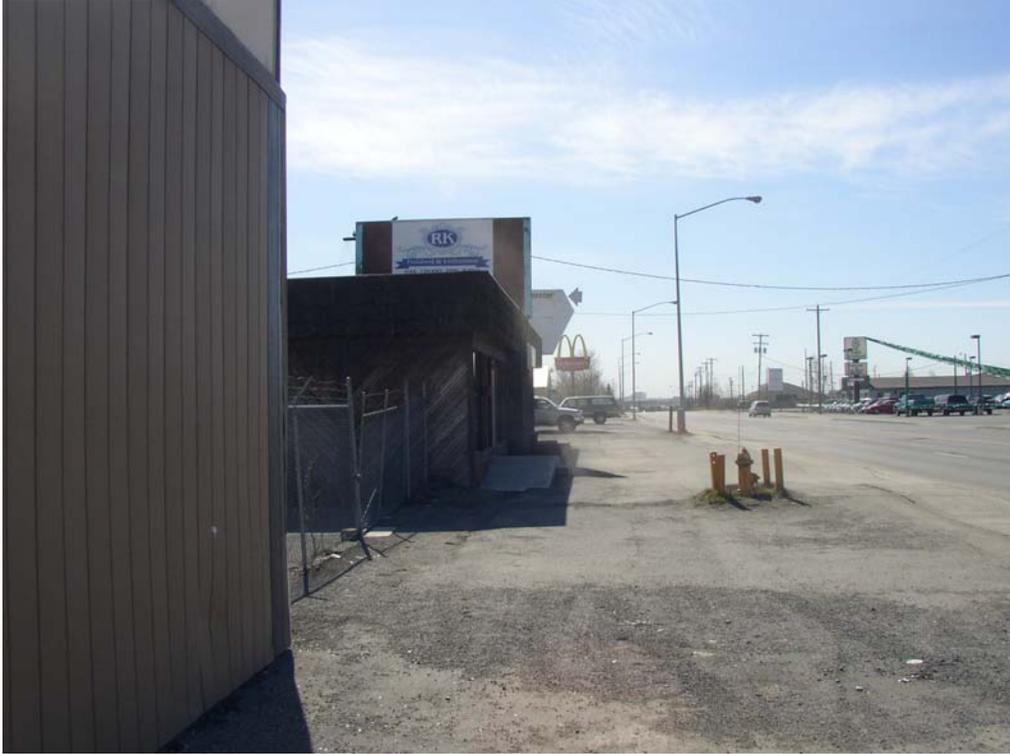
Adjacent properties are used for industrial/commercial purposes. RK Furnishings is located on the southwest edge of the property (Photo 27); Mountain Park and Liquidate (Photo 28) and Checker Auto (Photo 29) are located across from the property; and Alutiiq RV is located on the northeast edge of the property (Photo 30). None of these properties show any evidence of having an adverse environmental impact to the subject property, nor are they listed on any of the databases discussed in Section 4.1.

Photo 27. RK Furnishings building and McDonalds in background, taken from front of property (facing southwest).

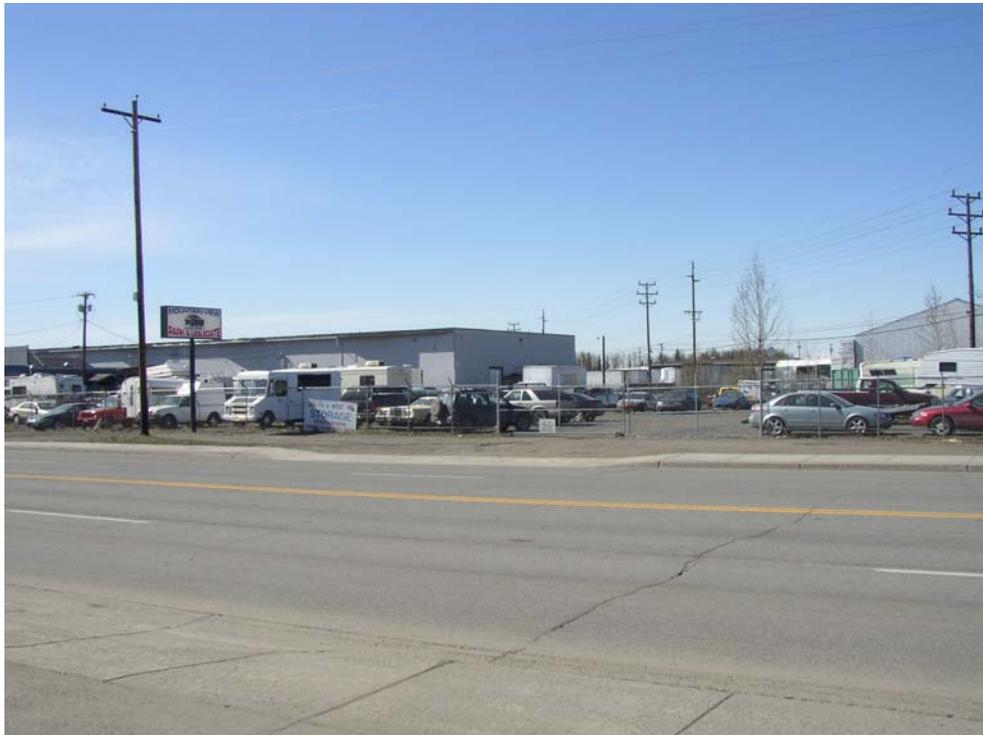
Photo 28. Mountain View Park and Liquidate across Mountain View Drive from Carey property (facing northwest).

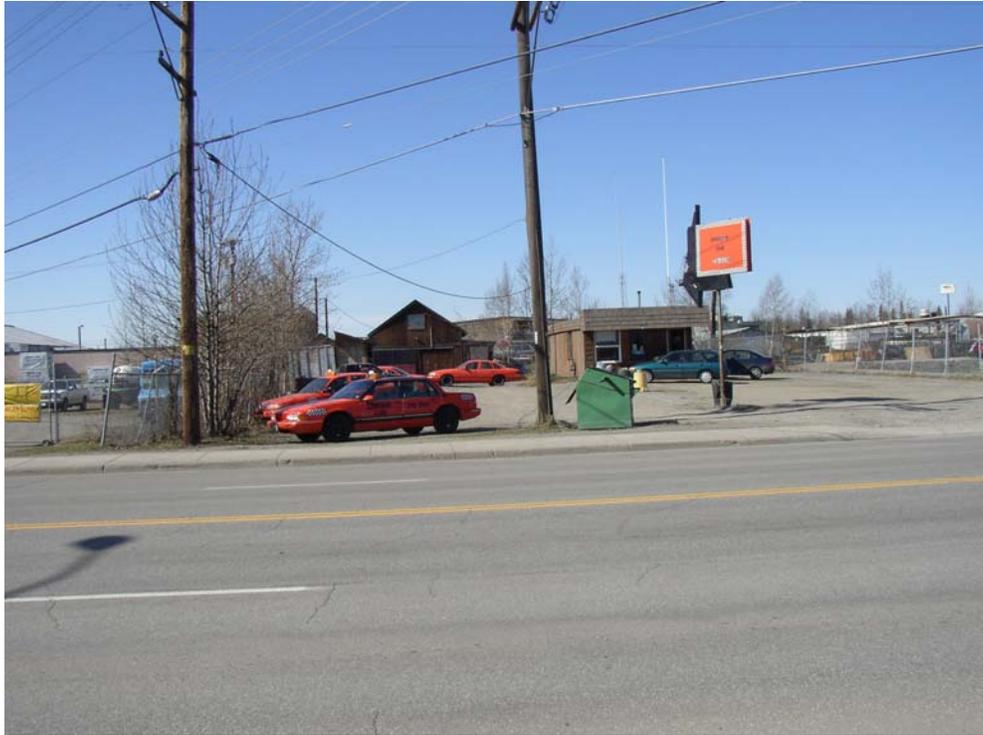
Photo 29. Checker Auto, taken across Mountain View Drive (facing northwest).

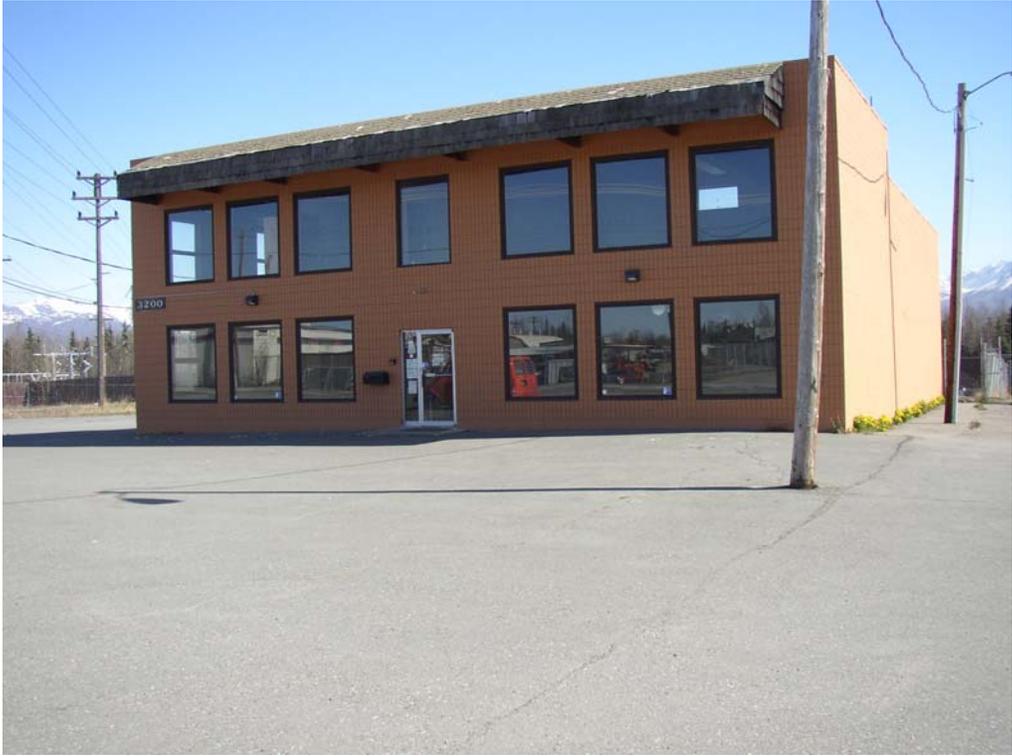
Photo 30. Front of Alutiiq RV building (facing east).
