DRAFT
Limited Site Assessment and
Hazardous Building Materials Survey
Former Arctic Village Power Plant
Arctic Village, Alaska

May 2016

**LIMITED SITE ASSESSMENT AND
HAZARDOUS BUILDING MATERIALS SURVEY
FORMER ARCTIC VILLAGE POWER PLANT
ARCTIC VILLAGE, ALASKA**

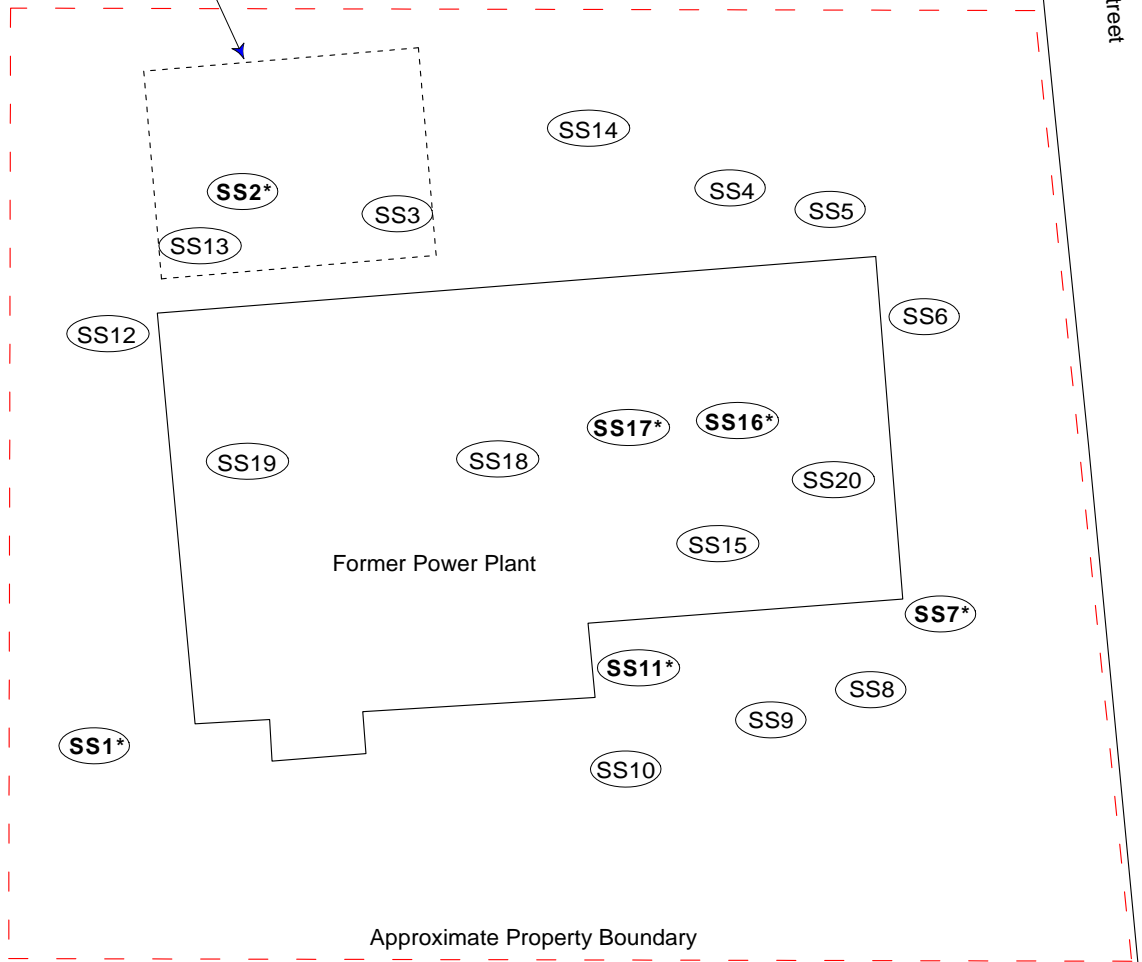
Former Arctic Village Power Plant Arctic Village, Alaska	
SITE PLAN	
May 2016	32-1-17754-001
  SHANNON & WILSON, INC. Geotechnical & Environmental Consultants	Fig. 2

N	W
SS1	68.12540	145.53847
SS2	68.12561	145.53848
SS7	68.12550	145.53809
SS11	68.12550	145.53827
SS16	68.12554	145.53825
SS17	68.12557	145.53833

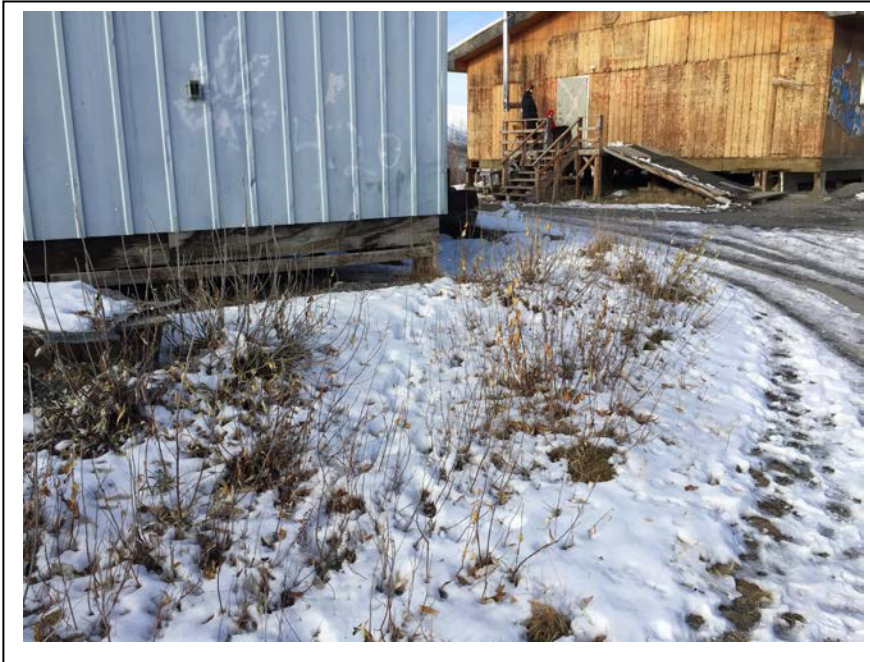
Photograph 5: Looking northwest at the former power plant and the Arctic Village Store/Youth Center. (September 22, 2015)

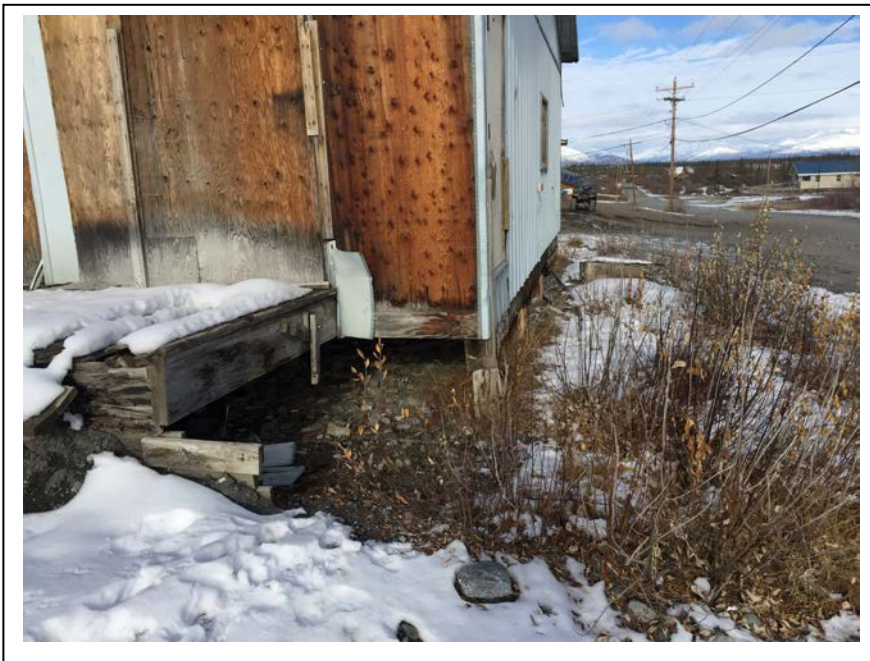
Photograph 6: Looking north at the former power plant and Main Street. (September 22, 2015)

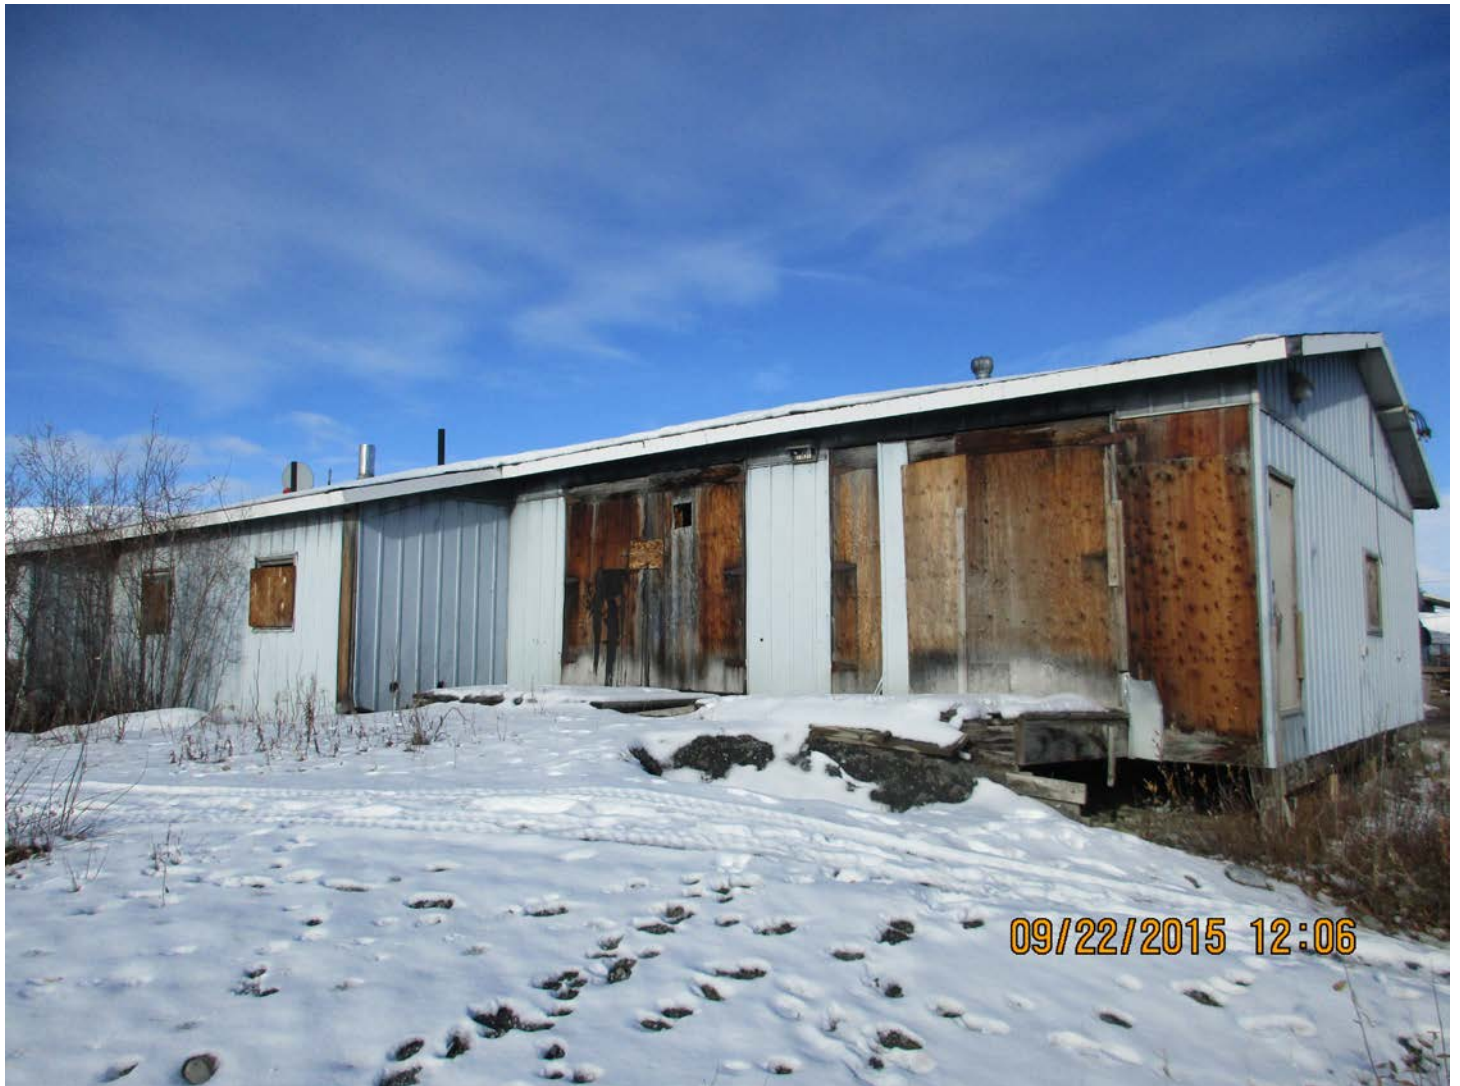
Figure 1 – The former Arctic Village Power Plant, in Arctic Village, Alaska.
