Property Assessment and Cleanup Plan **Former Moravian Church** Kwigillingok, Alaska

By:
Shannon & Wilson, Inc.
5430 Fairbanks Street, Suite 3
Anchorage, Alaska 99518

November 2013

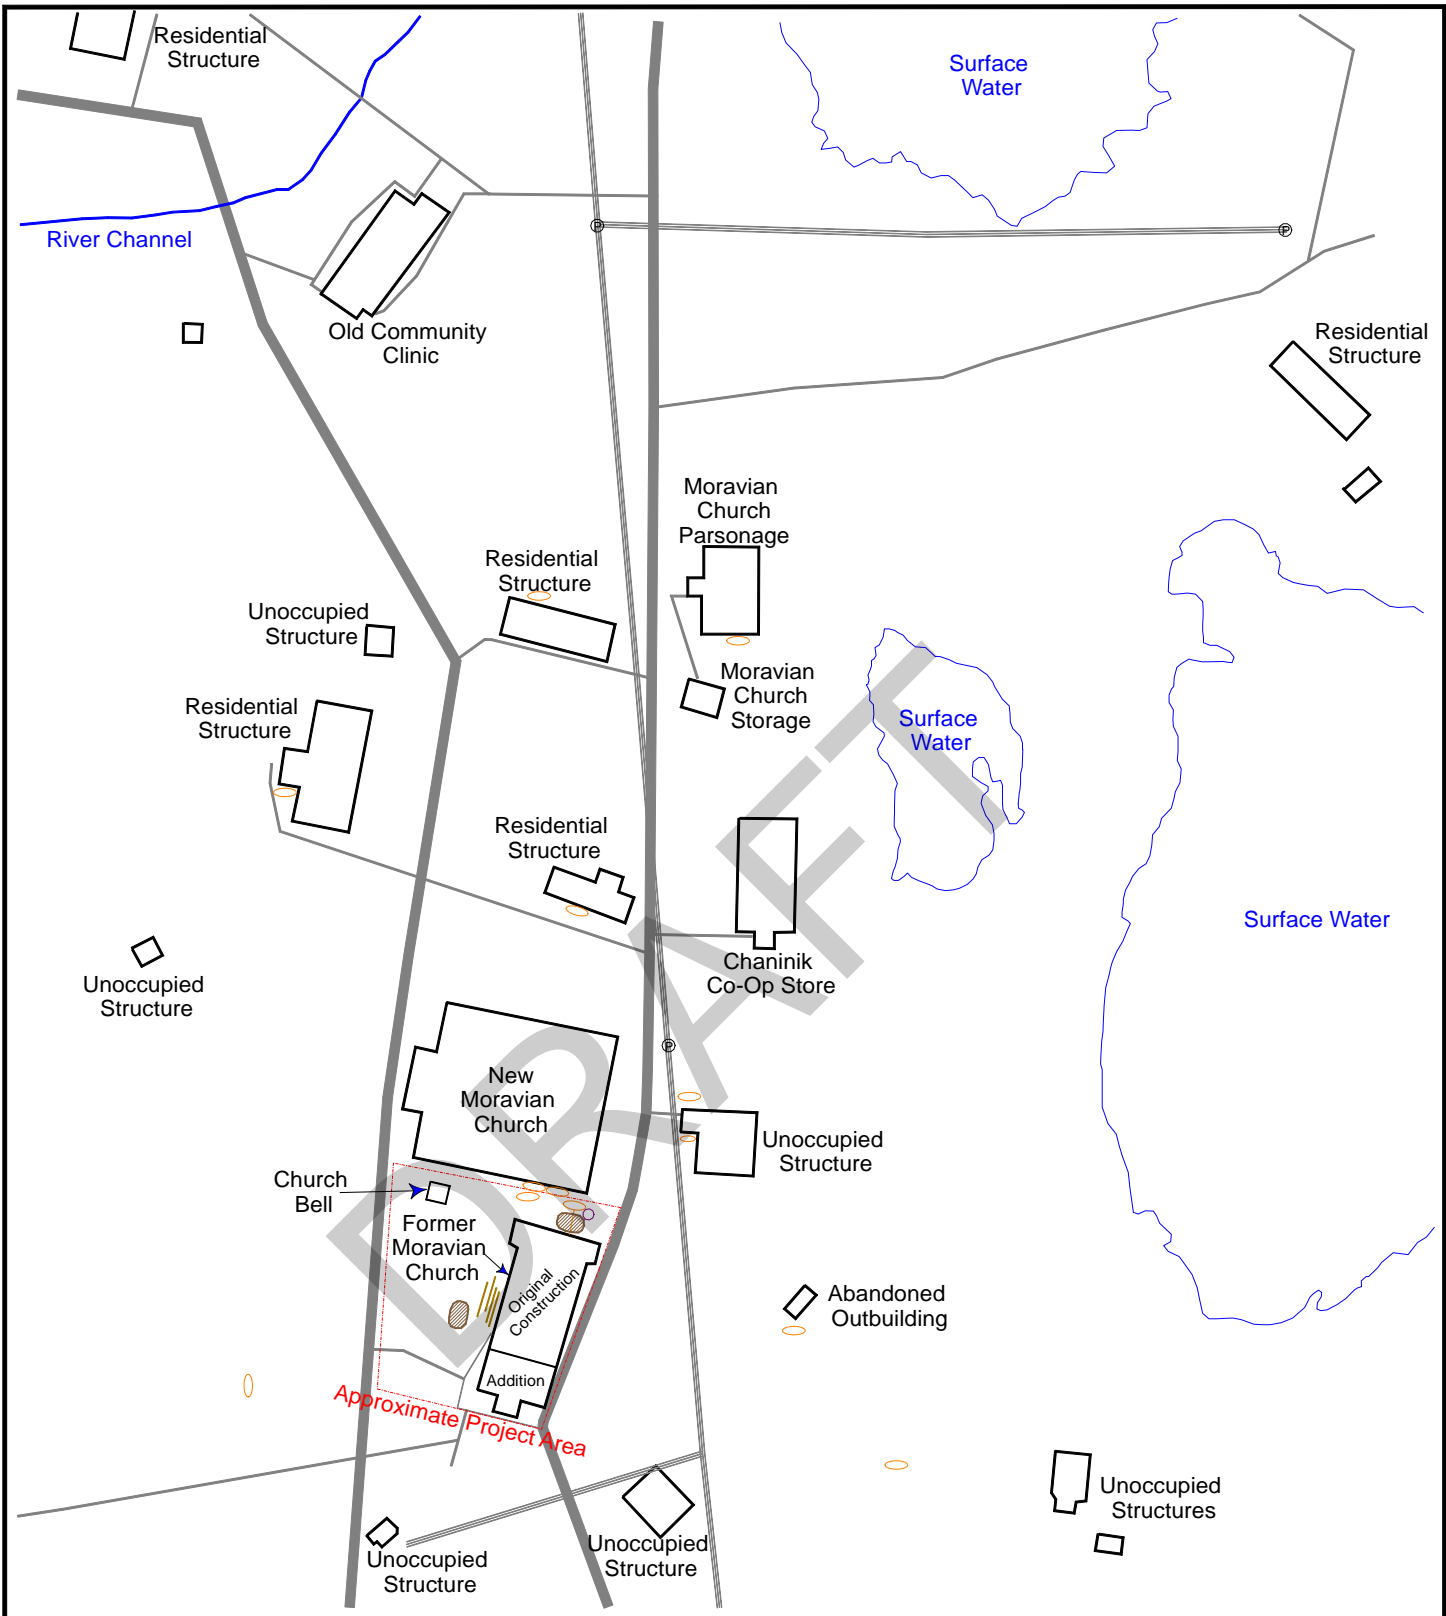
Former Moravian Church Kwigillingok, Alaska	
SITE PLAN	
November 2013	32-1-17593
SHANNON & WILSON, INC. Geotechnical & Environmental Consultants	Fig. 2

Discarded construction materials are stored north and west of the Old Church as shown in Photos 7 and 8 and on Figure 2. Additional materials were observed under the Old Church structure (Photo 9). What appear to be felled utility poles are located along the northwestern portion of the structure (Photo 10).

The new church is located adjacent north of the Old Church building. The new church is serviced by two 300-gallon heating oil tanks as shown in Photo 11 and on Figure 2. According to Mr. John, the ASTs were installed in 2011. Evidence of leaks and/or spills associated with the ASTs was not observed during the September 9, 2013 site visit. ASTs were also observed adjacent to multiple structures as shown on Figure 2.

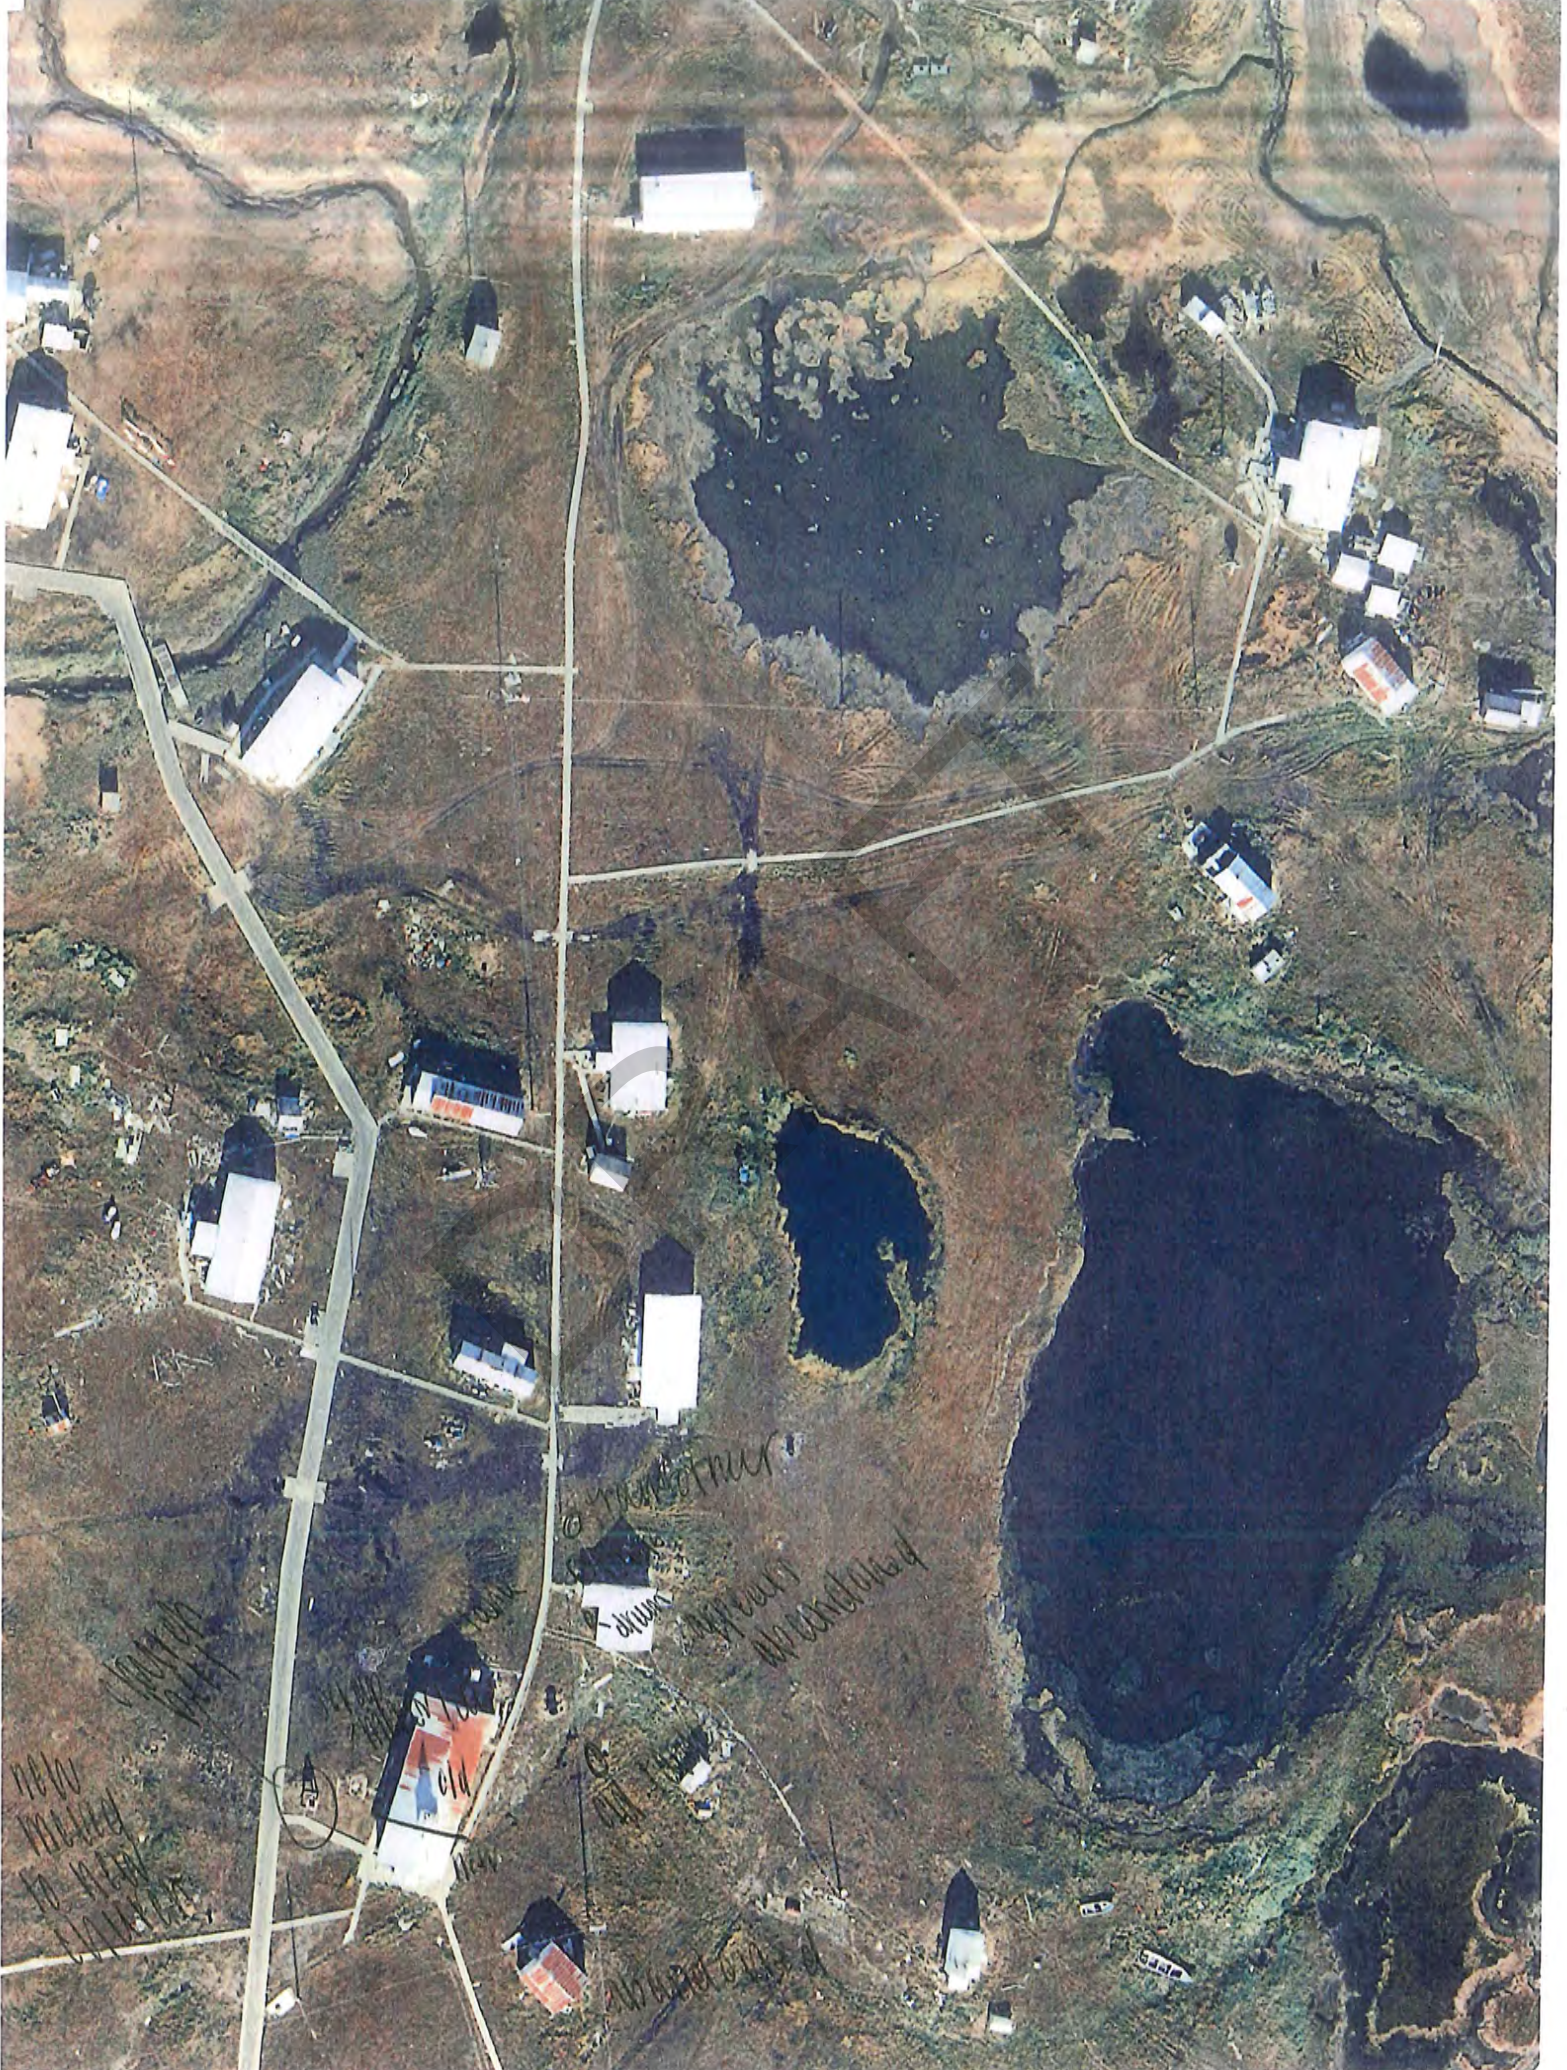
The Old Church is a single-story structure located in the southern portion of Kwigillingok. The Old Church is currently abandoned and access is restricted with plywood panels attached with screws over the doors and arctic entry (Photo 1).

Photo 1: Exterior of the Old Church; looking north.
(September 9, 2103)
