Investigation Report - Final

**Site Name: Old School
Chevak, Alaska
Hazard ID: NA**

**E3 Environmental, LLC
219 East International Airport Road, Suite 100
Anchorage, Alaska 99518**

November 17, 2015

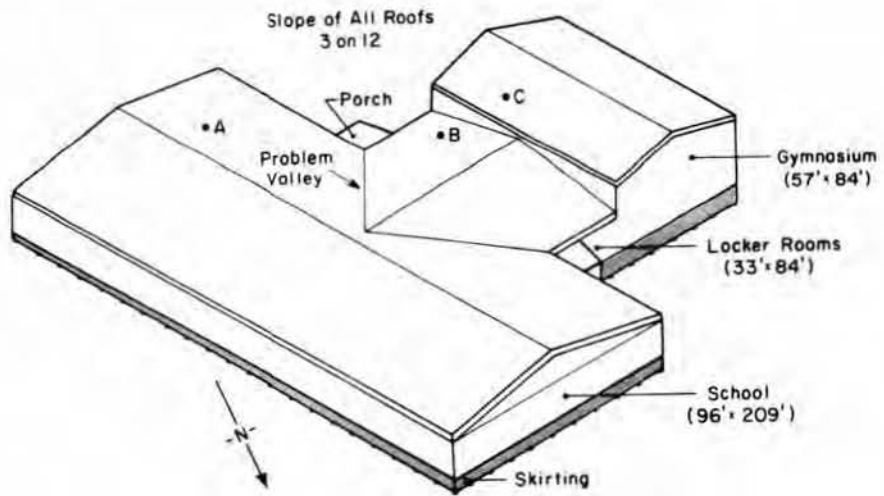
Figure 2. Isometric drawing of Chevak school.

Once the building was occupied, severe leaks developed in the areas of the roof valleys, particularly in the lower portion of the "problem valley" shown in Figure 2. Valley leaks were caused by entry of snow meltwater. These leaks did extensive damage to the suspended ceilings and threatened to ruin the carpet and other inside furnishings.

were lifted at points A, B and C in Figure 2. A small amount of frost was present on the underside of the roofing at point A. A quarter-inch of frost was present at B and 3/8 in. was present at C where some ice was observed on the insulation. These observations convinced all concerned that large quantities of warm moist air from within the building passed into the roof through gaps in the plywood deck and others in the insulation above. The underside of the cold corrugated metal roofing was an excellent condenser and, as the warm moist air passed up through the roof sandwich, frost formed on the metal. Warmer weather and sunshine warmed the frosted underside of the corrugated metal roofing. At some point it was warm enough to melt the frost and meltwater dripped onto the insulation where it either refroze, or in warmer weather flowed downslope. At a gap or seam in the insulation, the water flowed down to the deck. Since there were many gaps in the plywood deck, the water leaked into the building.

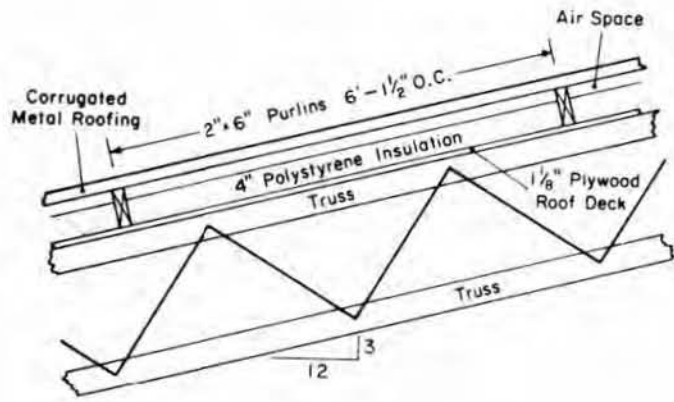
Figure 3. Cross section of roof.

The complex is elevated above the ice-rich permafrost on wooden piles. Wooden skirting, open near the ground, is present along the perimeter of the building. Glued laminated wooden floor beams placed on the piles support wood floor trusses. Steel and wooden columns and bearing walls with 2 × 6 studs support the roof which, like the floor, consists of glued laminated roof beams, wooden trusses and the roof itself. Each roof is sloped 3 on 12 and consists of a 1-1/8-in. plywood deck resting on the roof trusses. Above the plywood, 2 × 6 purlins run along the roof, 6 ft—1 1/2 in. on center, parallel to the eaves. Four inches of expanded bead polystyrene insulation is placed between the purlins which support corrugated metal roofing. This roof system is shown in Figure 3. No vapor barrier is indicated on the as-built drawings.

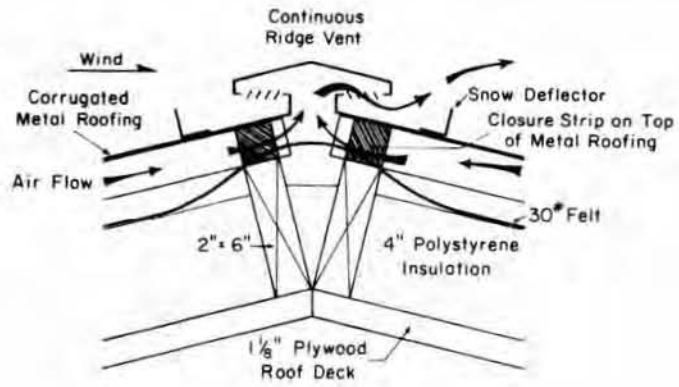
Figure 5. Detail of ventilated ridge.

The ridge is the only safe place for maintenance personnel to walk along these roofs, particularly when there is snow on them. Accordingly, the ridges have been used as foot paths and the ridge vents (Fig. 5) have been flattened against the ridges. Although crushed, some air can still pass through them. The flattened ridge vents should be removed and replaced with elastomeric closure strips and a solid galvanized cap, robust enough to sustain foot traffic. Every 20-ft, the ridge cap should be penetrated with a 2-½-to 3-in.-diam, 24-in.-high black-painted vent stack (upside-down). The eaves should remain blocked to preclude snow infiltration. If the roof is vapor-sealed as recommended above, we expect that the combination of local winds, air leaks in the metal roofing, and the modified ridge ventilation system will provide enough air movement to facilitate the small amount of summer drying required by the roof.

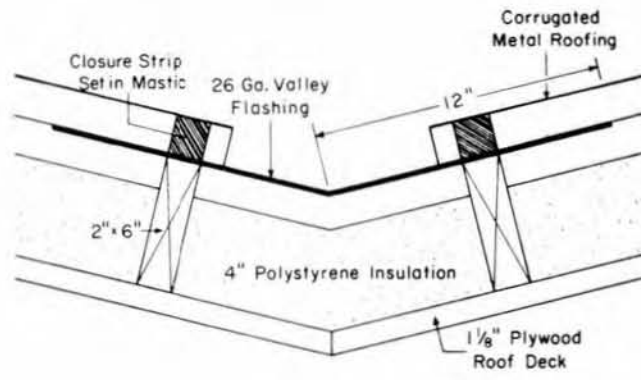
Figure 8. Valley detail.

Figure 8 is a cross section of the Chevak school's roof valley. Considering the thermal movements to which the metal is subjected, it must be assumed that the seals between the flashing, closure strip and corrugated metal are not water-tight. As long as the valley is clear, water drains down the valley and off the roof. However, when the valley contains slush and ice, meltwater rises in the valley and gets behind the closure strips (Fig. 8). Since the depth of the channel provided by the valley flashing is only about 2 in., it does not take much ice and slush to cause water to overtop the flashing and enter the roof.

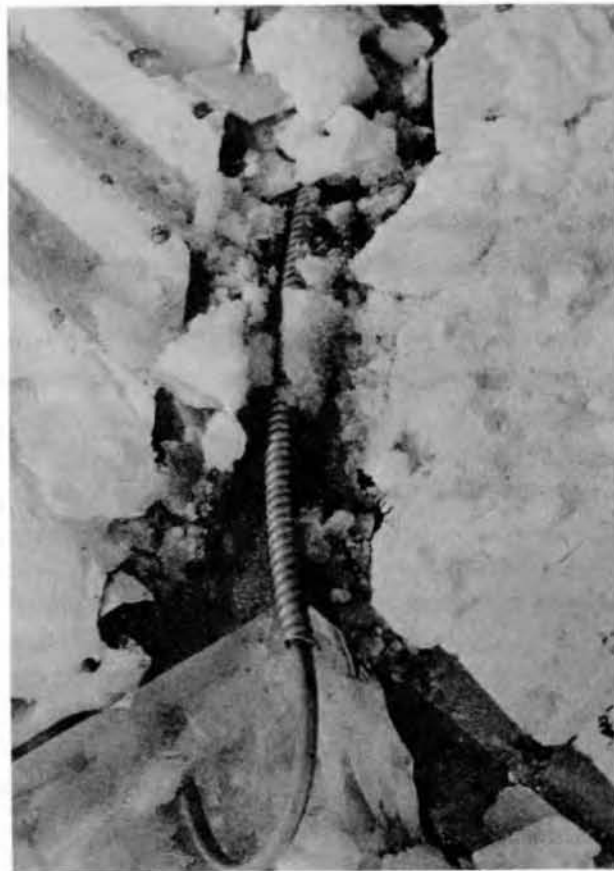
BIA personnel solved the problem of valley leaks by installing electrical heat tapes in the lower half of each valley (Fig. 9). These heat tapes maintain an open channel down each valley which allows drainage of the meltwater.

Figure 9. Electrical heat tape that has prevented the formation of slush and ice dams in the valley.

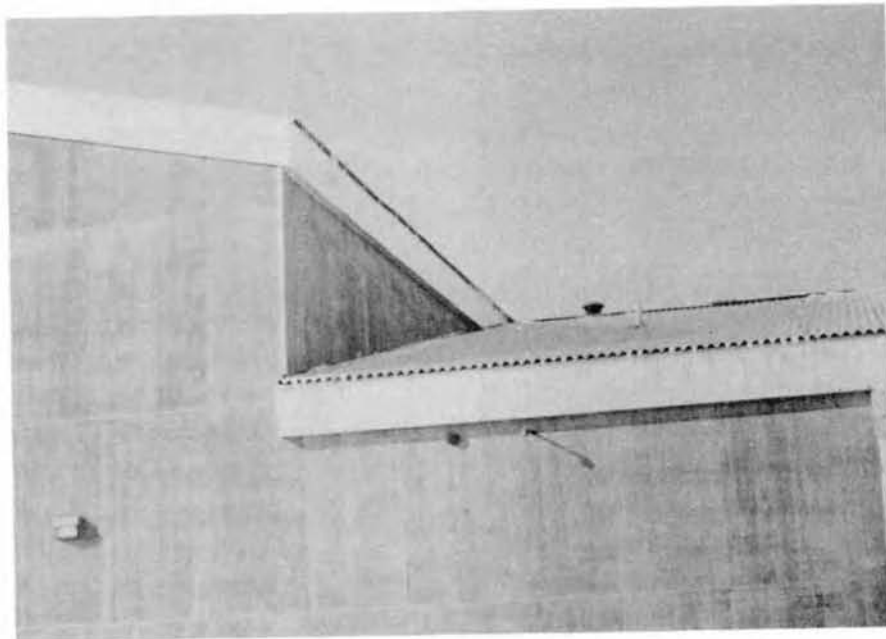
Figure 11. Intersection of gymnasium wall and locker room roof.

Leaks also developed at the intersection of the locker room roof and the gymnasium wall (Fig. 11). Water from these leaks damaged walls in the boys' and girls' locker rooms.

We did not investigate the leaks at the intersection of the gymnasium wall and the locker room roof. BIA personnel speculated that meltwater from the gymnasium roof was entering the ridge vent of the locker room roof where that roof intersects the wall of the gymnasium (Figs. 2 and 11).

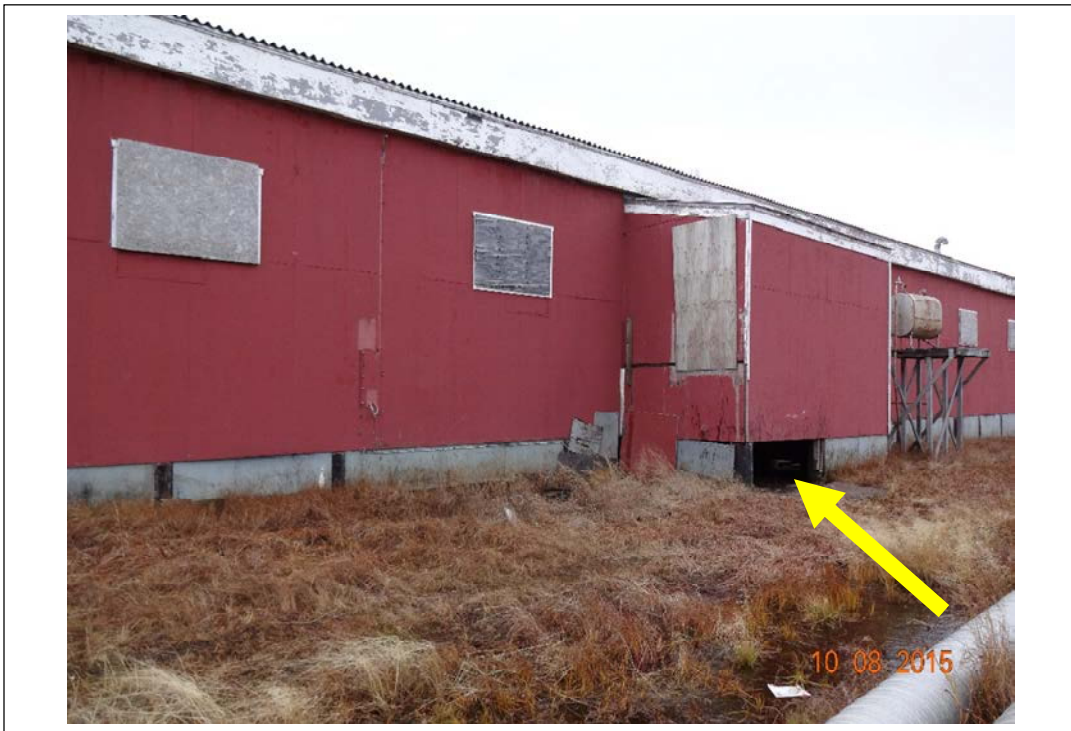
Photo 19. Northeast edge of school. Looking approximately southwest. The picture below is taken where the arrow points. October 8, 2015.

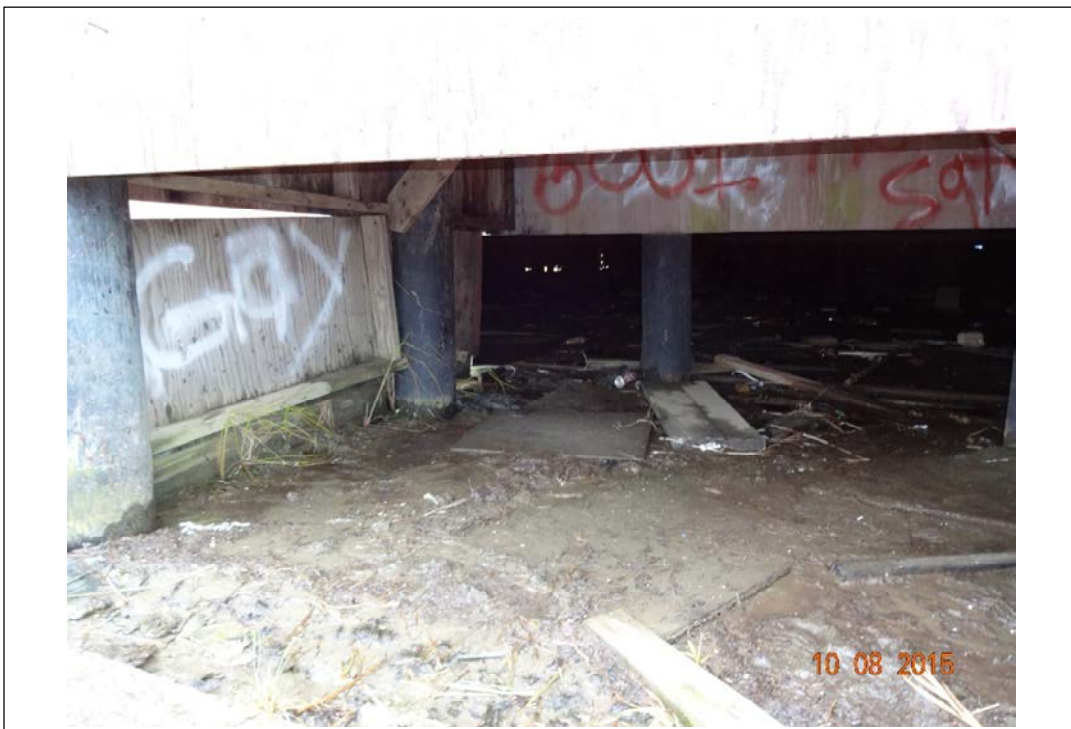
Photo 20. Northeast edge of school. Looking approximately southwest. This picture was taken where the arrow points in the above picture. October 8, 2015.

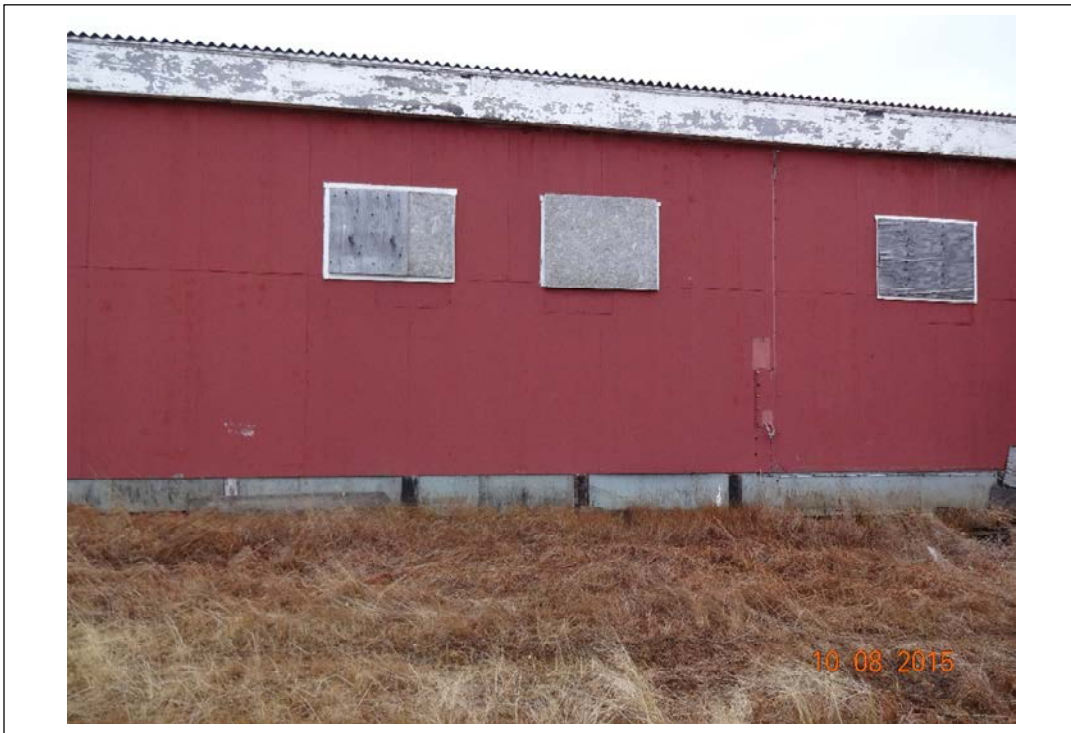
Photo 21. Northeast edge of school. Looking approximately southwest. October 8, 2015.

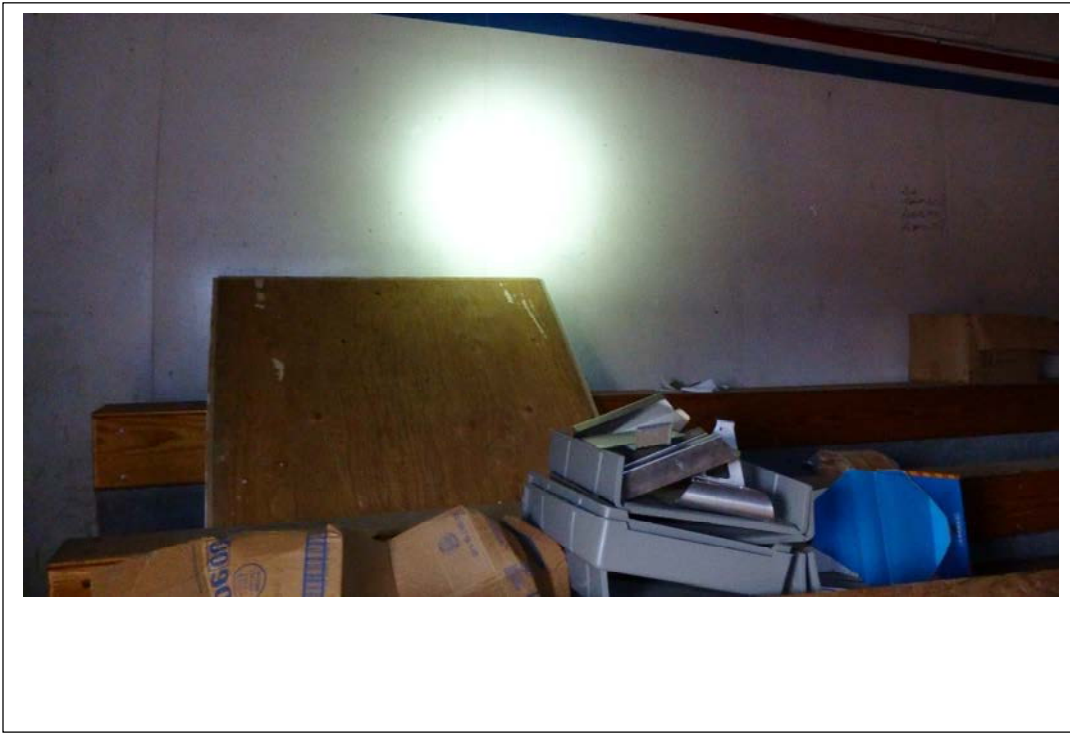
Photo 1. General interior conditions. Gymnasium. October 8, 2015.

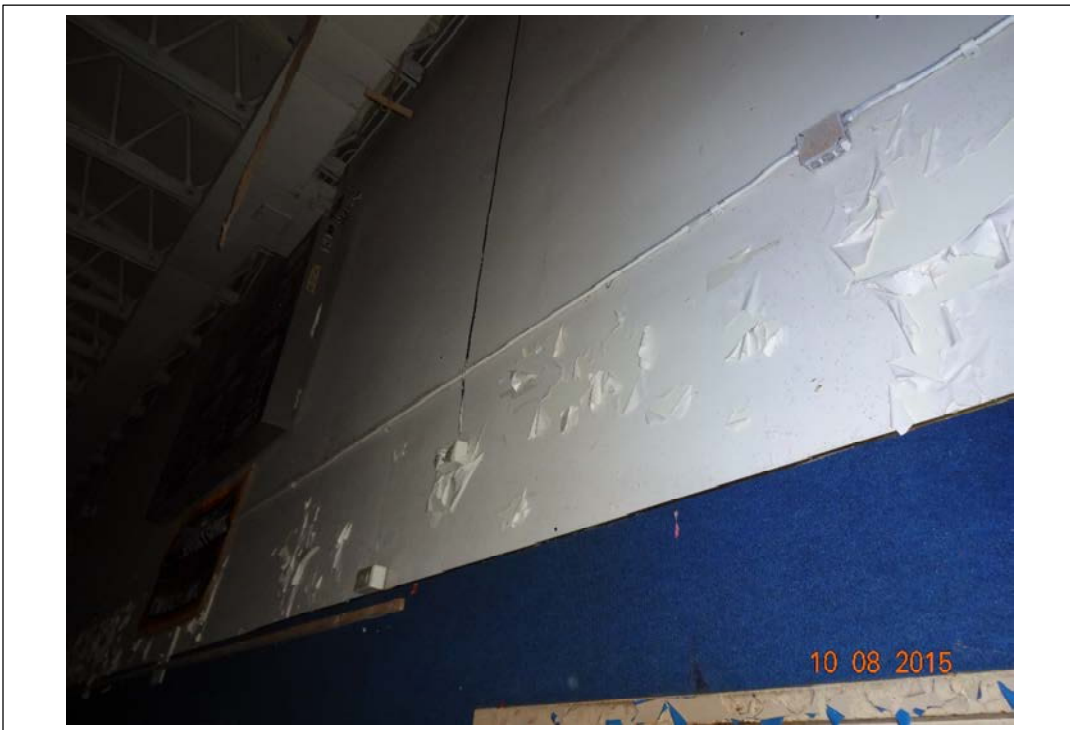
Photo 2. General interior conditions. Gymnasium. October 8, 2015.

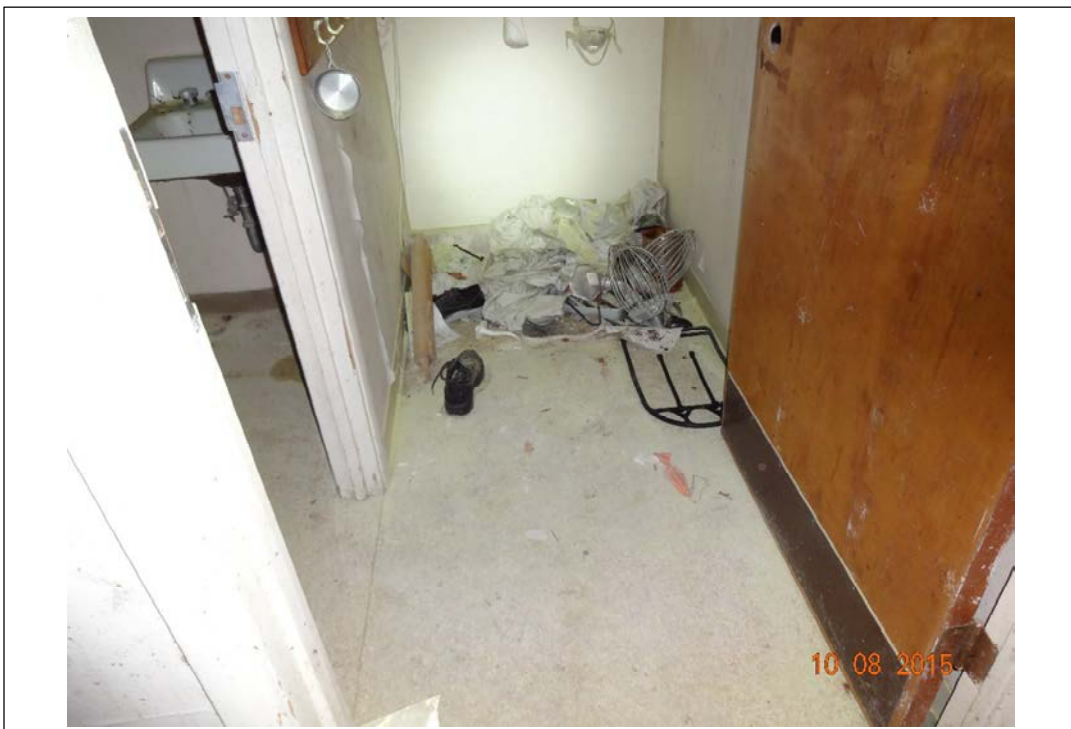
Photo 8. Asbestos-containing linoleum linoleum in Room 10. October 8, 2015.

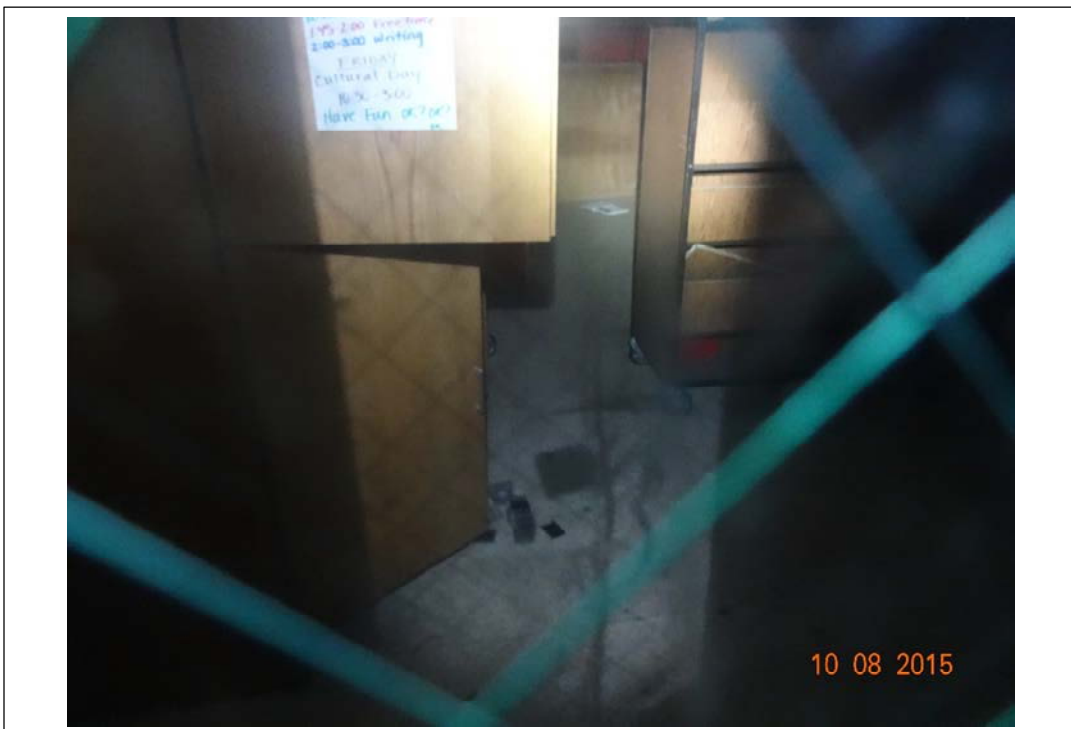
Photo 14. Asbestos-containing linoleum in Room 43. October 8, 2015.

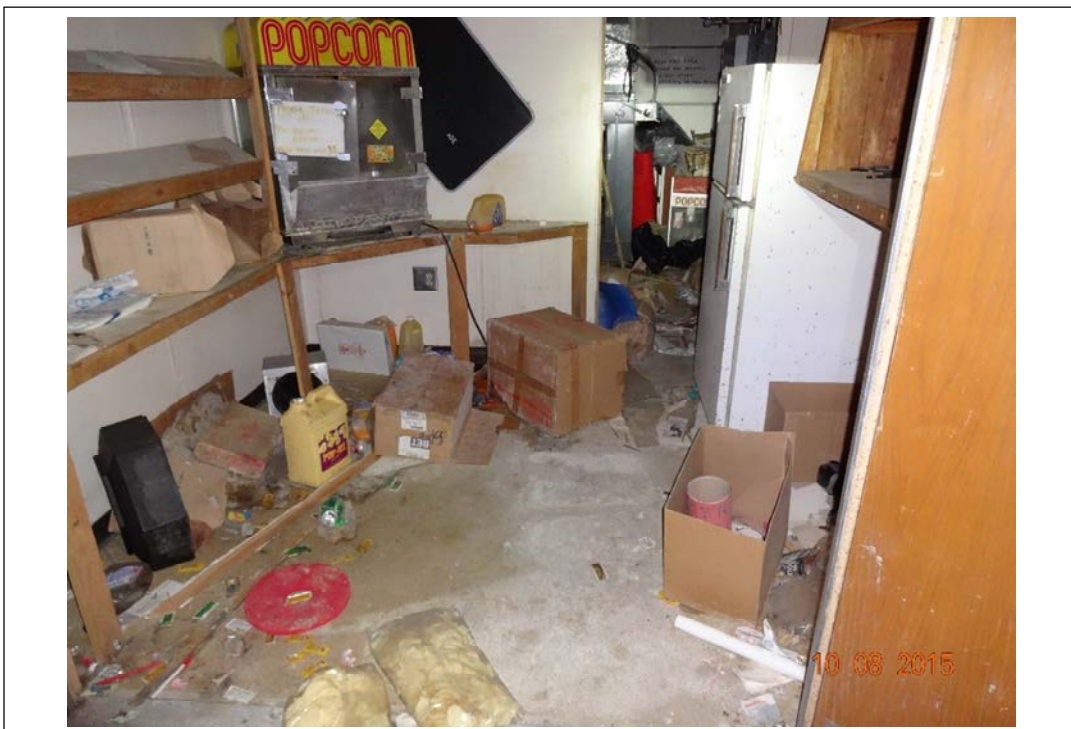
Photo 16. Asbestos-containing linoleum of Room 61. October 8, 2015.

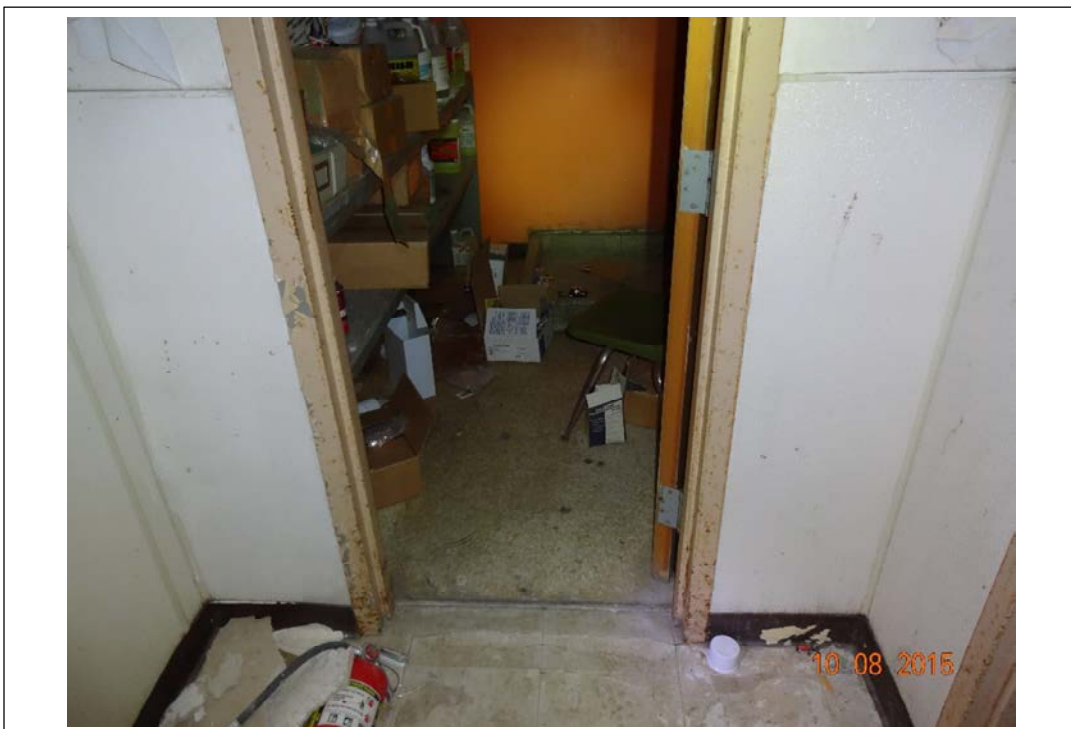
Photo 18. Room 56. Not cited on the November 4, 1991 notice as asbestos-containing but appears to be same linoleum as asbestos-containing rooms. October 8, 2015.

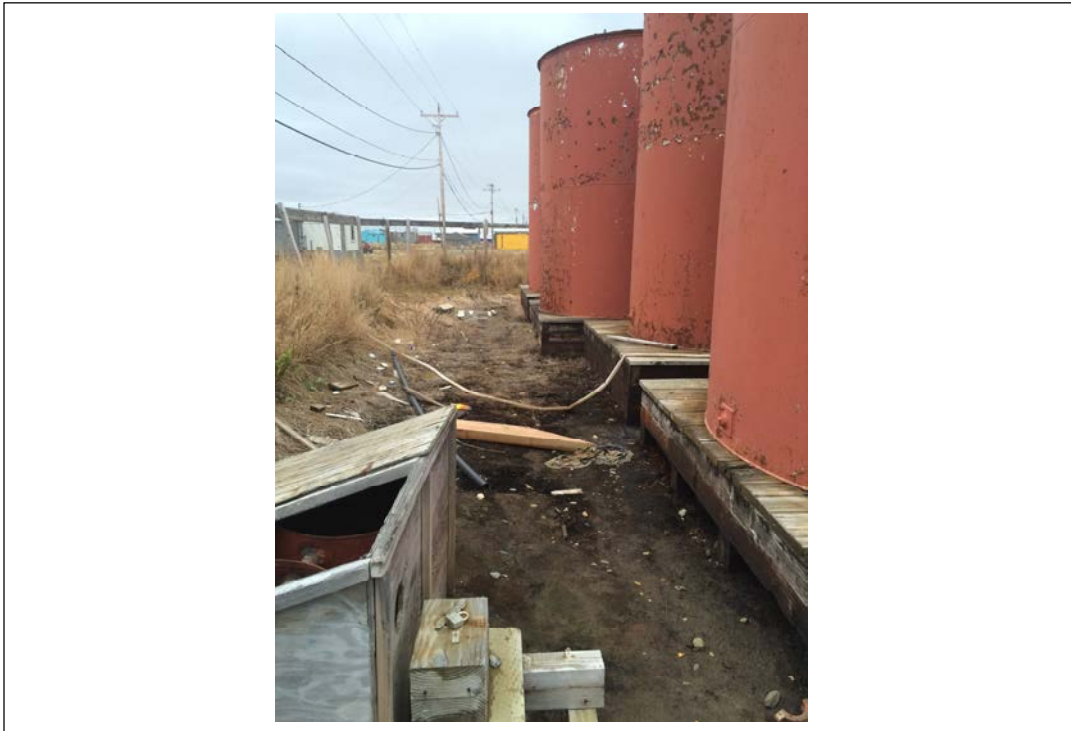
Photo 1. Taken from east corner of Old School Tank Farm. Looking southwest. October 8, 2015.
