# DETAILED ACTION PLAN SHAGELUK CITY TANK FARM

## WASTE EROSION ASSESSMENT & REVIEW (WEAR)

MAY 2015

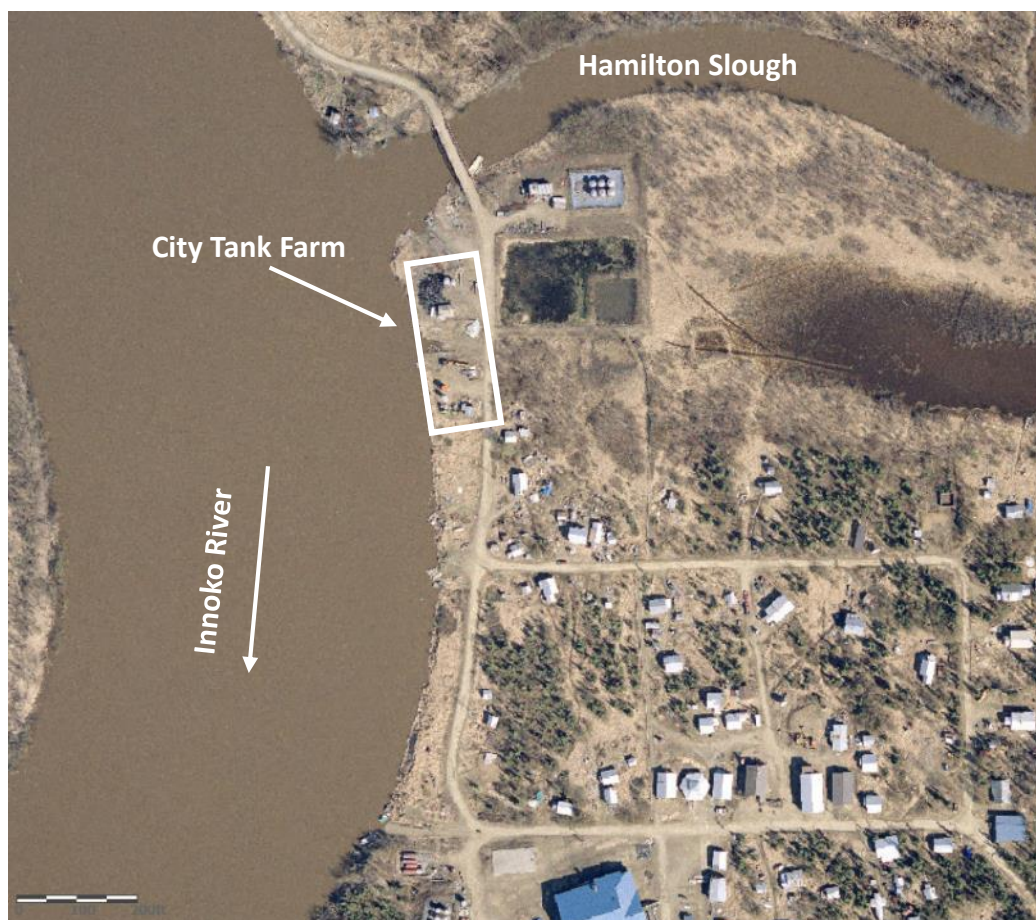
Imagery Dated 2001. WEAR Map at <http://dec.alaska.gov/eh/sw/wear.html>

The **Shageluk City Tank Farm** is located at latitude 62.657605 and longitude -159.534266 and was inspected for the Waste Erosion Assessment and Review (WEAR) project on September 11, 2013. The tank farm is owned and operated by the City of Shageluk. This site includes two tank farms, a shed containing potentially hazardous materials, and a variety of materials and debris.

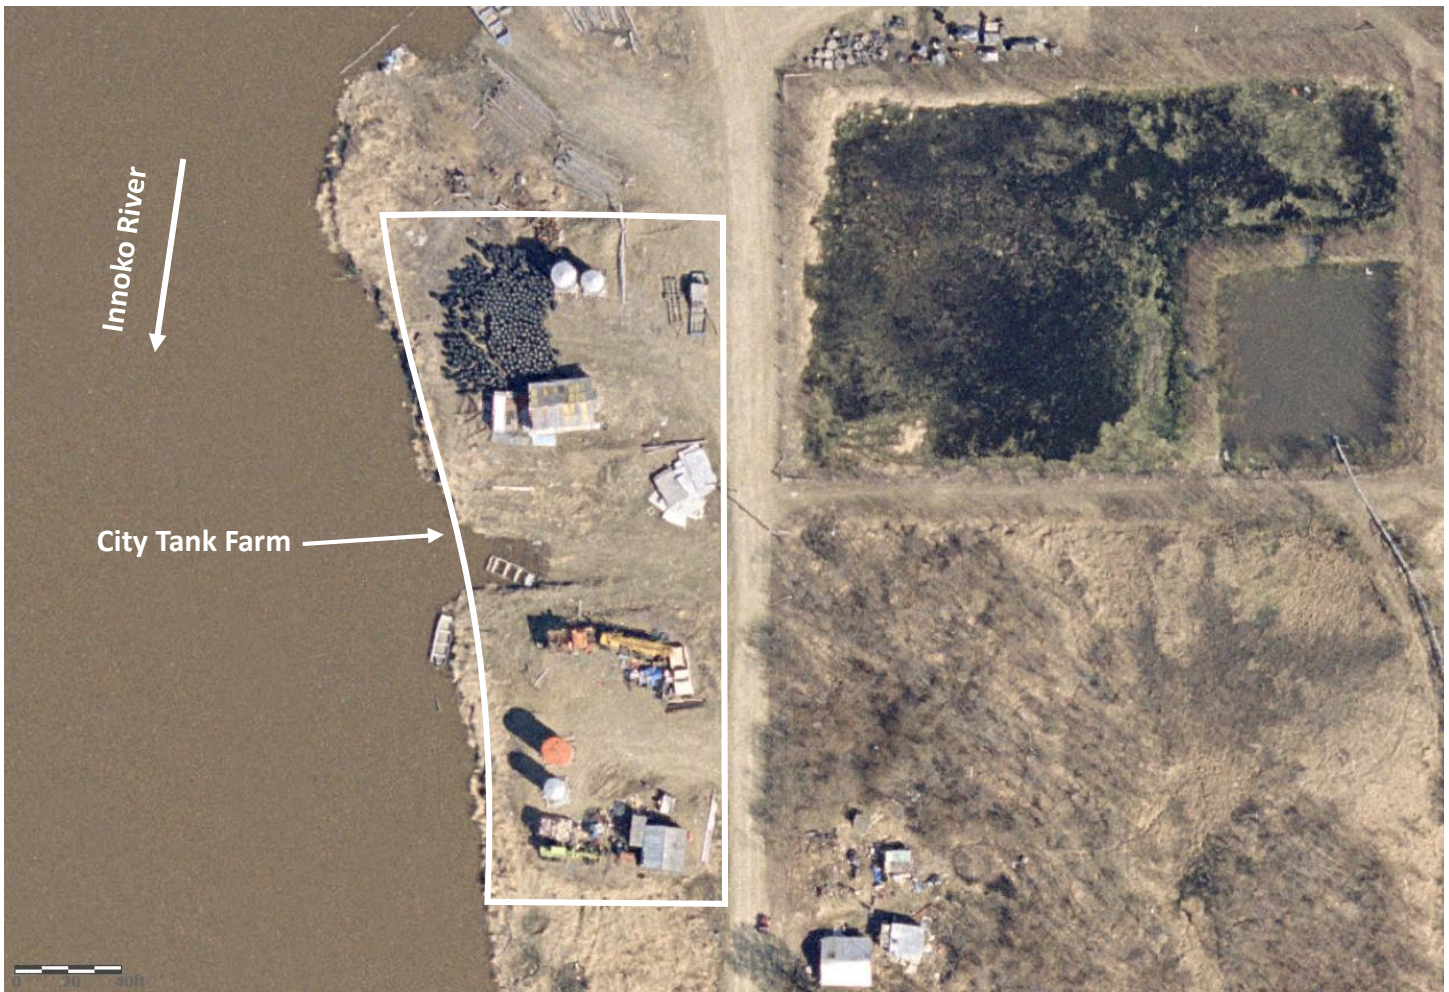
Imagery Dated 2001. WEAR Map at <http://dec.alaska.gov/eh/sw/wear.html>

Note: The above image does not include a 3rd grey tank with the northern group that is currently onsite and documented in this report.

As the Shageluk City Tank Farm is no longer in service, it is recommended to remove the site. The empty fuel tanks can be cut into smaller pieces for easier transport and disposal. The Shageluk Landfill is permitted and could accept many of the materials from this site. The contents of the shed (paint, corrosives, lead acid batteries, etc.) cannot be placed in the landfill and should be shipped out of the community. The soil should be characterized for any residual contamination and should be cleaned up as appropriate. Continued drinking water monitoring is recommended.
