**Technical Memorandum 1**

**Assessment of the Existing Wastewater Disposal System  
(Septic Tank/Drainfield)**

**Tununak, Alaska**

**August 8, 2018**

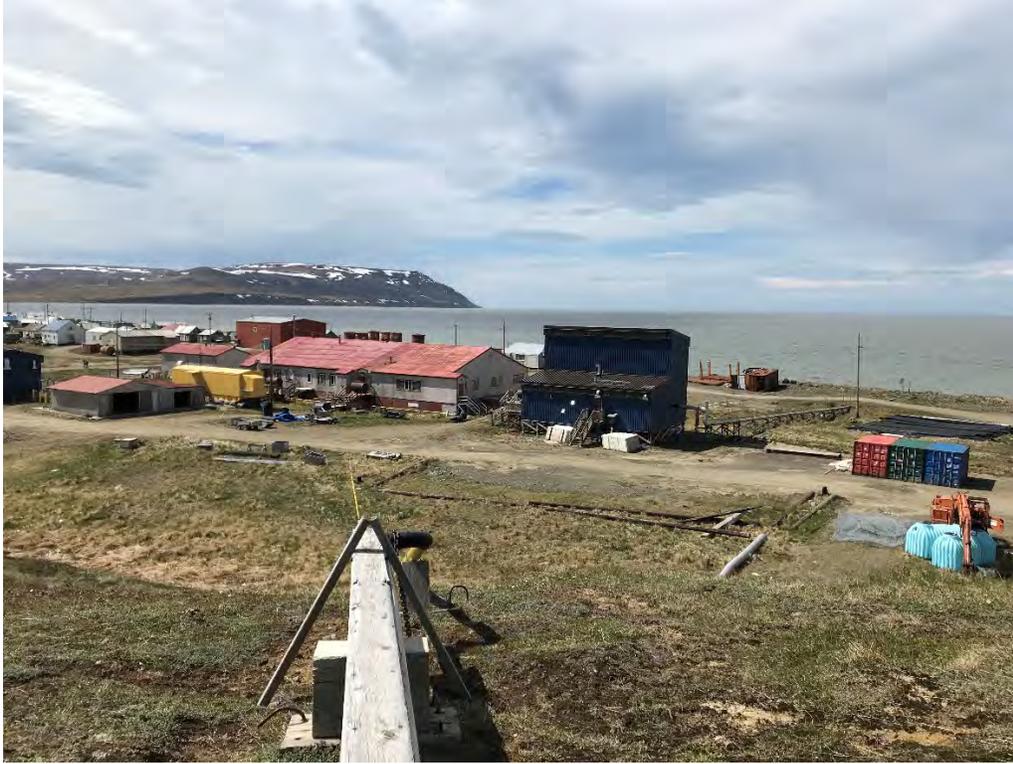
*Photo 1 - Looking West from Tununak School Towards Septic Tank and Drainfield System in foreground with the septic tanks on the left side and drainfield on the right side of the open field.*

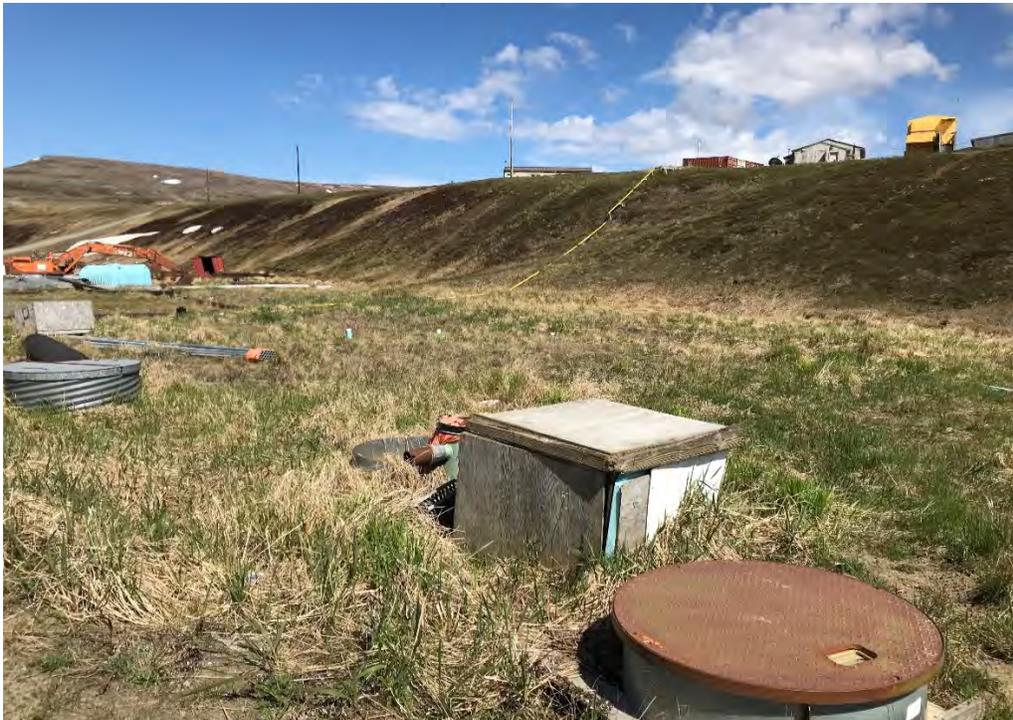
*Photo 2 - Manholes and Clean-Out on 4,000-gallon Septic Tank. Photo 1 was taken from the hill in the background.*

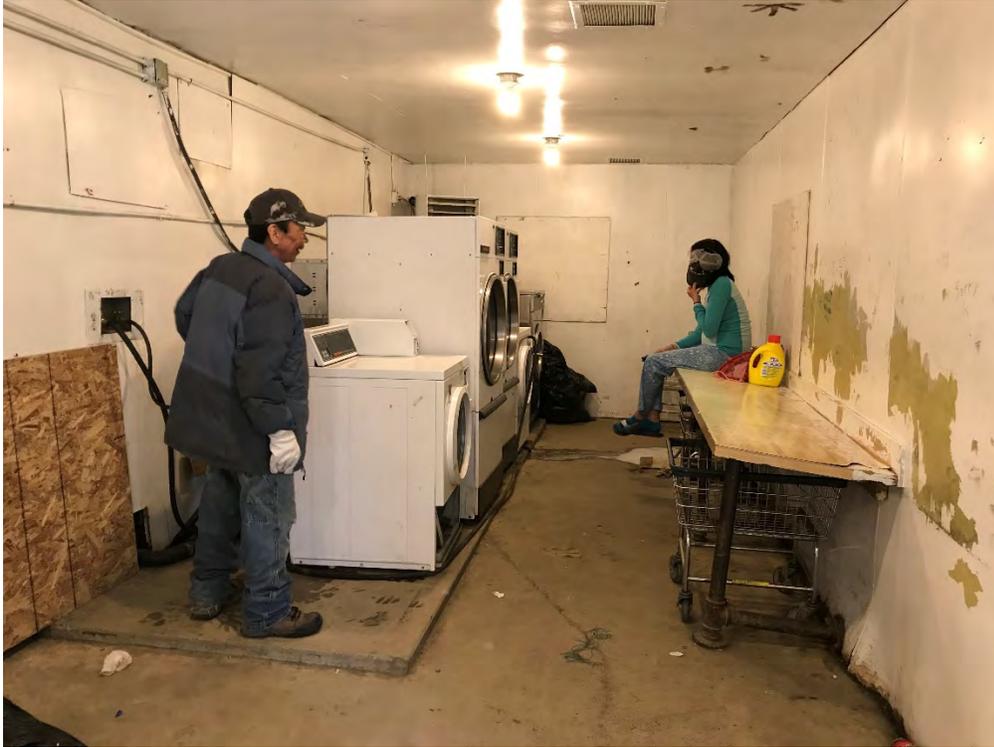
*Photo 3 - Interior of Washeteria. Laundry user sitting on folding table and Joe James to the left setting up discharge hose for adequacy test.*

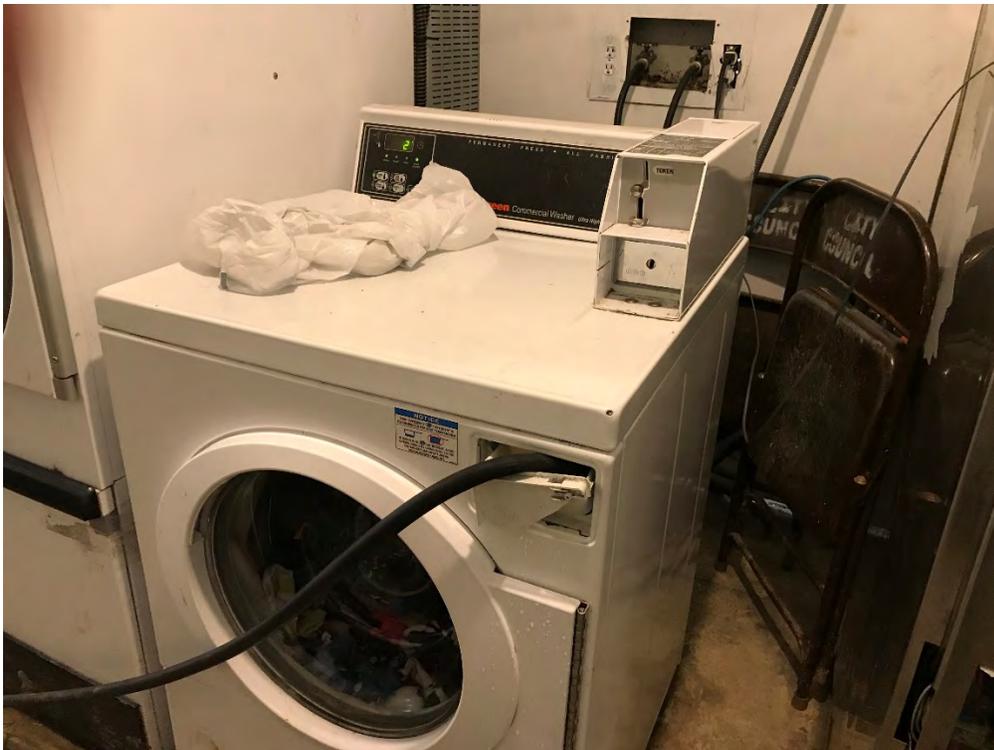
*Photo 4 – Water hose inserted into washer to provide additional wash water for overloaded washer.*

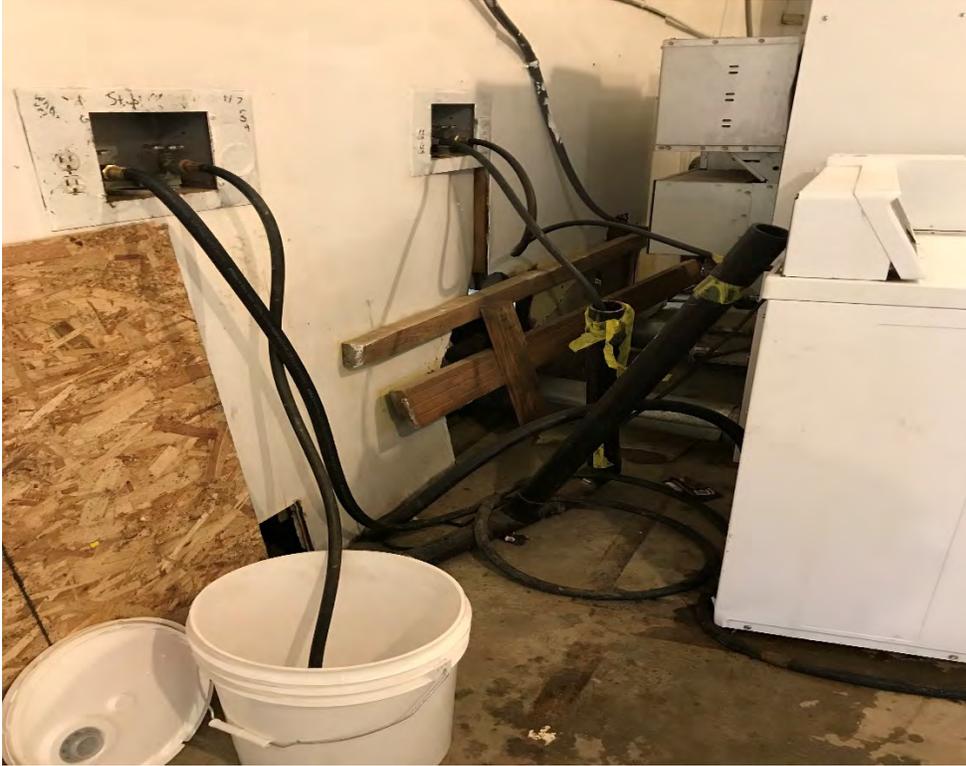
*Photo 5 – Discharge hose in 5-gallon bucket used during adequacy test to measure rate of flow.*

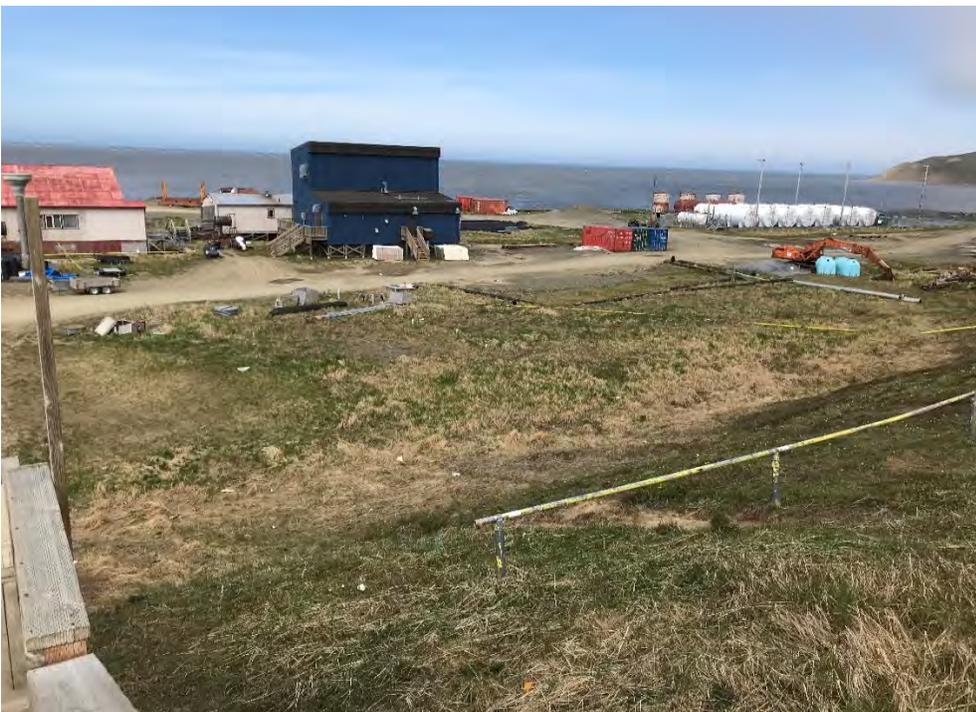
*Photo 6 – Looking north from Washeteria towards the septic tank and drainfield system located in the open field. The septic tanks are on the left side and the drainfield on the right side of field.*

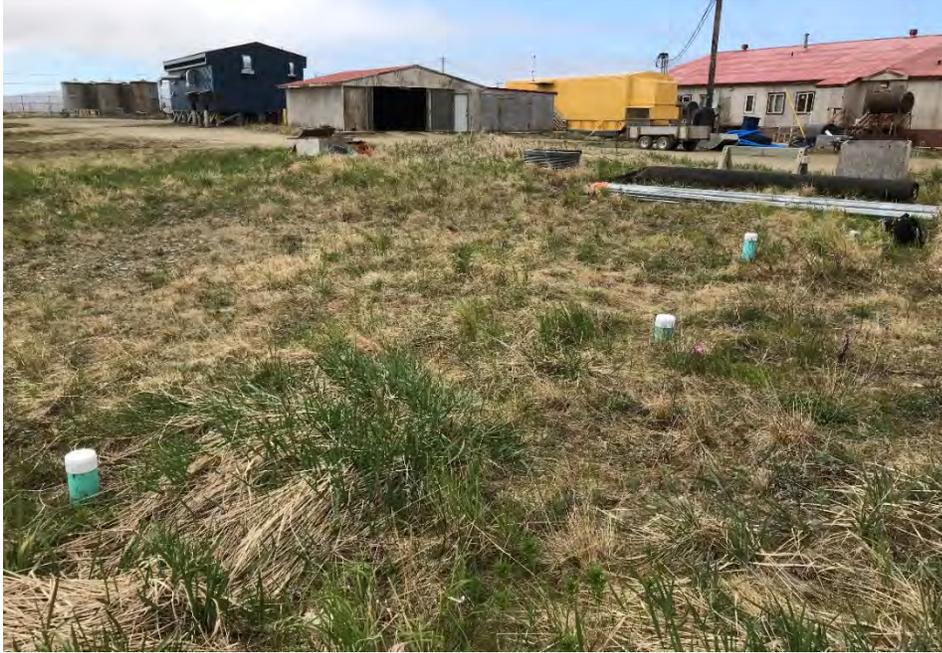
*Photo 7 – Looking southwest towards observation pipes on the south end of the drainfield with septic tank covers in the background.*

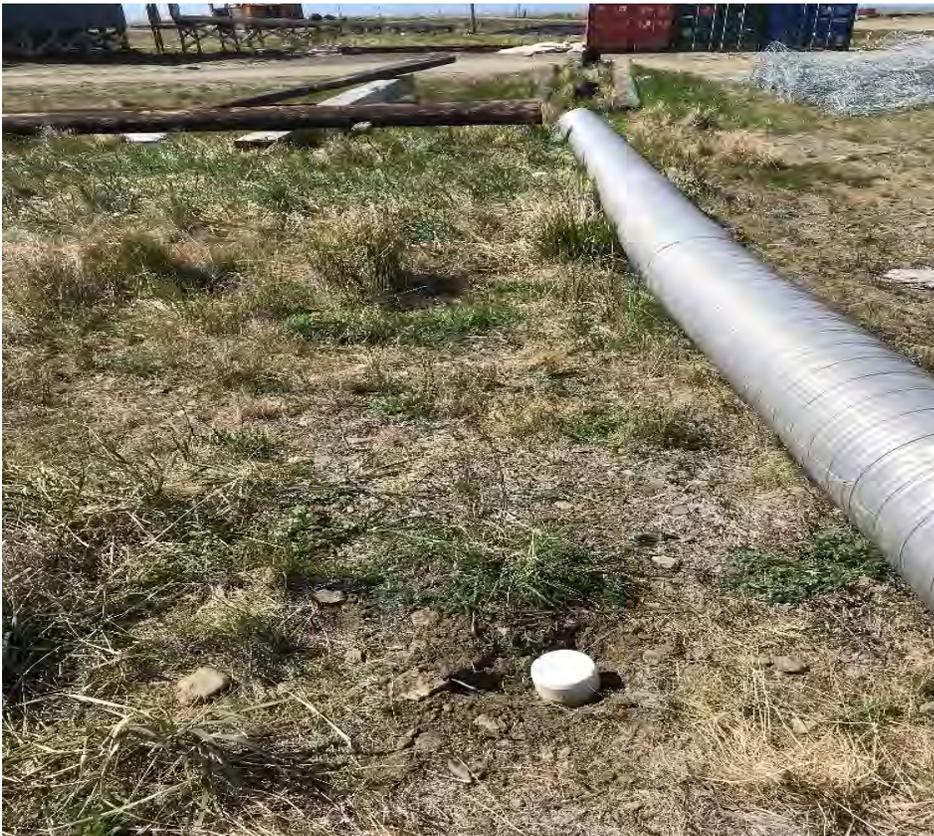
*Photo 8 – Looking west toward observation pipe on north end of drainfield.*

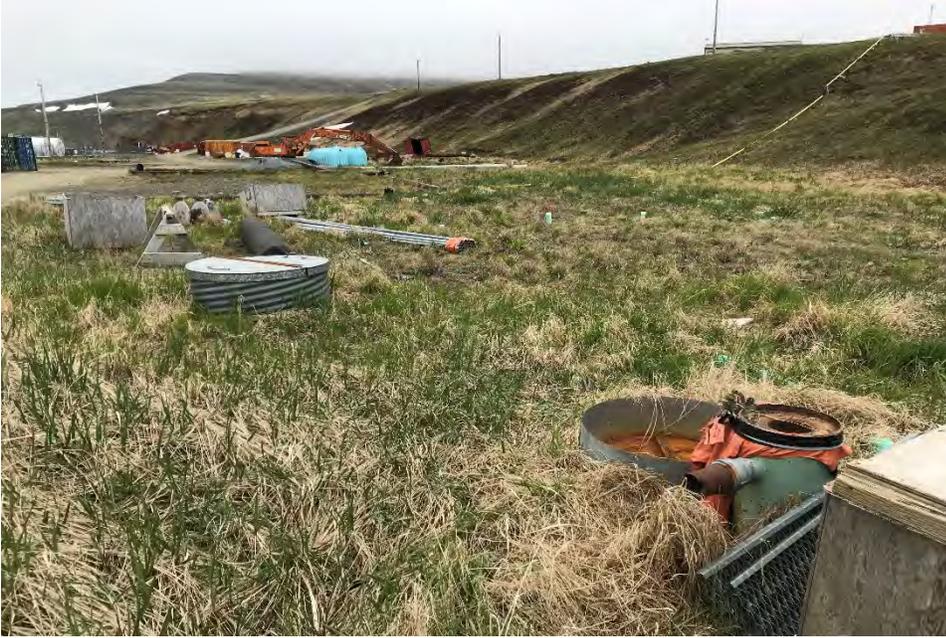
*Photo 9 – Looking north towards septic tanks manholes and clean-outs with observation pipes on south end of drainfield in the background.*

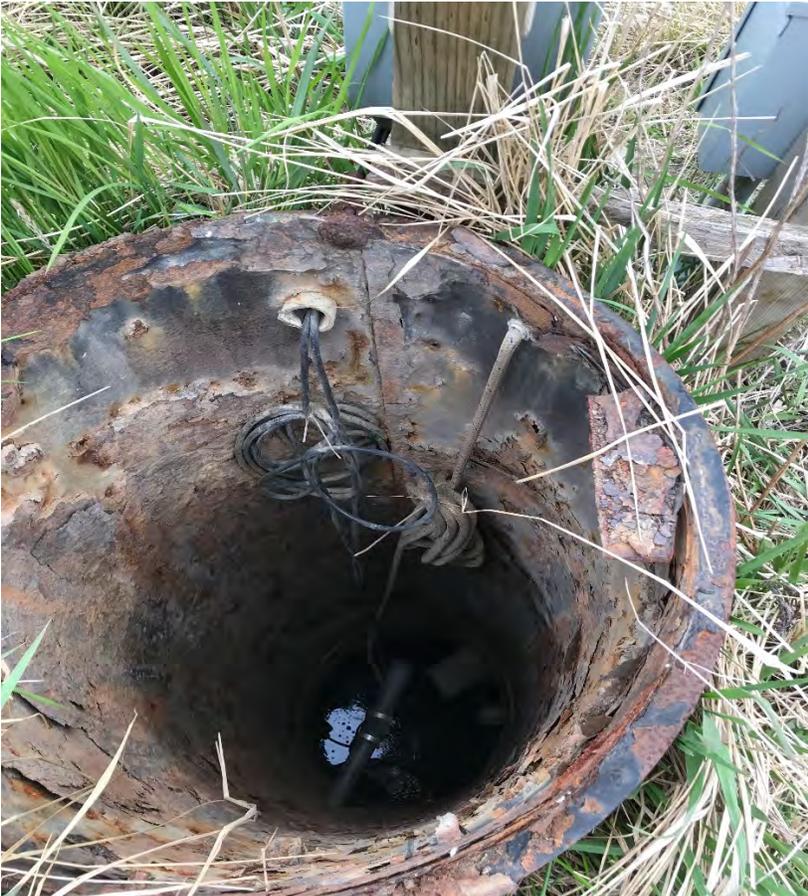
*Photo 10 – Lift station located at outlet end on the 2,000-gallon septic tank*

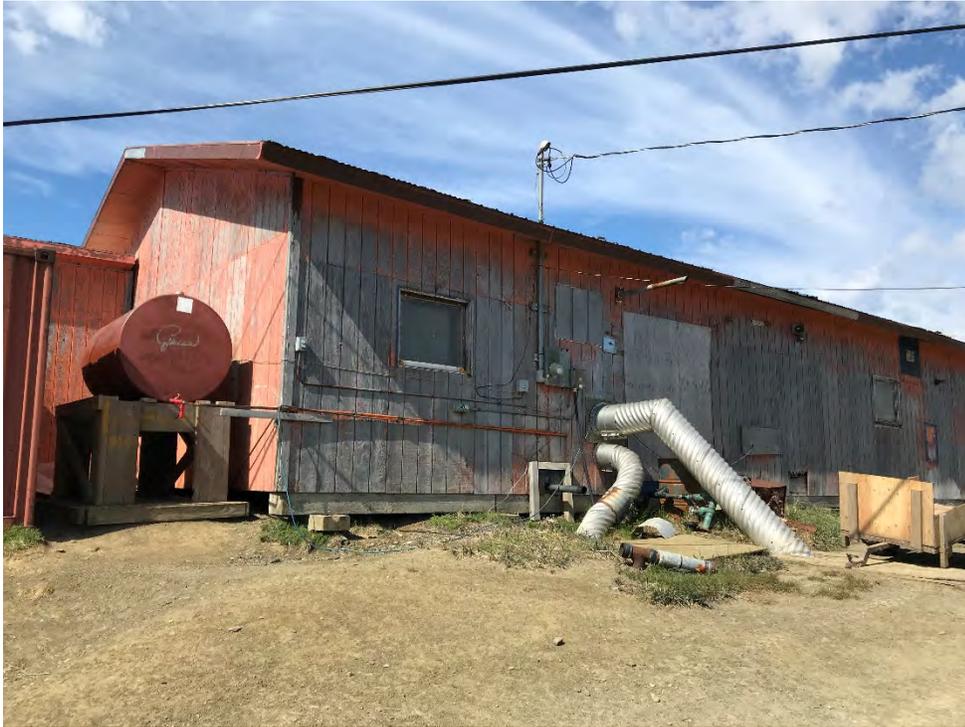
- Photo 1: WTL (Arctic pipe) entering the east side of the Washeteria/ WTP. The second Arctic pipe shown in the photo located below the WTL is the water service line to the nearby clinic.

*Photo 1 – Water transmission line entering the east side of Washeteria/WTP*

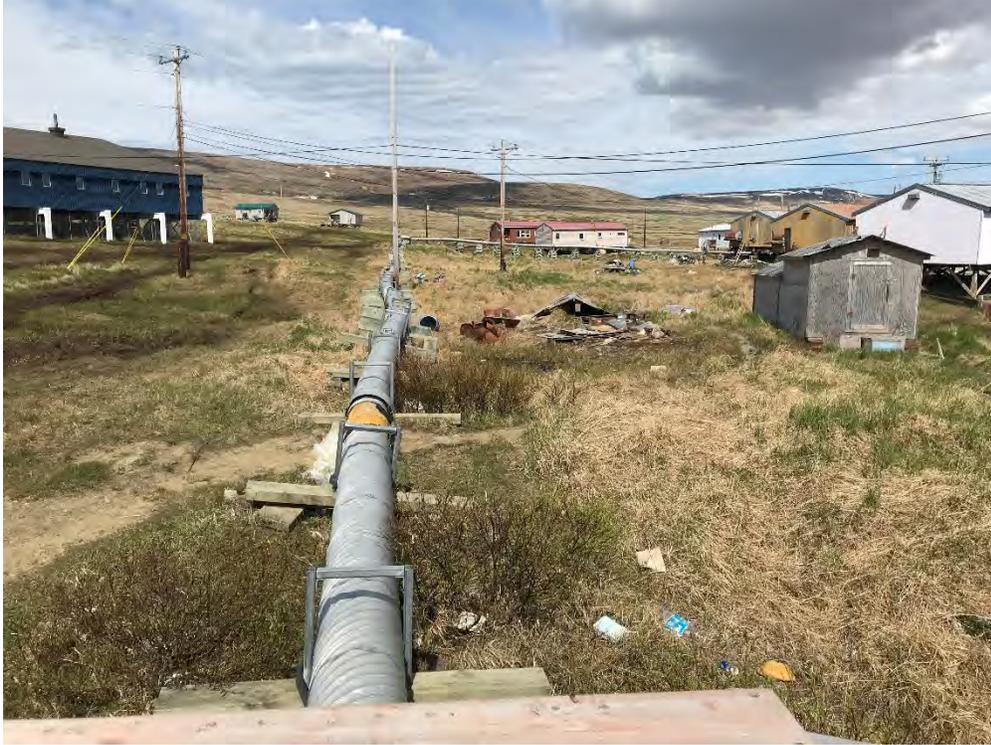
- Photo 3: WTL looking north towards Access Box #2 located at the far end of the water line before making the 90-degree turn to the right. Tununak School is located to the left (west) of the WTL. Note the variation in the alignment of the WTL and poor structural support from the timber foundation system for the Arctic pipe.

*Photo 3 - Looking north along west portion of the water transmission line with Tununak School shown in the upper left corner.*

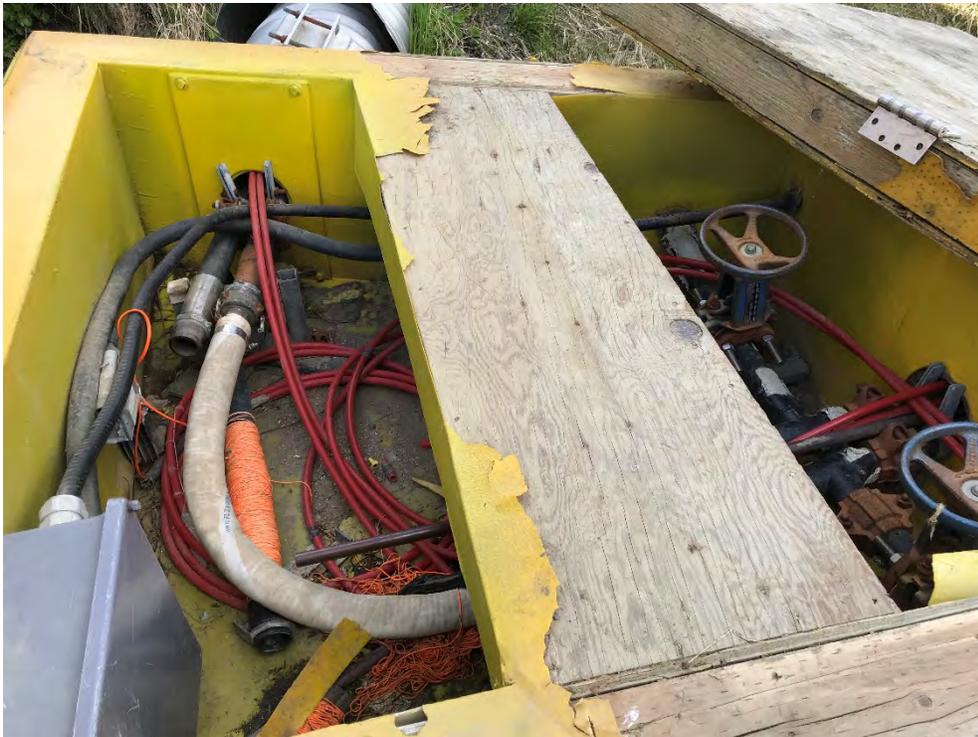
- Photo 4: WTL Access Box #1 was found exposed/open with the cover partially removed. It appeared maintenance work was being made on repairs to the water line. Subsequent discussions with the WTP operator confirmed they were working on repairs to the WTL, which occurs on an annual basis due to multiple operational problems with the water line freezing.

*Photo 4 – Uncovered water line turn box #1 located next to clinic.*

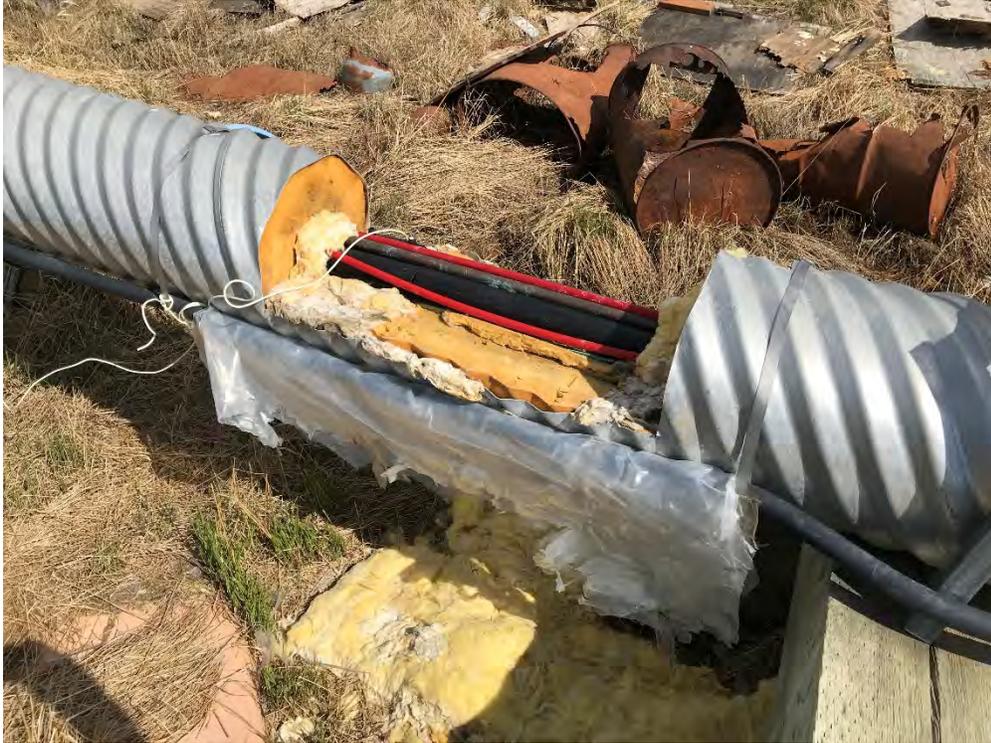
- Photo 5: Uncovered section of Arctic pipe that provided access for the operators to repair the WTL.
- Photo 6: This photo shows the same section of the WTL that was discussed in Photo 5 and shows the deteriorated foundation system.

*Photo 5 – Exposed section of Arctic Pipe on water transmission line.*

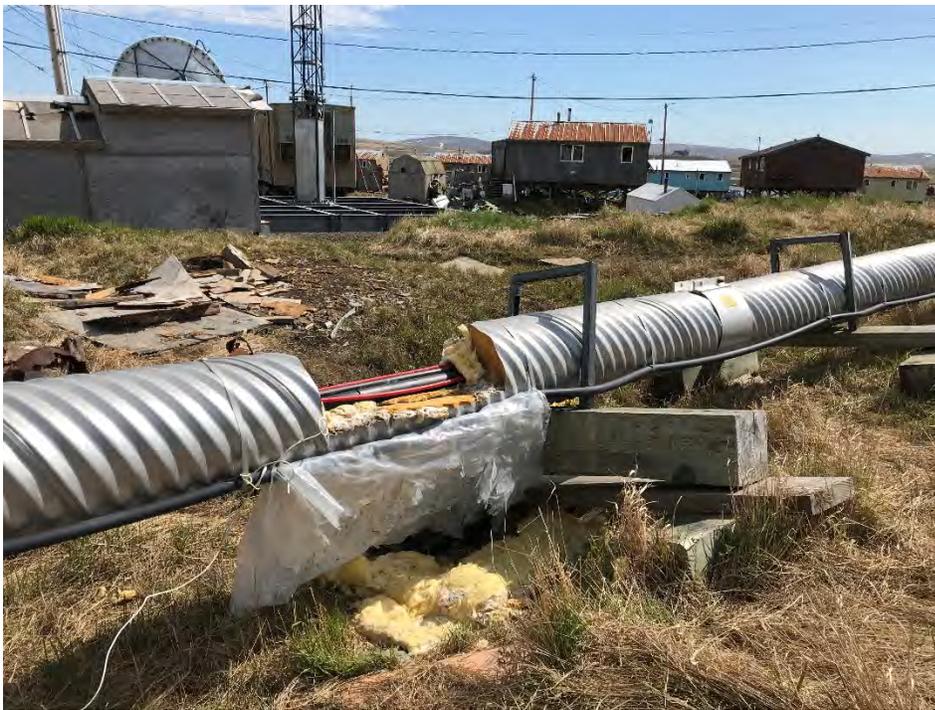
*Photo 6 – Looking southeast at exposed section of Arctic Pipe shown in Photo 5.*

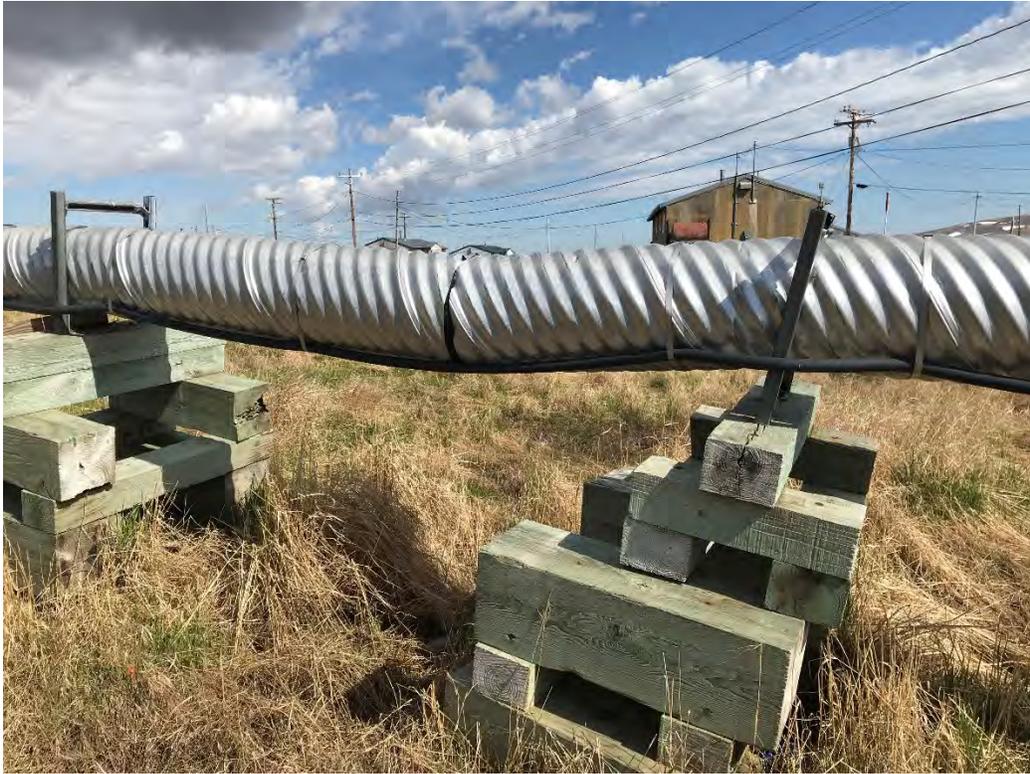
- Photo 9: A typical section of the Arctic pipe that has a significant sag due to the deteriorating structural conditions of the timber foundation system.

*Photo 9 – Looking east along west portion of the water transmission line with timber supports.*

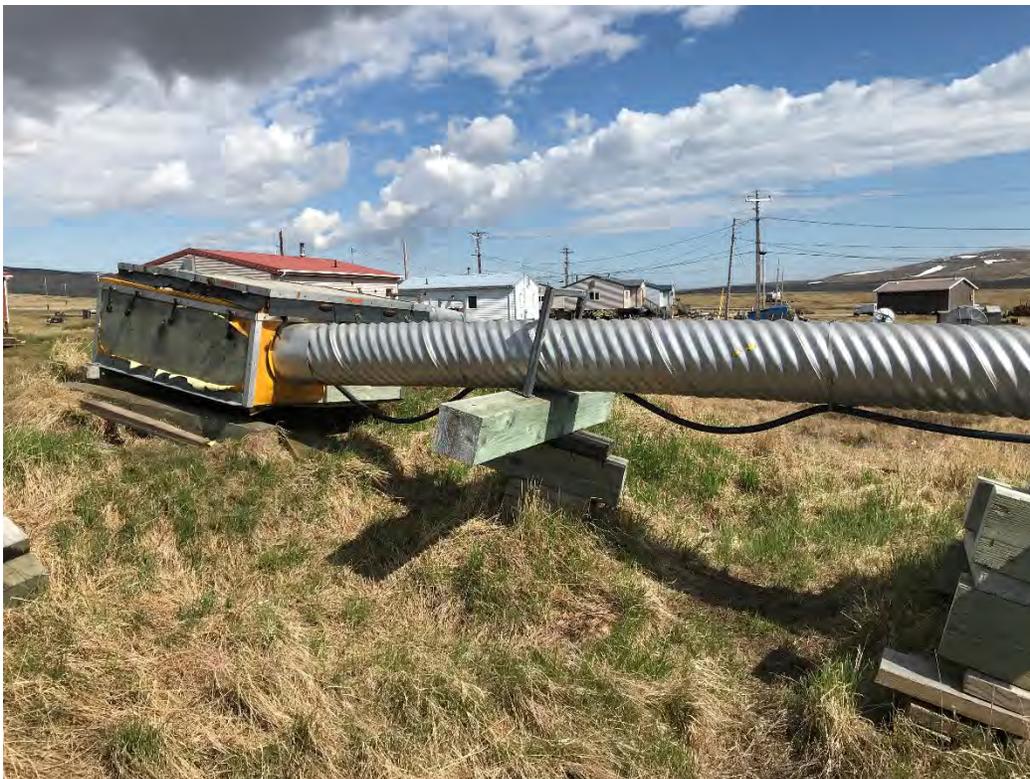
- Photo 10: WTL Access Box #2 that is not level due to significant deterioration of the box foundation. Note the Arctic pipe to the right of the turn box is pulling the box to the right due to the failing structural support system under the Arctic pipe. It is expected that, over time, the Arctic pipe would probably separate from the access box.

*Photo 10 – Looking east towards water line turn box #2.*

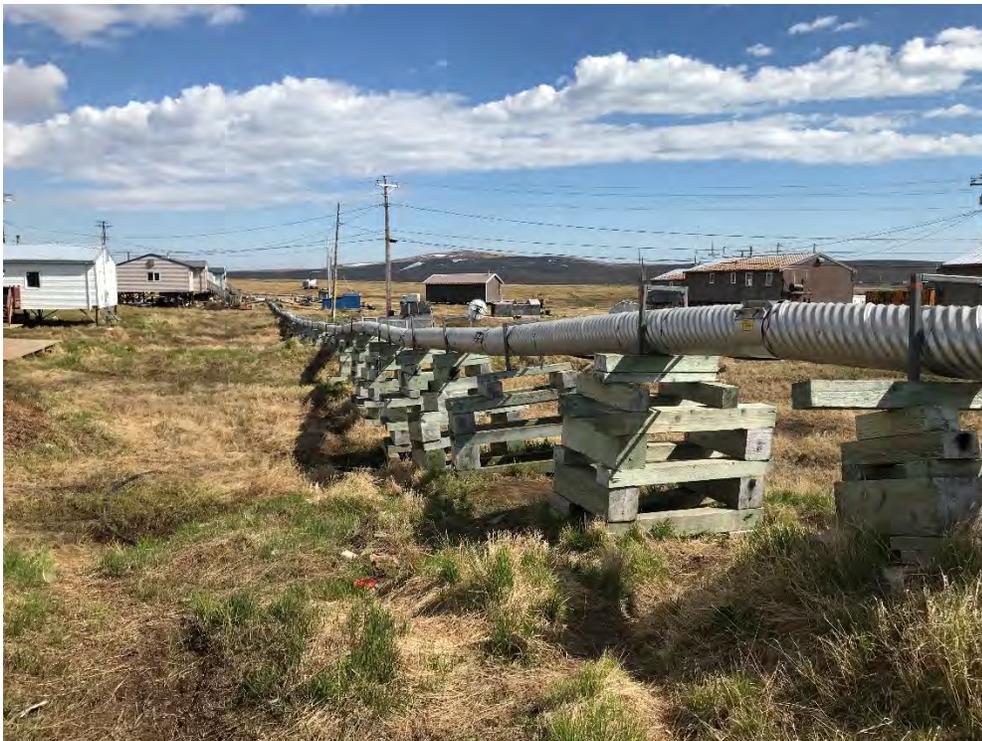
- **Photo 12:** Elevated section of the WTL built many feet above the ground surface that causes major issues for the operators to repair the water line. Several of the timber supports have moved due to unstable ground conditions and are not providing structural support to the Arctic pipe.
- **Photo 13:** Exposed section of Arctic pipe shows recent attempts to repair the WTL. The line has been retrofitted with recirculating glycol heat trace lines that barely squeeze through the 6-inch diameter carrier pipe. This photo shows two repaired connections to the 2-inch HDPE water line with a cut section on the parallel line that requires additional repair work. It was later learned from the operator that this type of repair work is done on a routine annual basis.

*Photo 12 – Looking east along the northern portion of the water transmission line.*

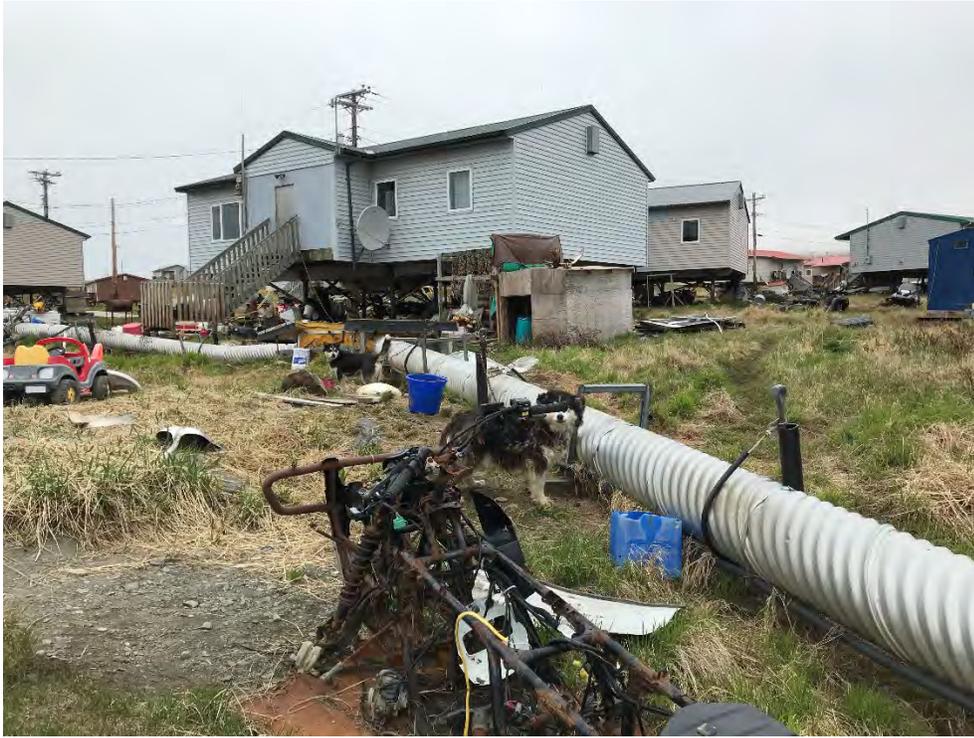
*Photo 14 – Looking north from the Unnamed Creek pump house along eastern portion of the water transmission towards the waterline turn box #3 shown just below house in background.*

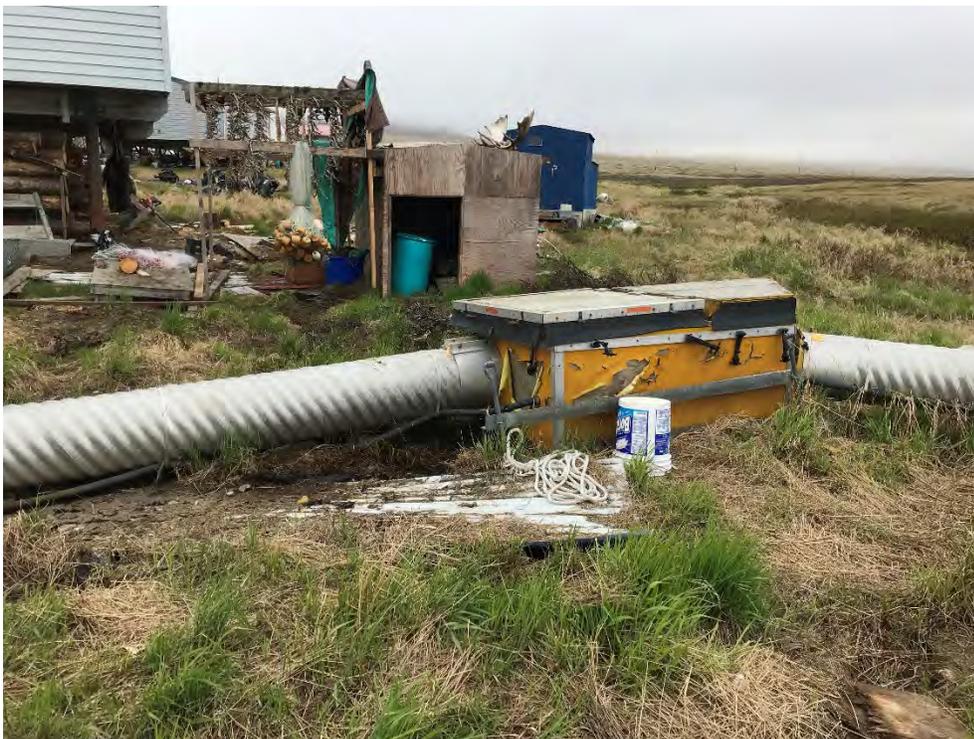
*Photo 15 - Looking east towards the waterline turn box #3.*

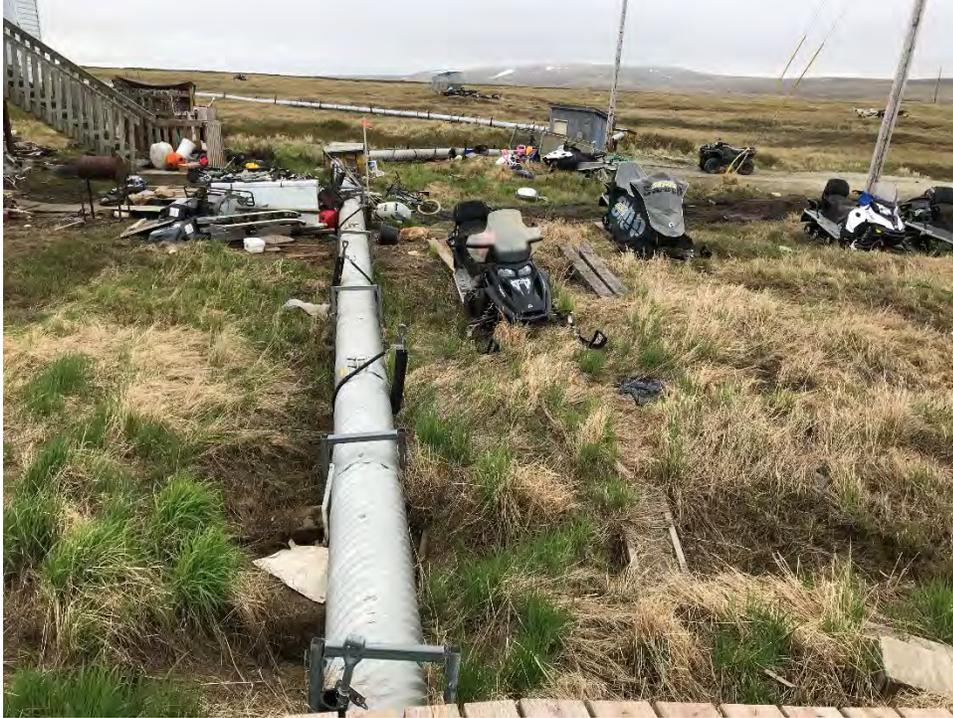
*Photo 16 – Looking east towards the water line turn box#3 and Unnamed Creek pump house with water transmission line in background from former Muskox infiltration gallery.*

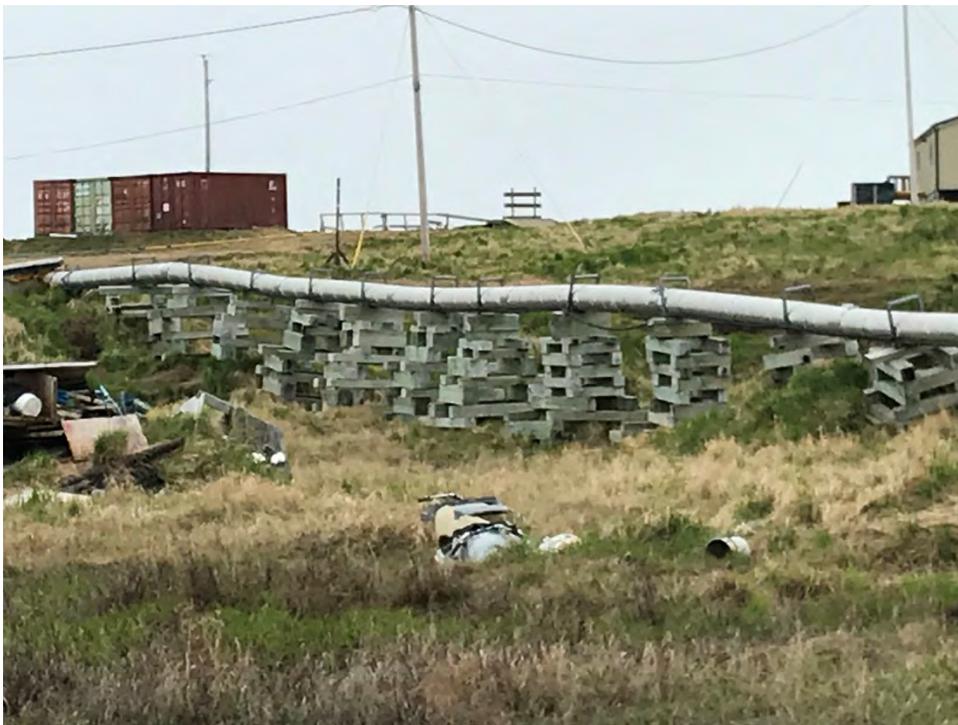
*Photo 17 - Looking north towards northern portion of the water transmission line set on elevated foundation system.*

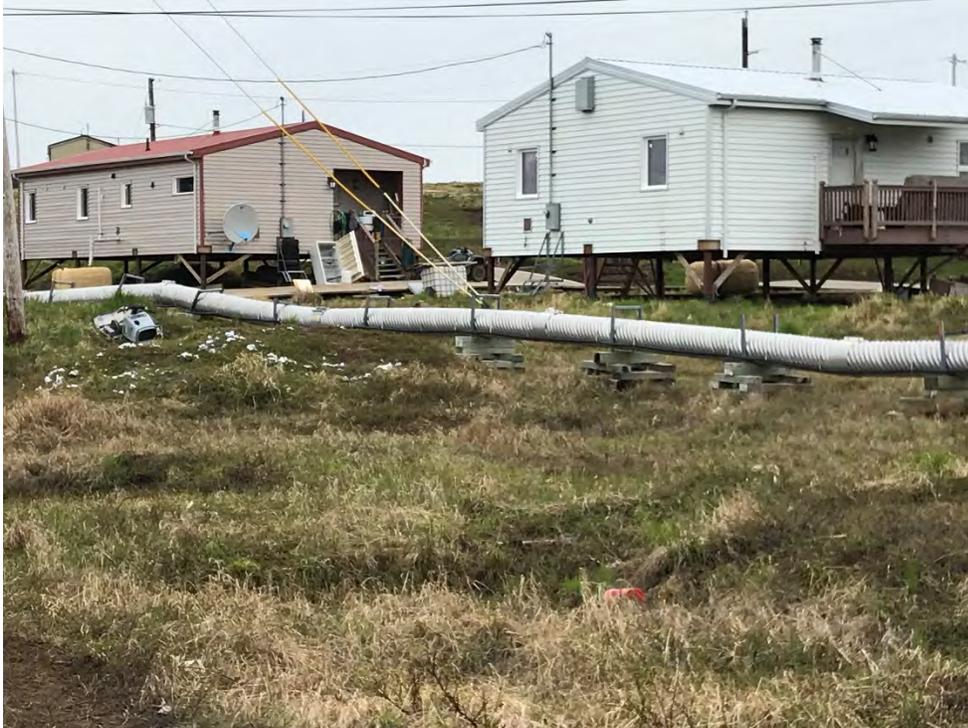
*Photo 18 - Looking north towards the northern portion of the water transmission line.*

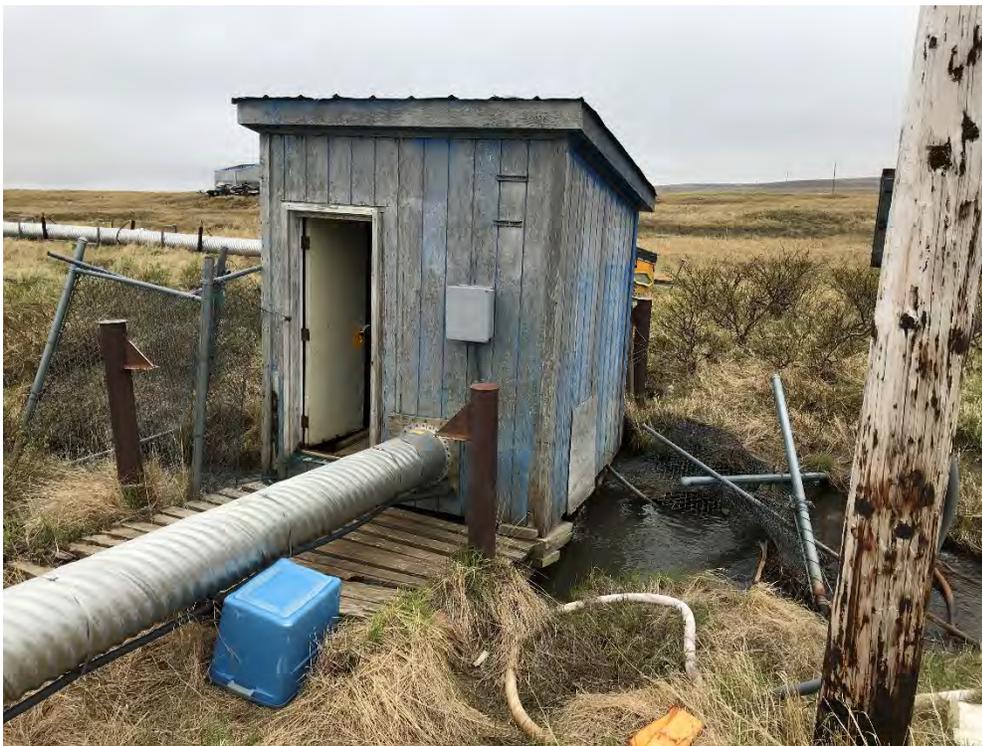
*Photo 19 - Looking south at water transmission line exiting the Unnamed Creek pump house. In the background is the water transmission line from the former Muskox Creek infiltration gallery.*

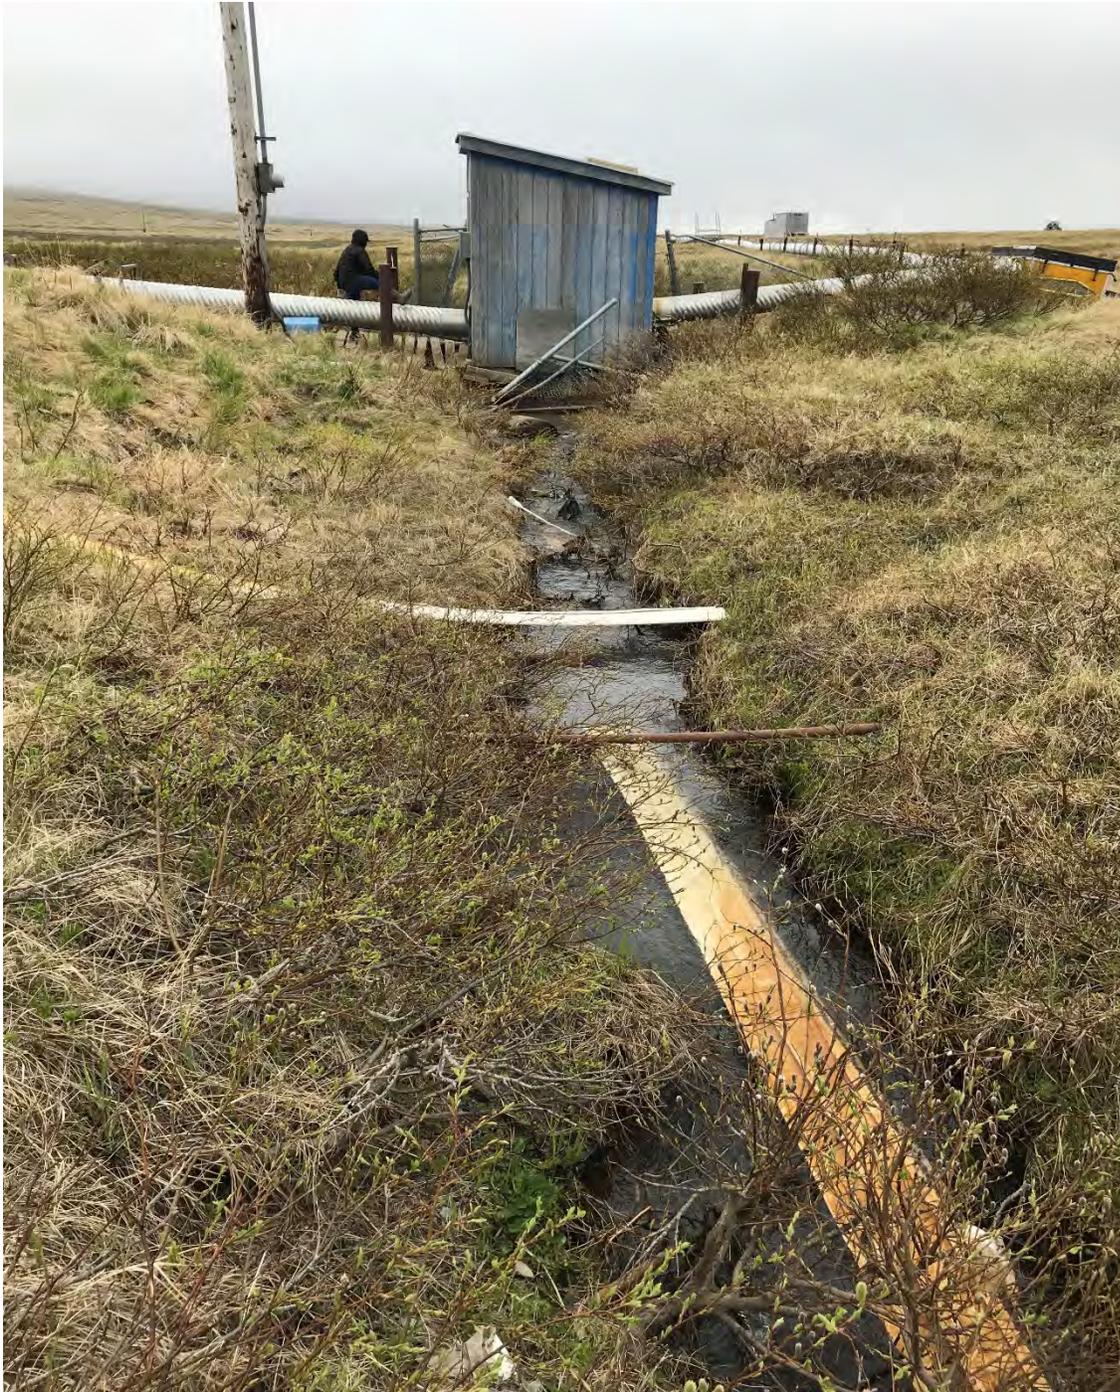
***Photo 20 - Looking east from the down gradient side of Unknown Creek towards the Unknown Creek pump house. Arctic pipe on right side is the water transmission line from the former Muskox Creek infiltration gallery. The Arctic pipe to the left of the Unnamed Creek pump house is the existing water transmission line to the Tununak washeteria/WTP.***

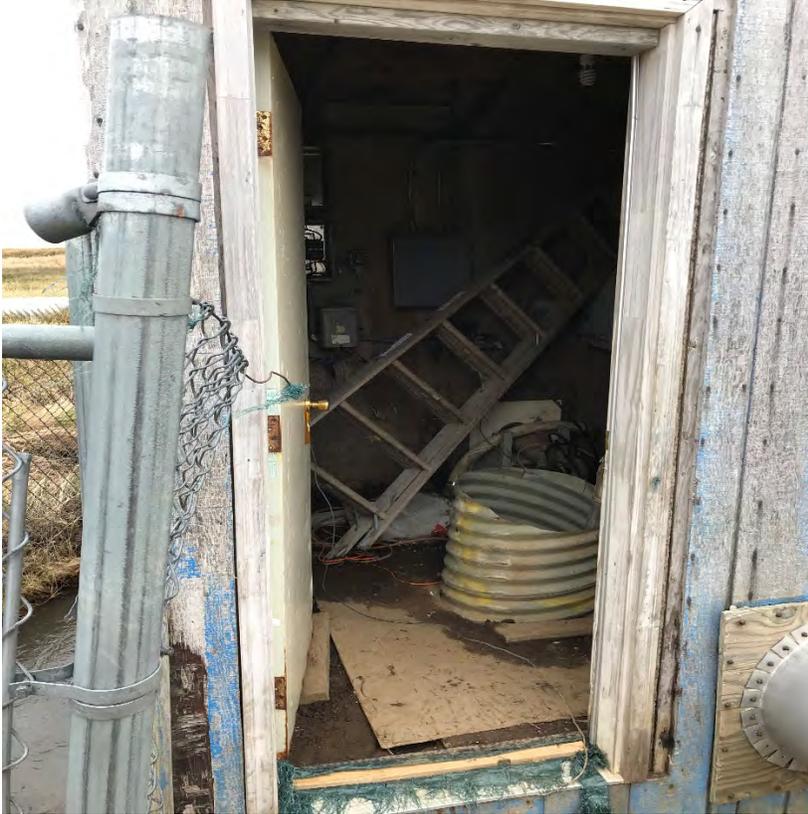
***Photo 21 - Looking into the Unnamed Creek pump house with the infiltration gallery consisting of the 24 inch diameter corrugated pipe shown in the center of the door opening.***

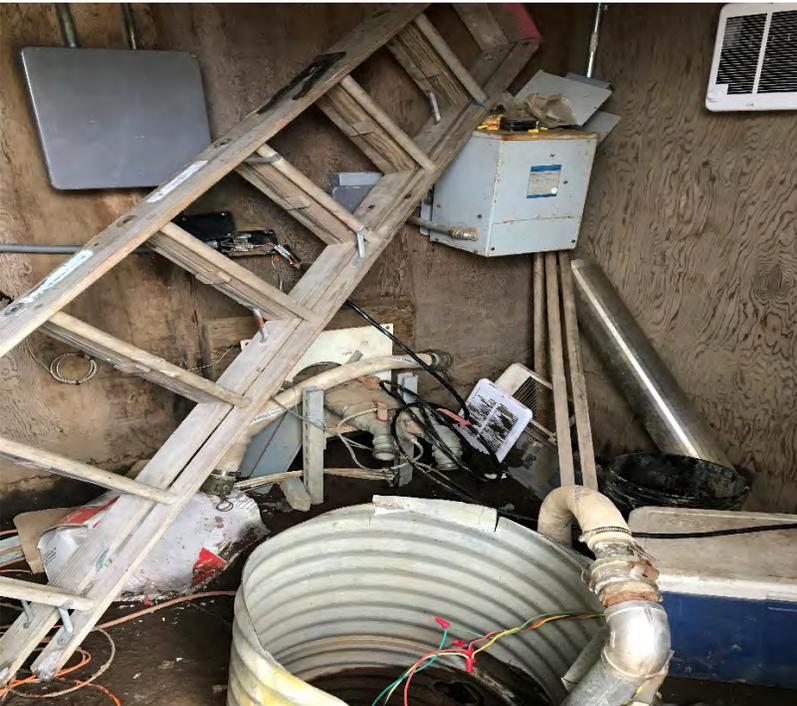
***Photo 22 - Looking inside the Unnamed Creek pump house with the infiltration gallery in foreground.***

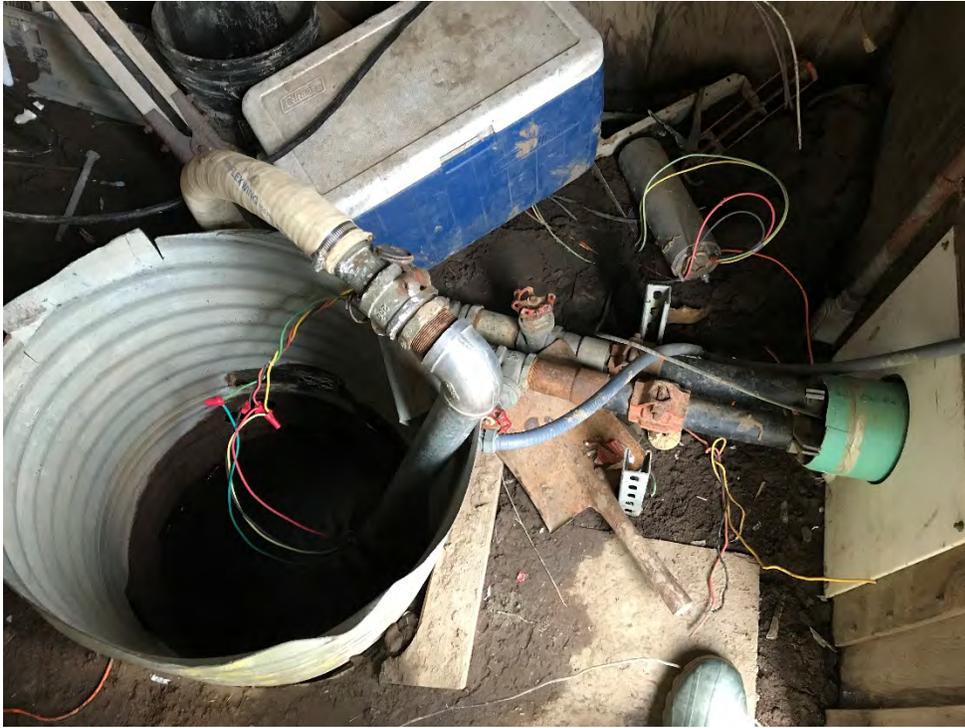
***Photo 23 - Looking down on the infiltration gallery consisting of the 24 inch diameter corrugated pipe. Electrical wiring hooked up for temporary use of the submersible pump that is plumbed into the water transmission line shown to the right of the well.***

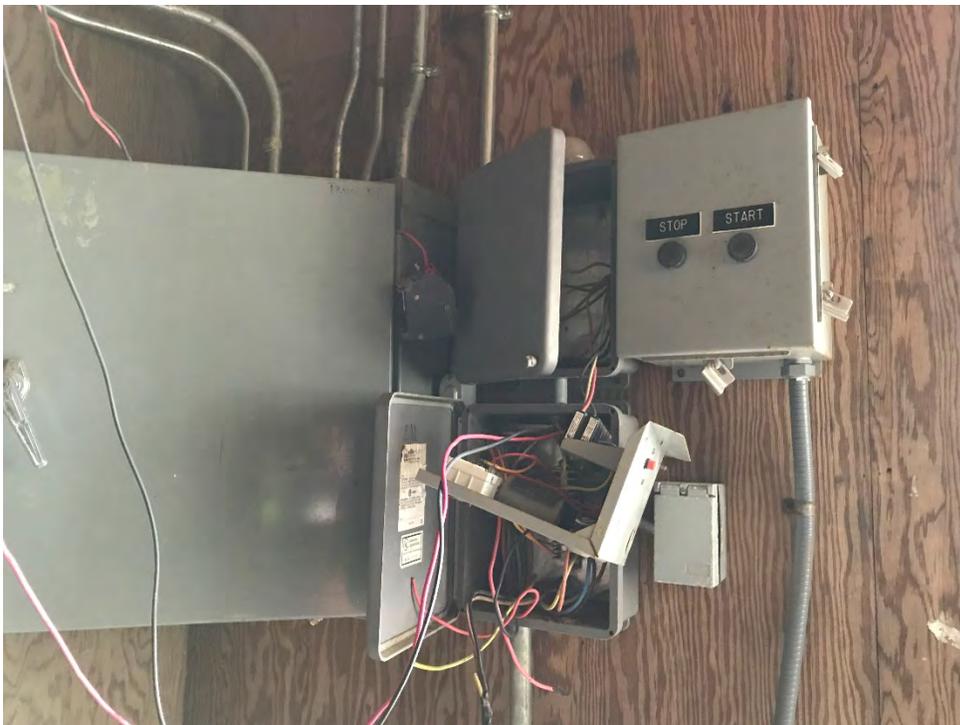
***Photo 24 - Electrical control boxes and pump relay for the submersible pump.***
