**Technical Memorandum 1**

**Assessment of the Existing Wastewater Disposal System  
(Septic Tank/Drainfield)**

**Tununak, Alaska**

**August 8, 2018**

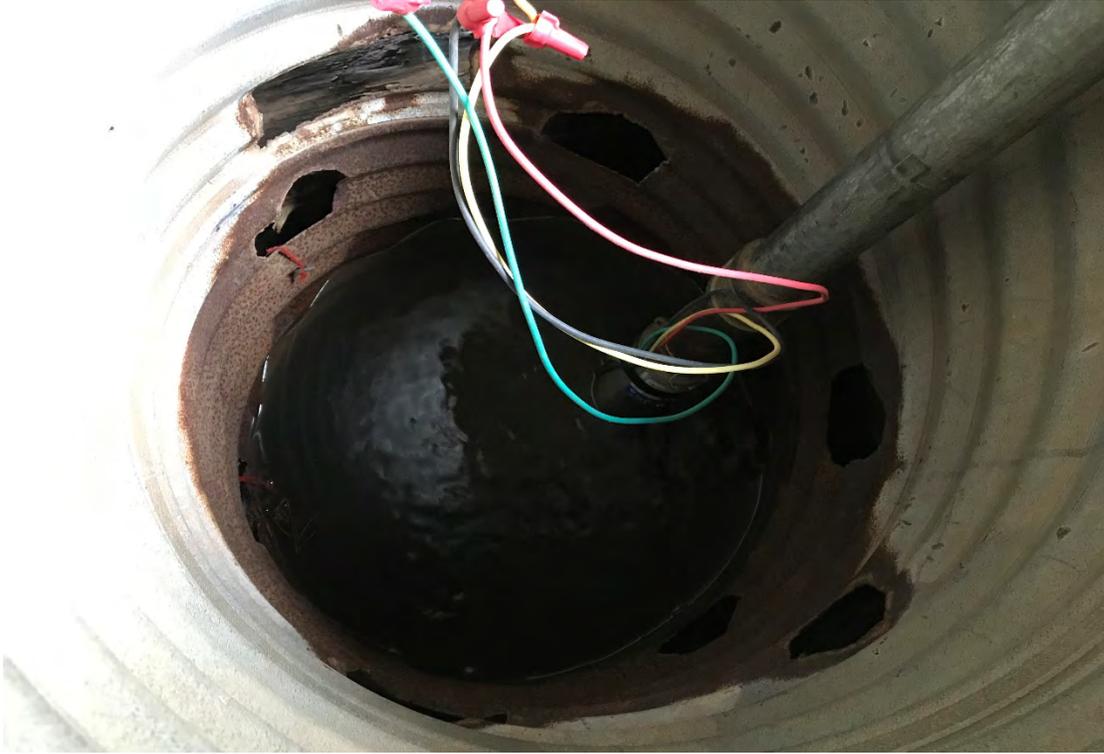
*Photo 25 - Looking down inside 24 inch diameter corrugated pipe used for the infiltration gallery.*

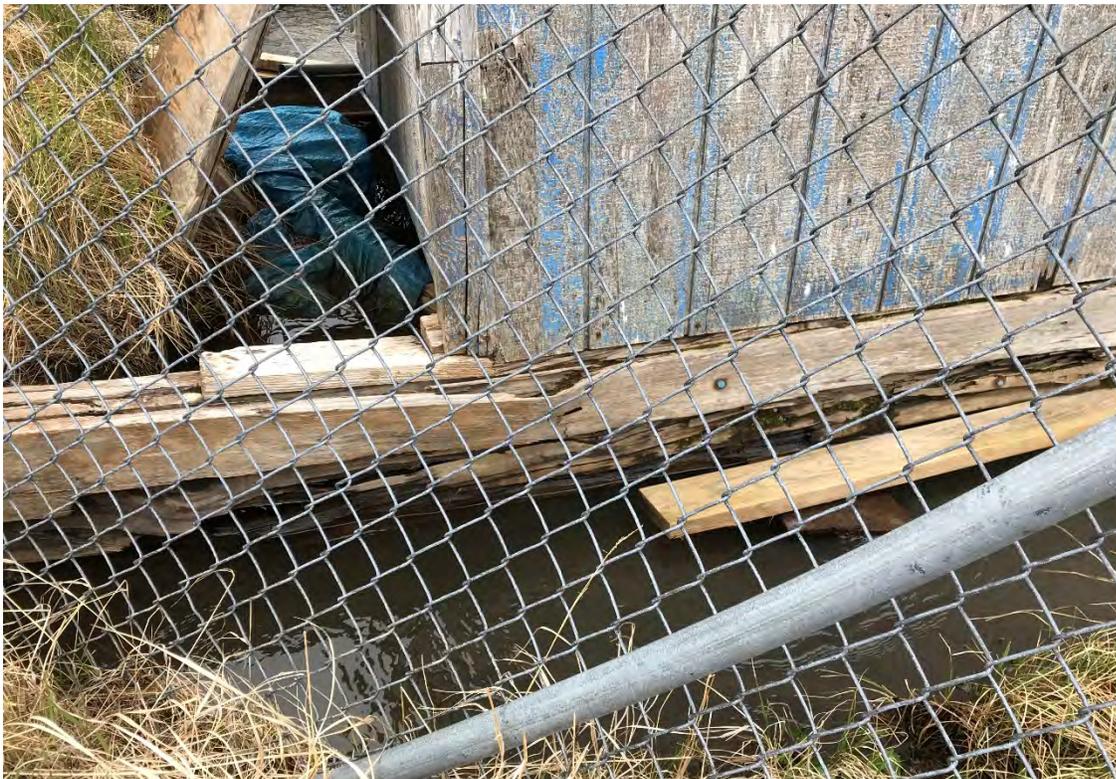
*Photo 26 - Foundation support beam for the Unknown Creek pump house suspended over Unnamed Creek.*

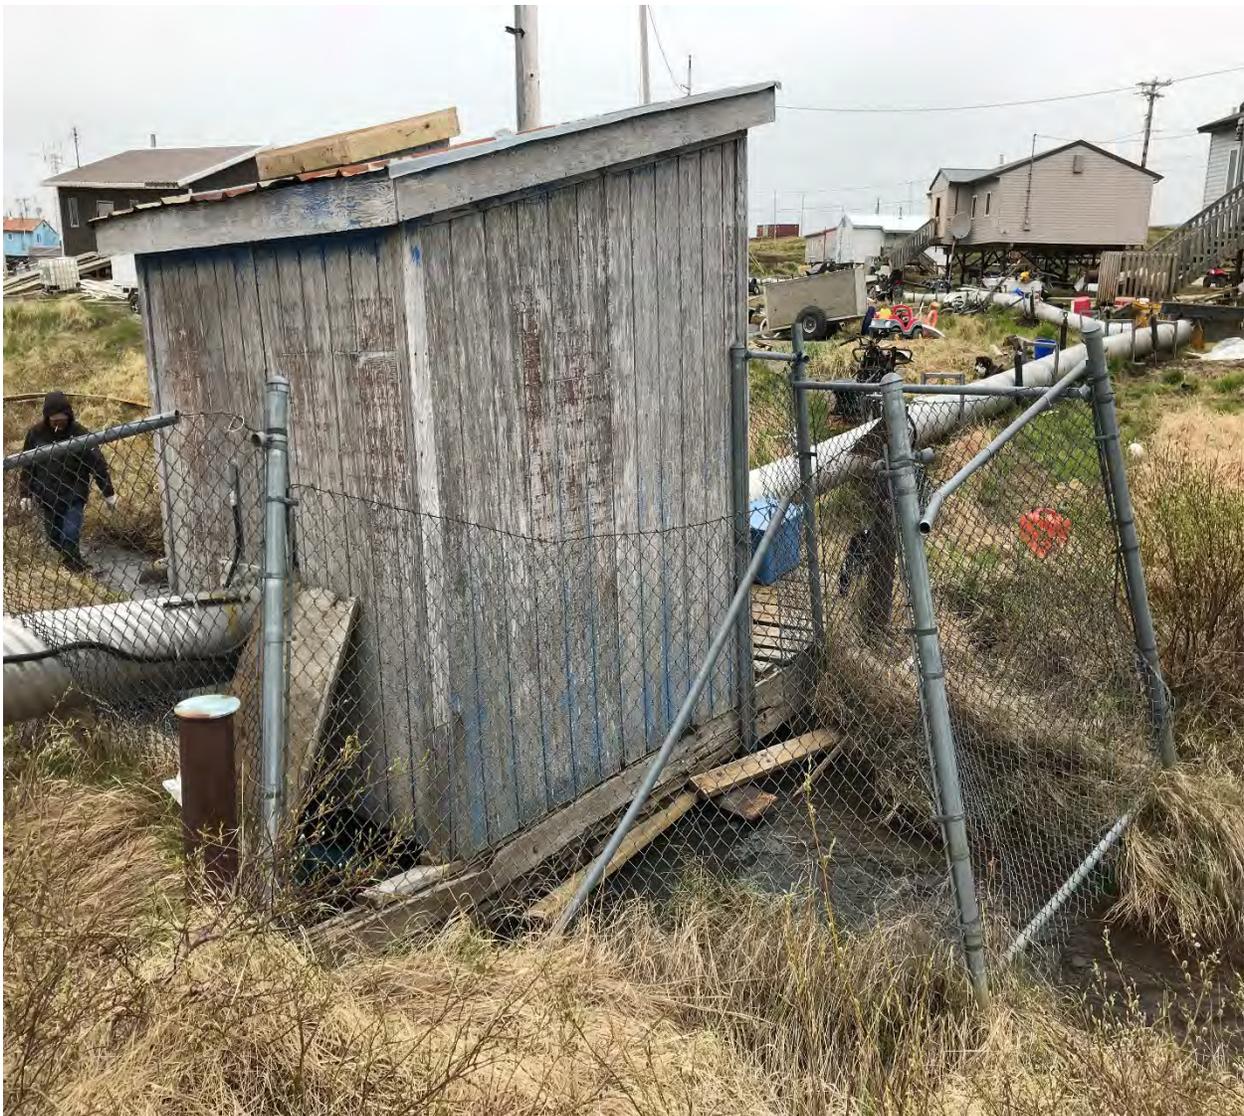
*Photo 27 - looking north at the rear side of the Unnamed Creek pump house suspended over Unnamed Creek. The Arctic pipe on the left side of the building is the water transmission line from the former Muskox Creek infiltration gallery. The Arctic pipe on the right side is the existing water transmission line from Unnamed Creek infiltration gallery to the Tununak Washeteria/WTP. On the roof of the pump house is an entrance use during the winter time when snowdrifts prevent access to the pump house where the operator must climb on the roof and enter the pump house through the roof opening.*

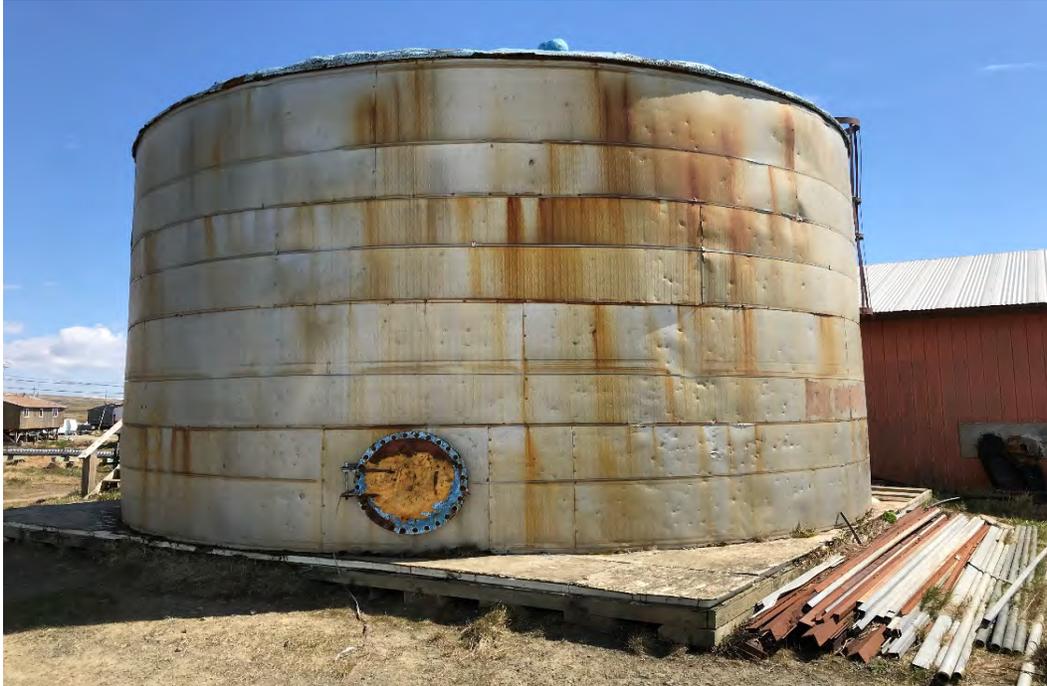
As shown in Photos 1 and 2, the exterior of the WST appears to be in reasonable condition considering the tank is 40 years old and had experienced adverse weather conditions from being located along the coast of the Bering Sea. Photo 1 shows the northwest side of the tank with apparent typical rust stains on the aluminum siding. Photo 2 shows the ladder access to the tank and a missing section of siding located just below the top of the tank. Photo 6 shows a torn portion of the exterior beneath the tank ladder which was probably damaged in the past when operators tried to use the ladder. A close-up view of the missing panel of the aluminum siding that exposed the foam installation near the top of the tank is shown in Photo 7. This is the only area that had missing siding, the remainder of the exterior appeared to still be intact and completely covered the underlying foam insulation. Photos 9 and 10 show the tank's overflow line that appears to be in satisfactory condition with the weather beaten exterior siding. The overflow drain needs to be screened.

*Photo 1- Looking south at the northwest side of the 50,000 gallon WST with Washeteria/WTP in background to the right.*

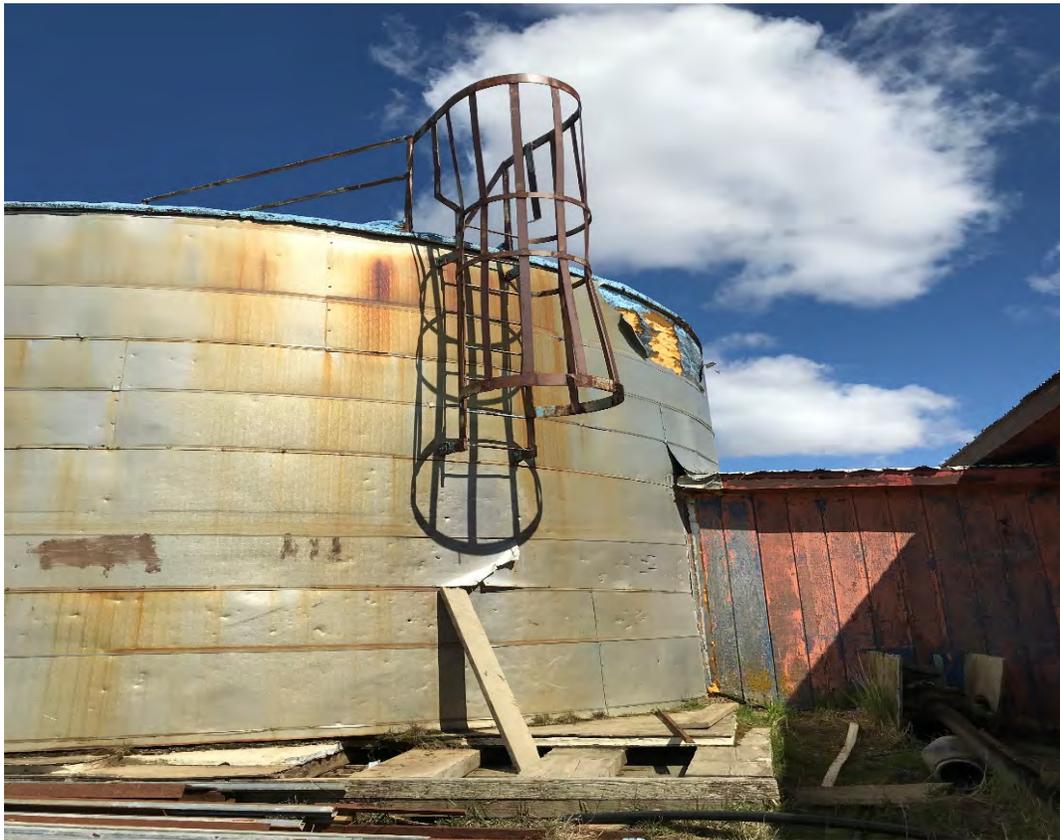
*Photo 2 - West side of the WST and roof access ladder with the Washeteria/WTP to the right.*

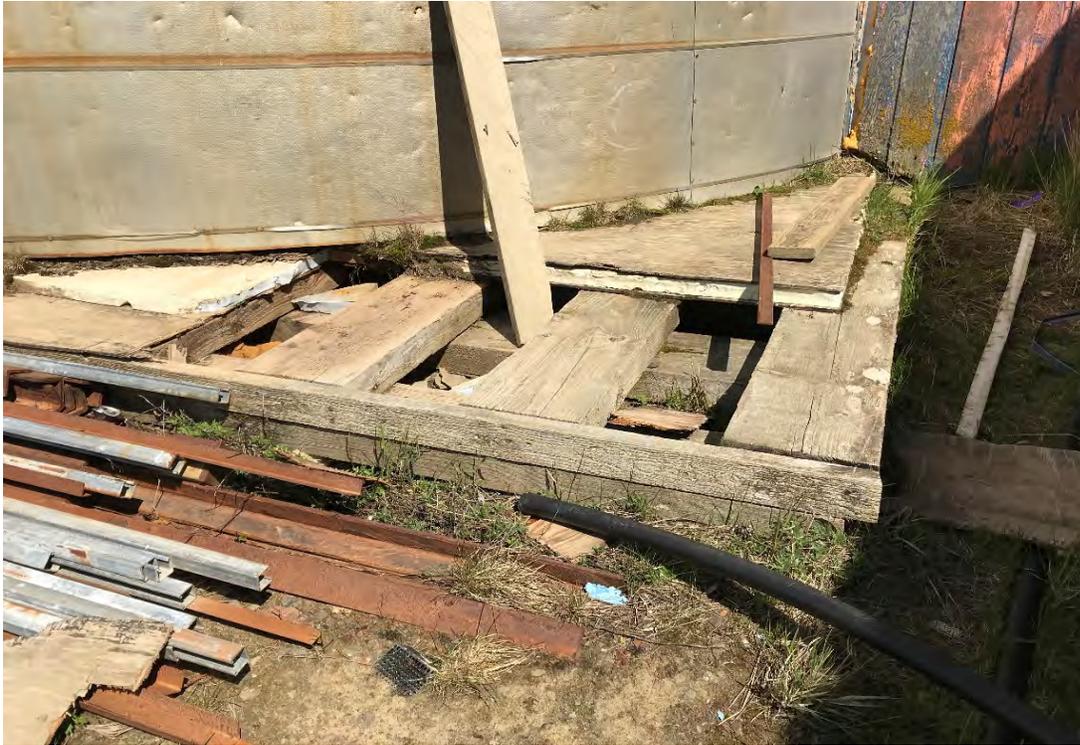
Photo 3 shows the southwest corner of the WST's foundation. Overall, the timber and high density-foam insulation board appeared to be in fair condition. The condition of the timber foundation beneath the tank, between vertical sections of floor joists/supports, is shown in Photos 4 and 5. The lumber members appeared to be in good condition with no signs of deterioration; however, some minor weather-worn sections of the exterior side panels on the lumber foundation were noted as shown in Photos 3, 10, 12, and 20.

*Photo 3 - Foundation at the southwest side of the WST*

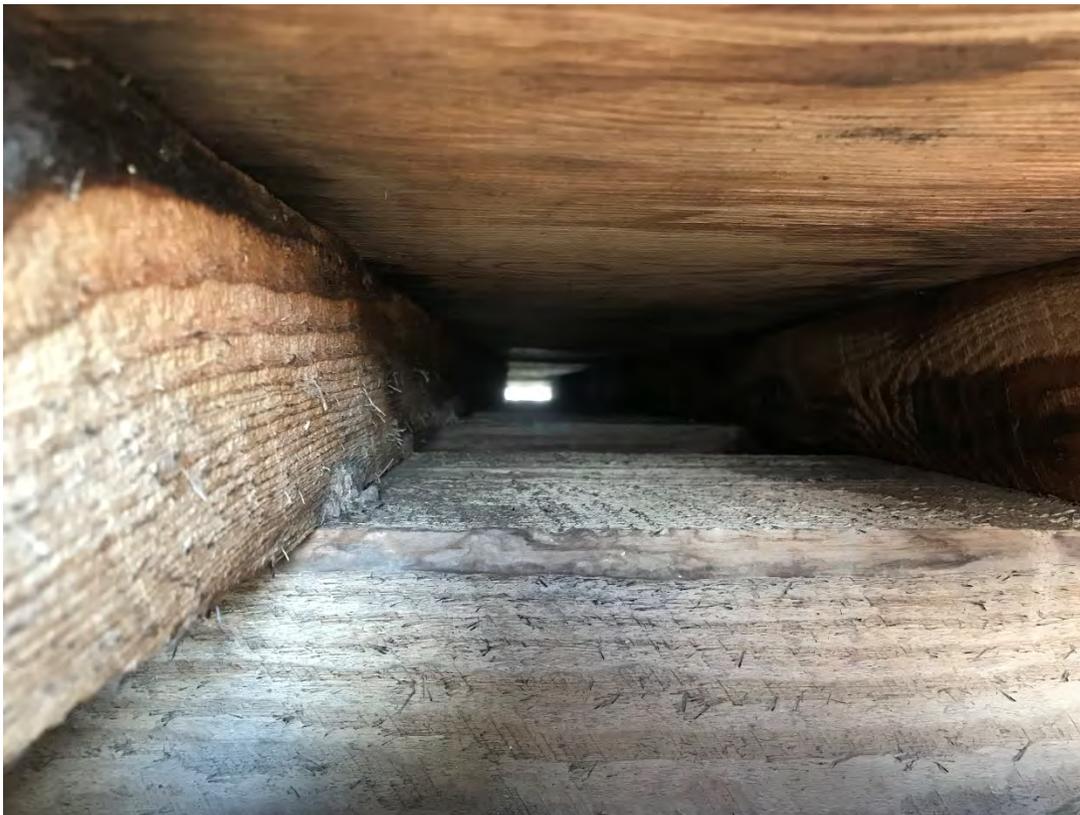
*Photo 4 - Looking east through spacing of WST timber foundation.*

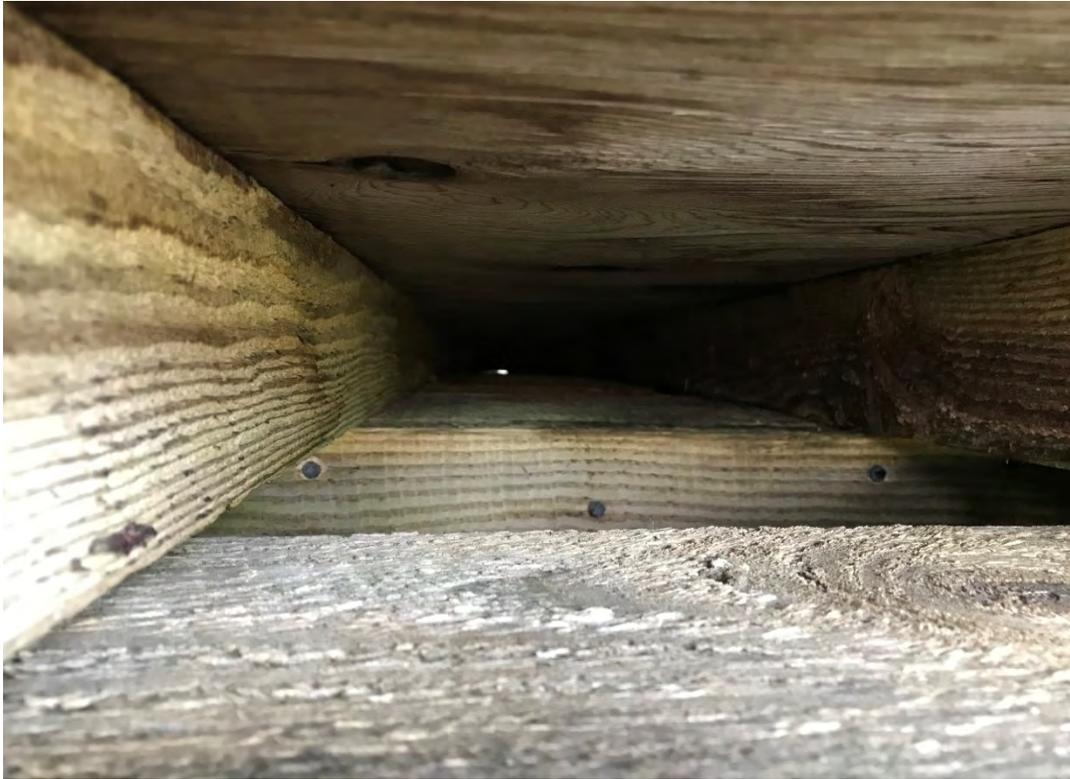
*Photo 5 – Looking West through spacing in W ST foundation.*

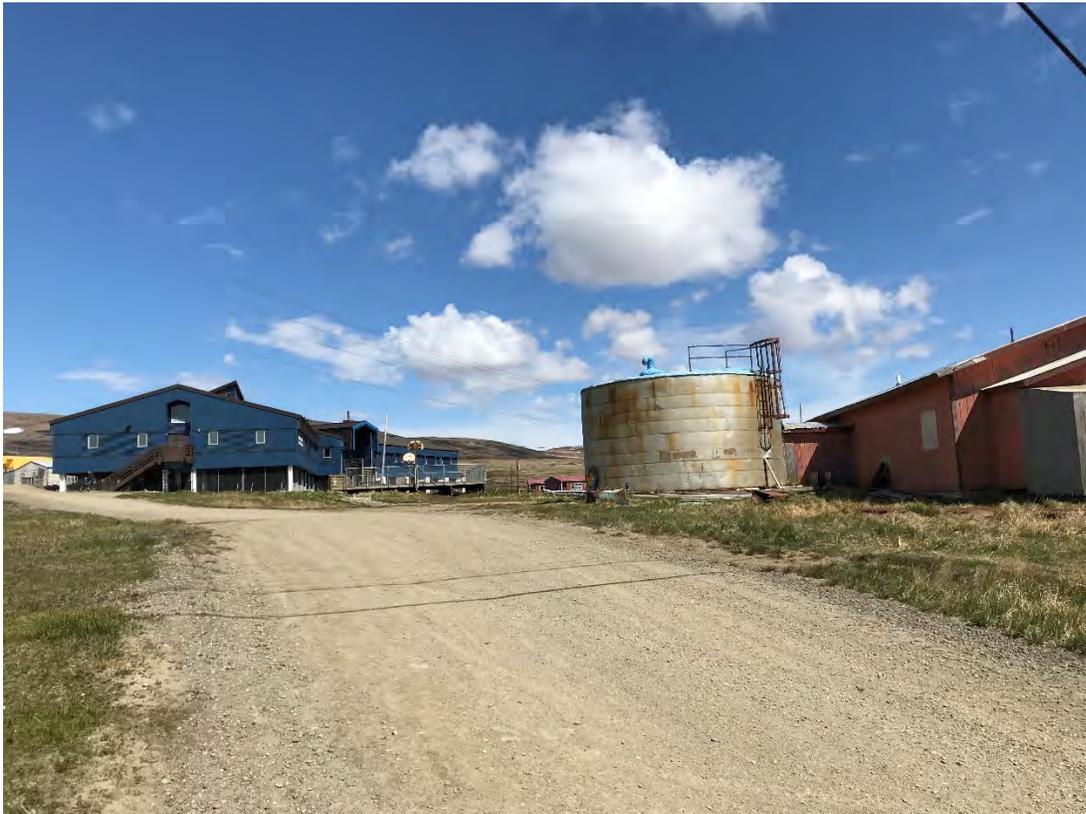
*Photo 9 - North side of WST looking at tank overflow pipe.*

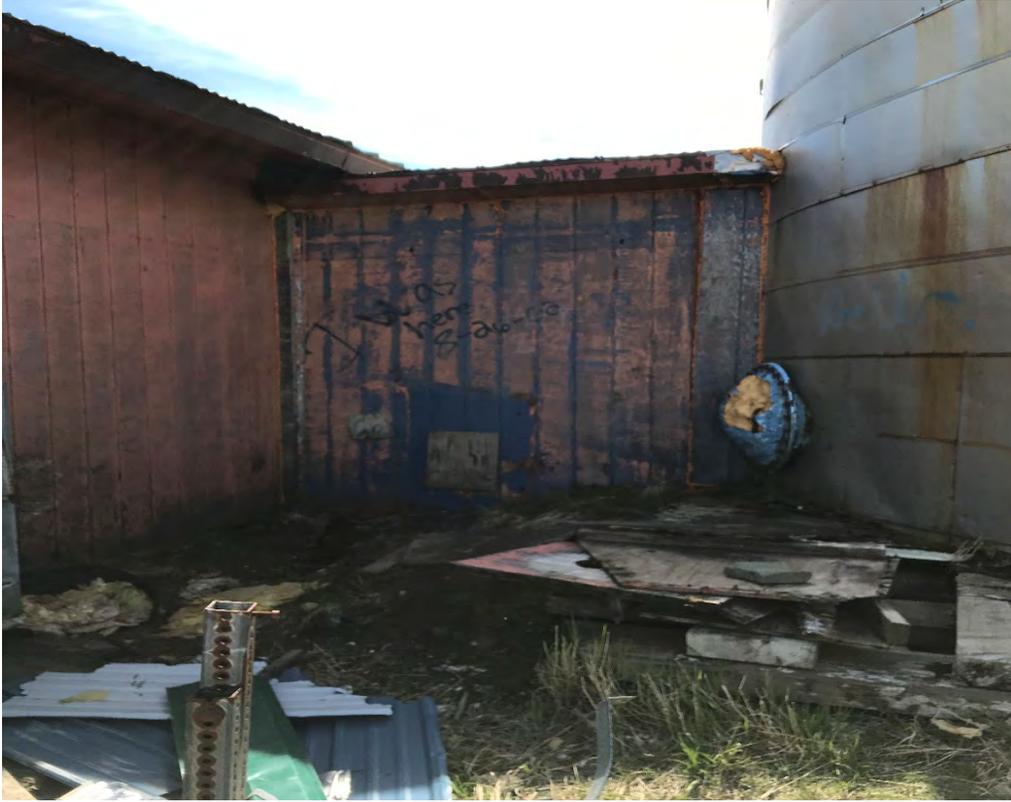
*Photo 12 - Manway to access the bottom of WST and foundation at the Northwest corner of tank*

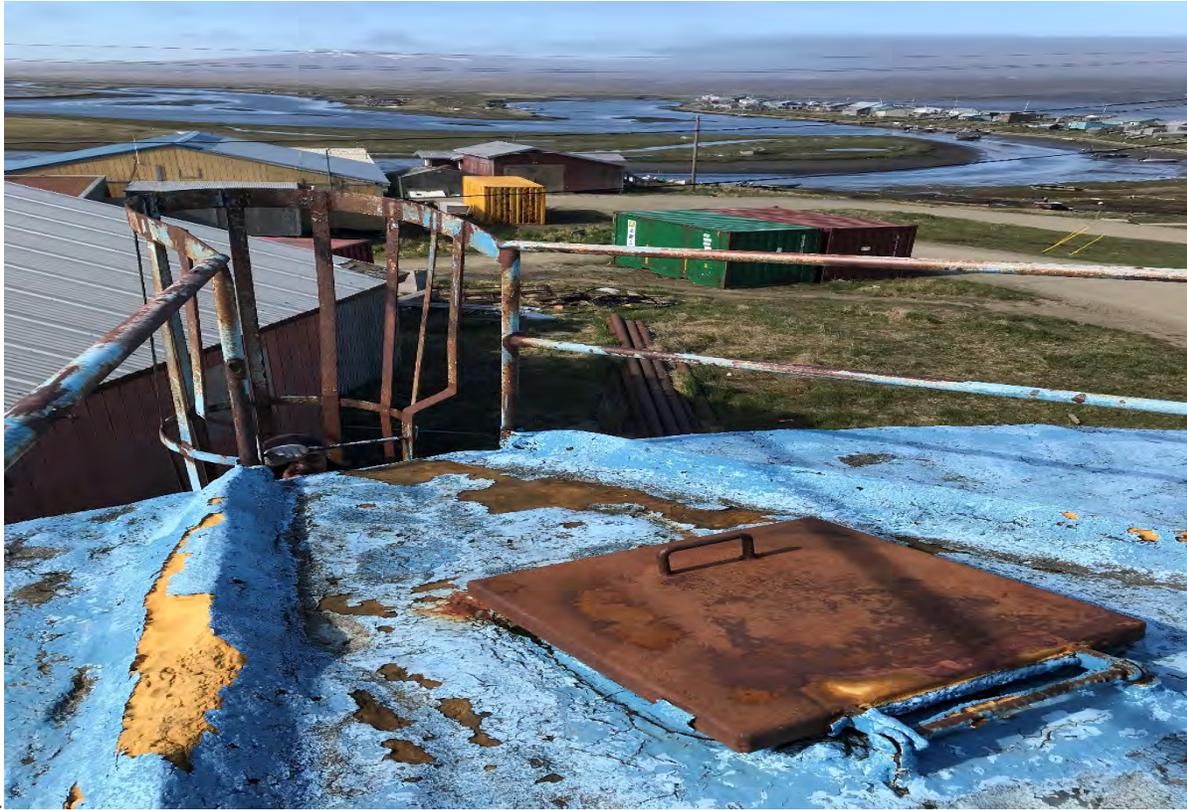
The exterior of WST cover was checked for deficiencies and was found to be in fair condition, with small sections of foam insulation missing. Photos 1 and 20 show the insulated edge of the tank cover, which appeared to be in good condition with no apparent damaged sections. Photos 13 and 14 show the overall condition of the exterior surface of the foam insulation on the tank cover. The photos show a missing section of insulation over the roof hatch. Photo 13 shows the condition of the ladder cage at the tank top, which appeared to be intact and functional. Photo 14 shows the tank vent pipe that needs to have a 90-degree extension installed on the pipe.

*Photo 14 - looking north at WST hatch vent and insulated roof.*

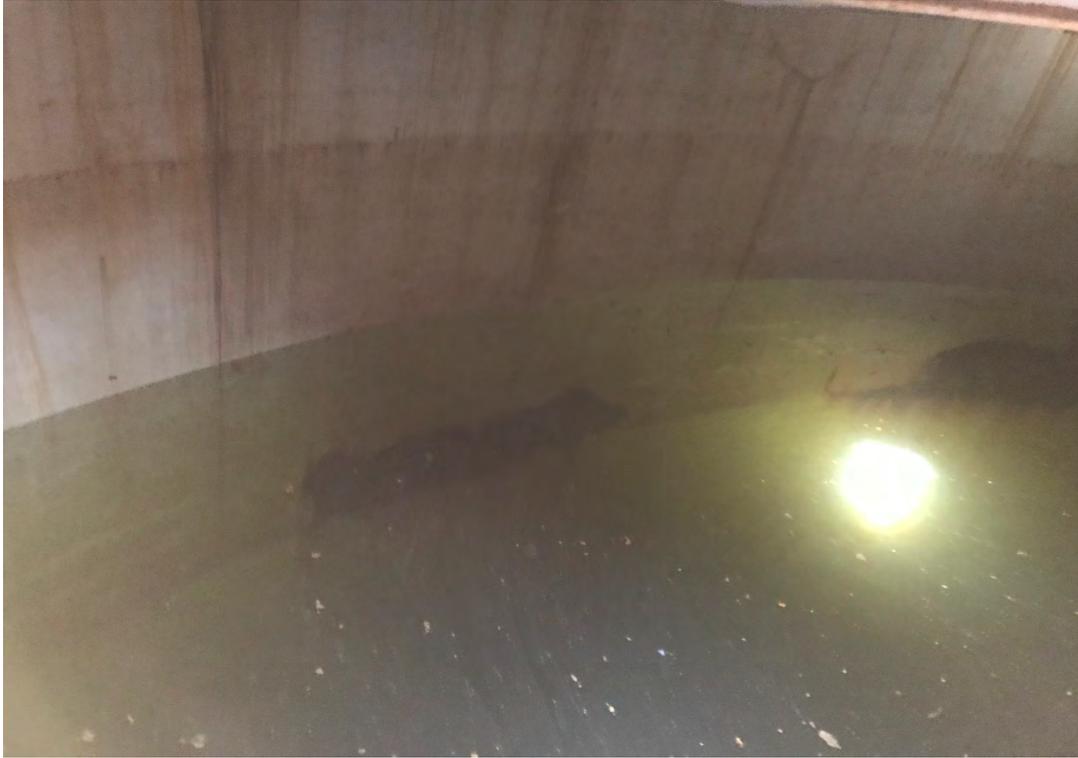
adjacent wall shown in Photo 18 shows obvious signs of surficial deterioration. Also, Photo #18 shows the underside of the WST cover that appeared to be in fair to good condition.

*Photo 18 – Looking inside the WST towards the east side of tank – note deteriorated side wall.*

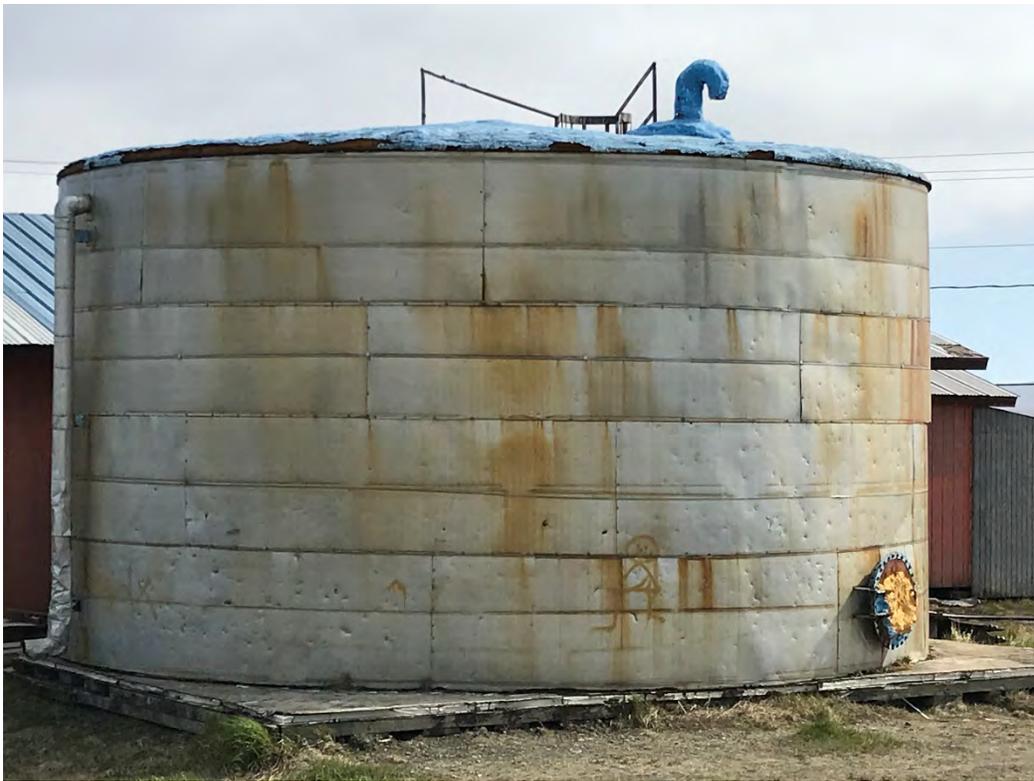
*Photo 20 – Looking at the northeast corner of the WST that shows the tank foundation.*

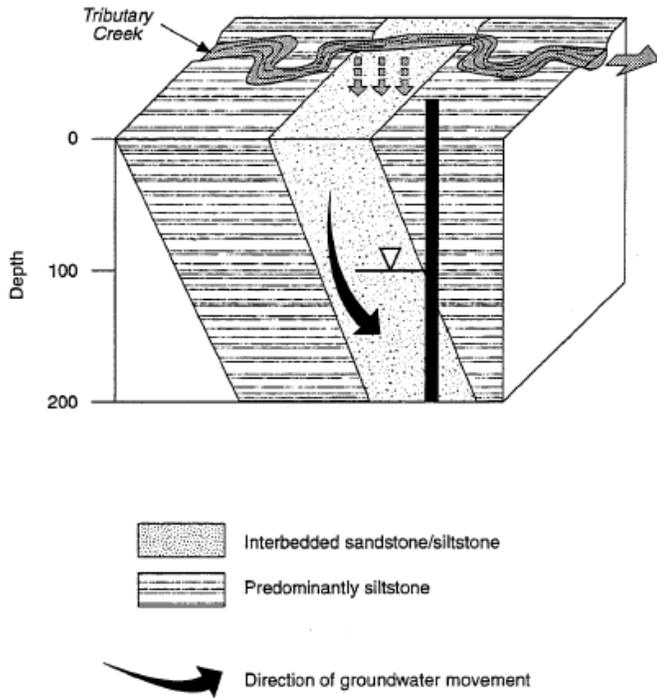
Figure 3- Conceptual groundwater model for deep water production wells in Toksook Bay (adapted from HDR Alaska Inc. 2005. City of Toksook Bay Sanitation Facilities Master Plan, Prepared for City of Toksook Bay.)

Exploratory drilling at Toksook Bay, 6 miles to the southeast of Tununak, provides insight into the water-producing capabilities of the Cretaceous sedimentary rocks (sandstone units) which are expected to underlie Tununak. At least 13 groundwater wells were installed at Toksook Bay from 1976 to 1994. Toksook Bay's primary production wells used prior to 1994 were found to be effected by salt water intrusion or fuel contamination and spurred new efforts to develop a deep groundwater well source in 1993-1994. Geologic mapping of coastal outcrops and river cuts was conducted, along with surface geophysics (very-low-frequency electromagnetic survey methods), to site locations for new wells. In 1994, seven wells were installed by air rotary drilling methods. Of the seven wells installed, three provided adequate quantity and treatable quality water for supplying water to the city. The wells were screened in the Cretaceous sandstone and production rates of 20 to 50+ gpm were reported (HDR, 2005). A generalized conceptual model of the hydrogeology of the Cretaceous bedrock was provided in the City of Toksook Bay Sanitation Facilities Master Plan, as shown on Figure 3, indicating recharge in the folded Cretaceous sandstone is provided primarily by surface water.

- The location of exploratory drilling for a new production well in the Cretaceous bedrock should be based on the anticipated location and depth of relatively permeable sandstone layers (site-specific conceptual hydrogeologic model) similar to that shown on Figure 3, which would benefit from additional field studies of the geology at Tununak.

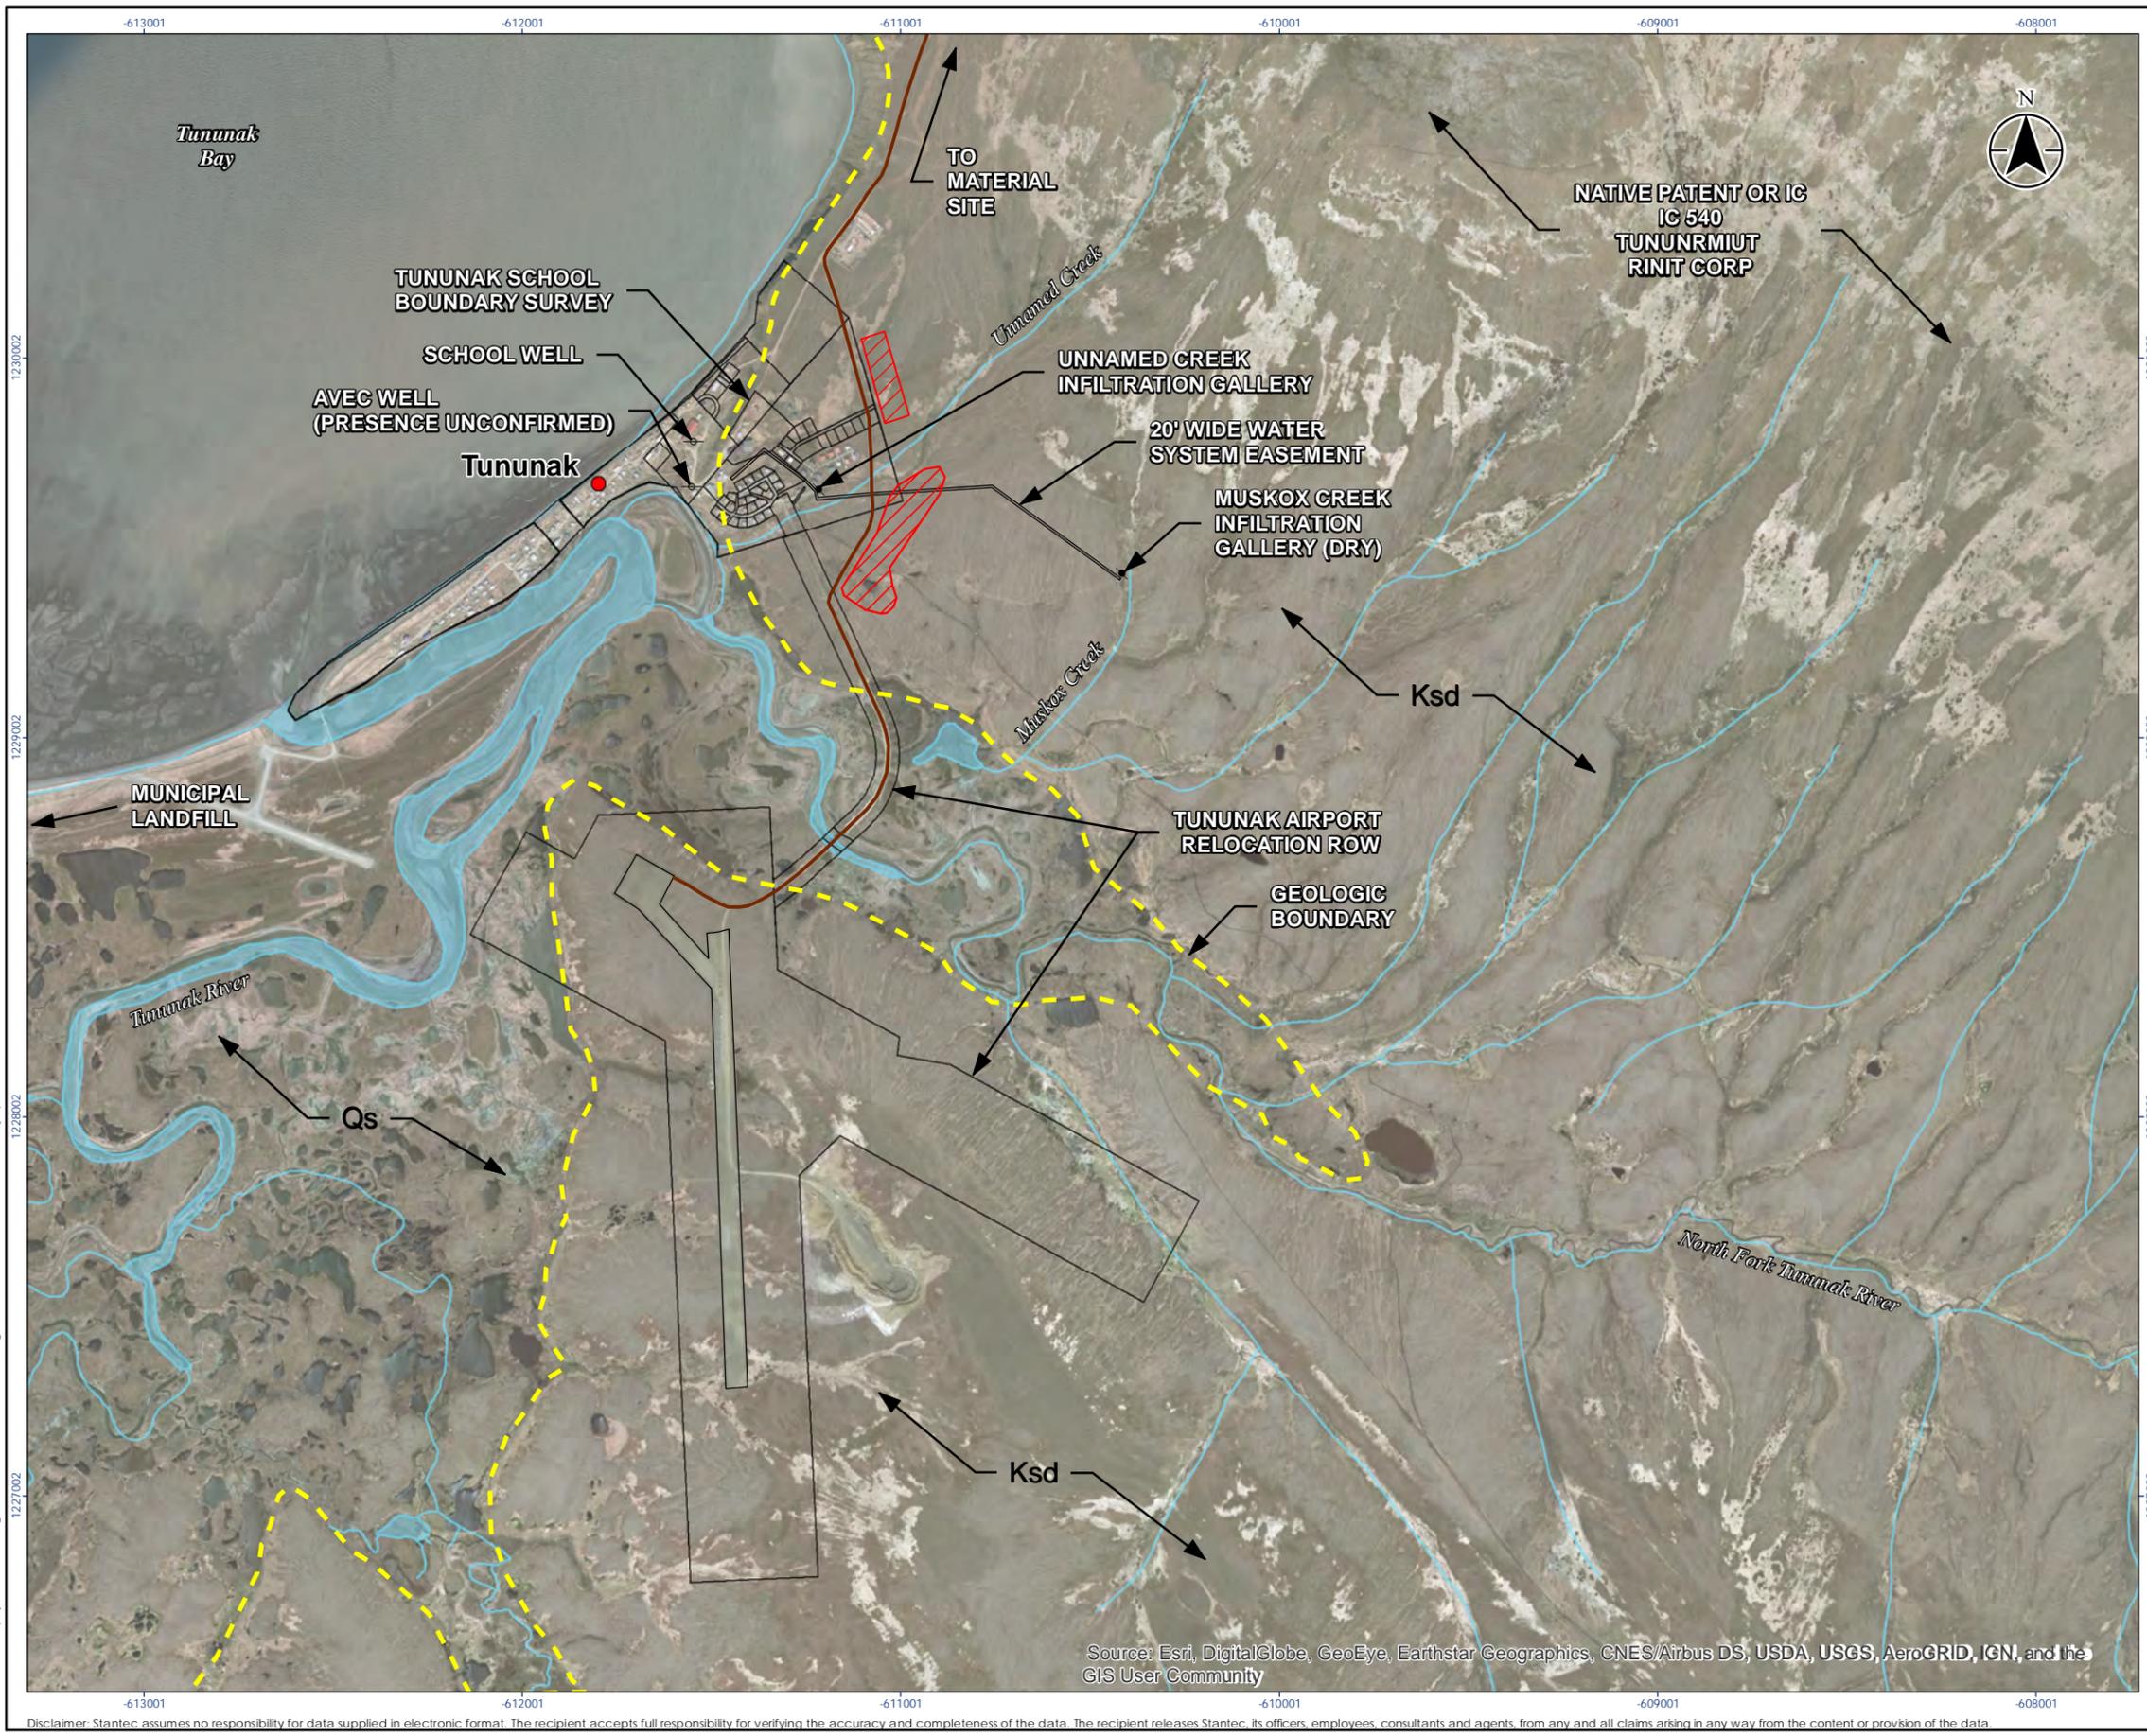
Figure 4 – Village of Tununak Site Overview with Proposed Deep Water Supply Investigation Areas

An updated aerial photography from 2015 is shown on Figure 4, along with general land ownership status and ADOT&PF right-of-way's. Land ownership data was obtained from the Alaska Department of Natural Resources (ADNR) Records Office, and needs to be evaluated by a formal title search prior to siting a new well location. Potential areas of further investigation for the drilling of deep water supply wells are depicted on Figure 4. These areas appear to be accessible for drilling a well with a truck-mounted drill rig, and are located within a reasonable conveyance distance to the washeteria and water treatment plant in Tununak, while also maintaining separation distance from surface water bodies.

- Title search to determine current landownership of potential drilling sites as shown on Figure 4. These drilling sites are shown on the figure in two shaded red areas labeled as “Proposed Deep Water Supply Investigation Areas”. The proposed drilling sites are located along the new airport road that was used to haul material for construction of the Tununak Airport. Although the two drill sites are shown on land owned by Tununmiut Rinit Corporation, the boundaries of the proposed sites are relatively general and could be adjusted to include the adjoining land that is owned by the Village of Tununak.
