**Greater Kuparuk Area (GKA)
Western North Slope (WNS)
Corrosion Programs Overview**

March 31, 2009

Commitment to Corrosion Monitoring
9th Annual Report to the Alaska Department of Environmental Conservation

Prepared by
ConocoPhillips Corrosion Team

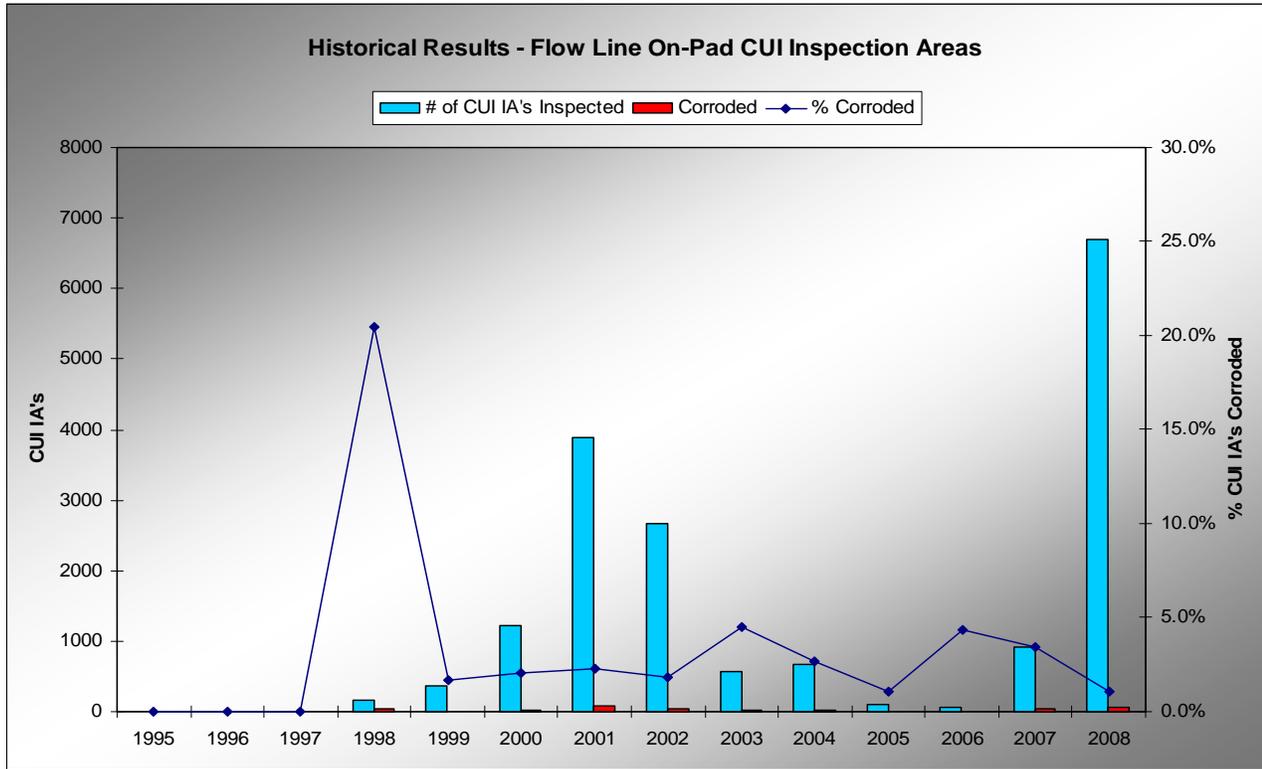
Figure 12. Summary of Flow Line On-Pad CUI IA's

The number of CUI IA's inspected with TRT, the number of CUI IA's found corroded, and the percentage of CUI IA's corroded for the flow line over tundra, flow line on-pad, and well lines are given in Figures 11, 12, and 13.
