Alaska Dept of Labor & Workforce Development

Office of Pipeline Safety
Research & Special Programs Administration

**JOINT AFTER-ACTION
REPORT
FOR
THE TAPS BULLET HOLE
RESPONSE
(October 2001)**

February 8, 2002

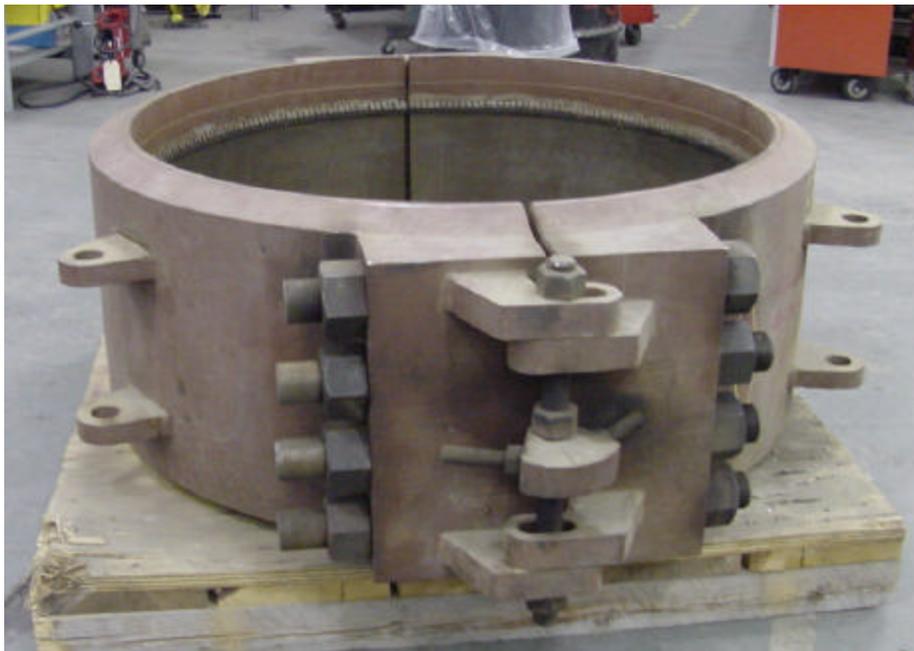
Figure IV-2: Plidco Pipeline Sleeve Clamp

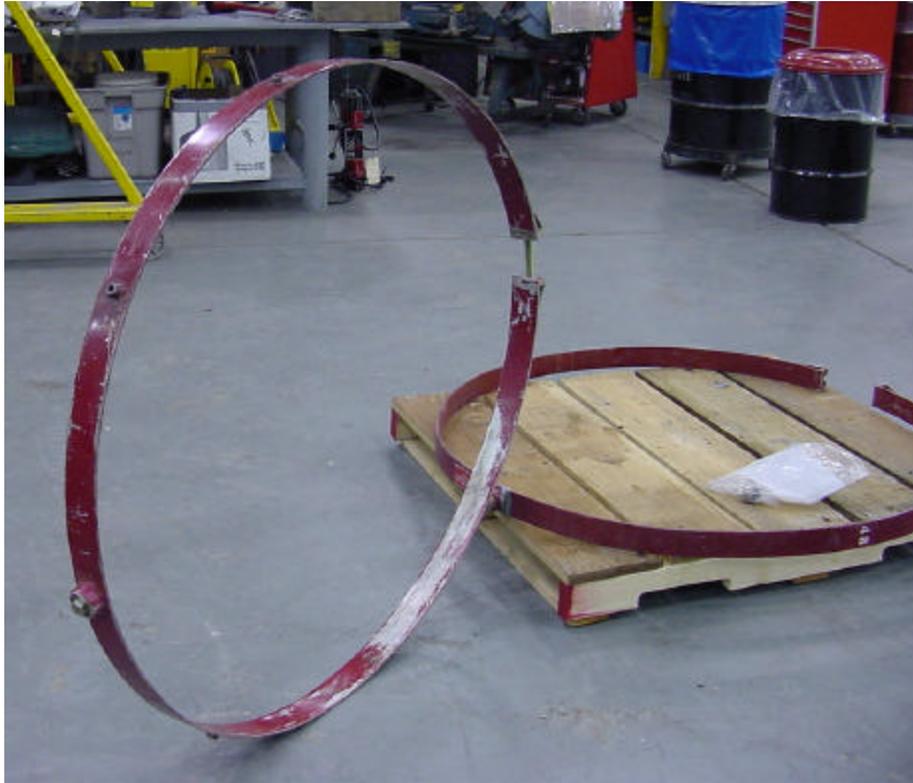
Figure IV-3: Plidco Bullet Hole Clamp

A hydraulic clamp, designed, built and tested for such a leak, was lifted by crane into place within 36 hours after the release. By the next morning, the bullet hole had been permanently plugged, North Slope oil production resumed at the normal pace, and the flow through the pipeline was restored.
