**Department of Environmental
Conservation**

Division of Spill Prevention and Response
Contaminated Sites Program

Re: Decision Document: White Pass Coach Cleaning Shop – Cleanup Complete Determination

White Pass Coach Cleaning Shop
21st and State Street
Skagway, Alaska 99840

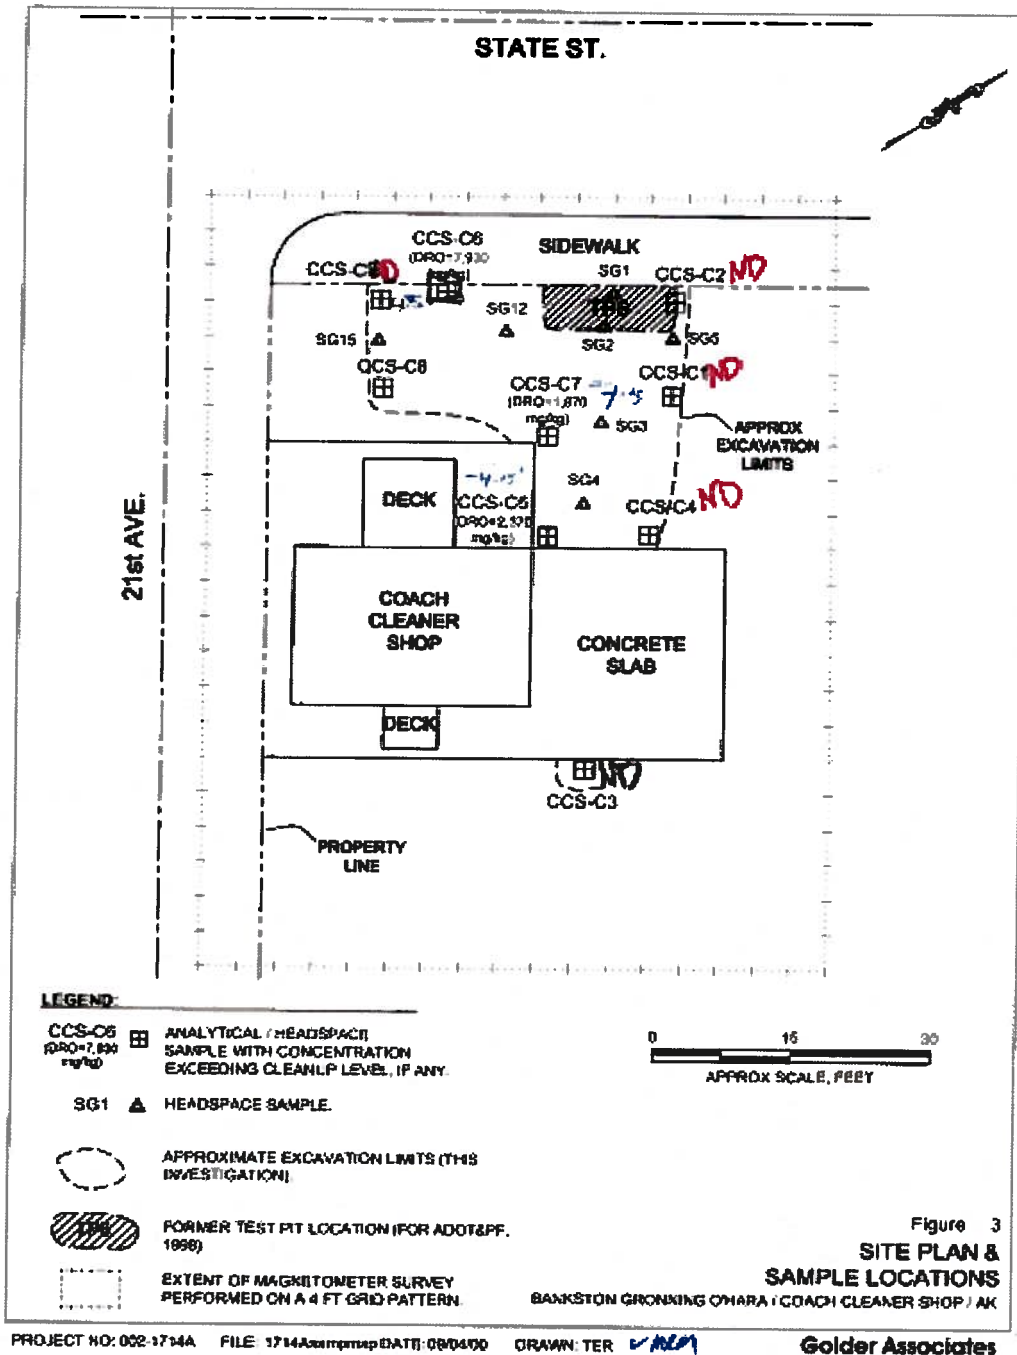
Figure 1. Site figure of the property location on the corner of State Street and 21 Ave, Skagway, Alaska.

The White Coach Cleaning shop was a railroad car wash down shop from 1898-1982 when the railroad ran from Skagway to Whitehorse. There is one small building and a small storage container left on the property. Since the building uses electric heat instead of an oil boiler, no fuel tanks are present on the property. In 1998-1999 the Alaska Department of Transportation and Public Facilities (ADOT&PF) reported diesel fuel on the water table in an excavated test pit on the western edge of State Street. The main objective of this test pit was to investigate diesel fuel along State Street. Two zones of free product were inferred to be present, one at the intersection of State Street and 20th Avenue, and the other just north of the intersection of State Street and 21st Avenue. The Coach Cleaning Shop site is located on the northeast corner of the intersection of 21st Avenue and State Street (Figure 1).
