Department of Environmental Conservation

Division of Spill Prevention and Response Contaminated Sites Program

Re: Decision Document: FAA - Flight Inspection Field Office Cleanup Complete Determination

FAA- Flight Inspection Field Office 4620 International Airport Road Anchorage, Alaska 99502

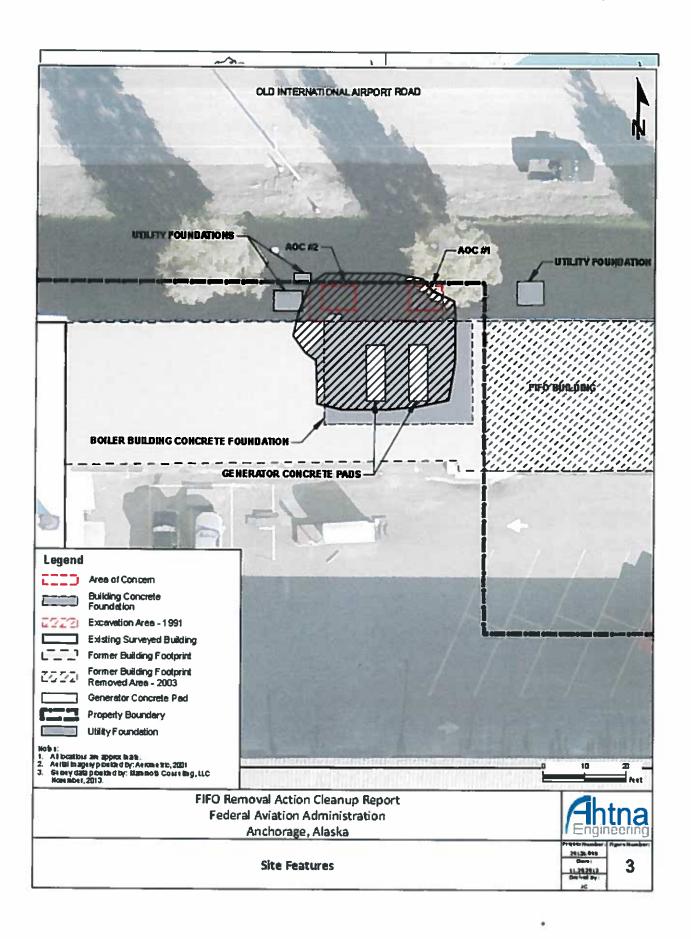
FAA Flight Inspection Field Office Location Map FAA Flight Inspection Field Office Site Figure Jon Schleder

1. Any proposal to transport soil or groundwater off-site requires ADEC approval in accordance with 18 AAC 78.600(h). A "site" [as defined by 18 AAC 75.990 (115)] means an area that is contaminated, including areas contaminated by the migration of hazardous substances from a source area, regardless of property ownership. (See attached site figure.)
