**DEPT. OF ENVIRONMENTAL CONSERVATION
DIVISION OF SPILL PREVENTION AND RESPONSE
CONTAMINATED SITES PROGRAM**

RE: **Site Closure and Record of Decision (ROD)**
for Former Quality Fabrication site, 360 East 100th Avenue, Anchorage, Alaska
ADEC Database Record no. 1998210120501)¹

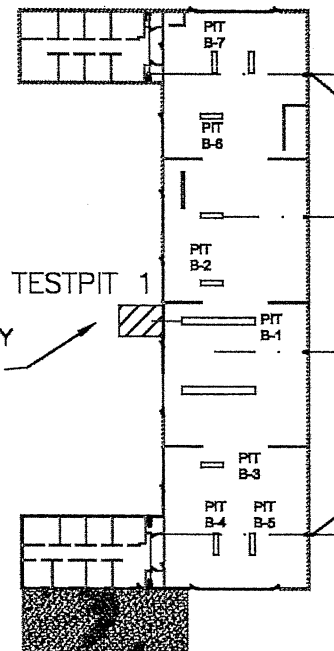
TESTPIT 3

TESTPIT 1

TEST PITS BY
ESL, 1998

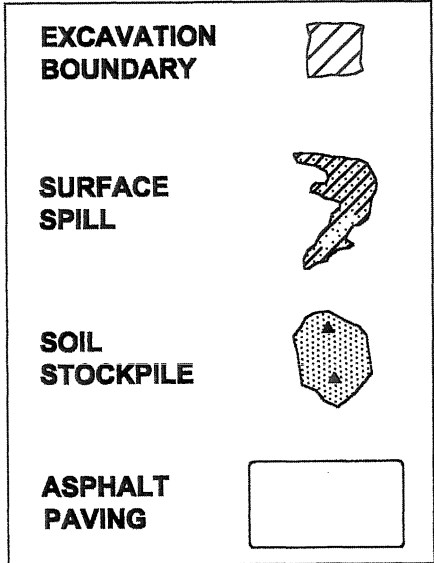
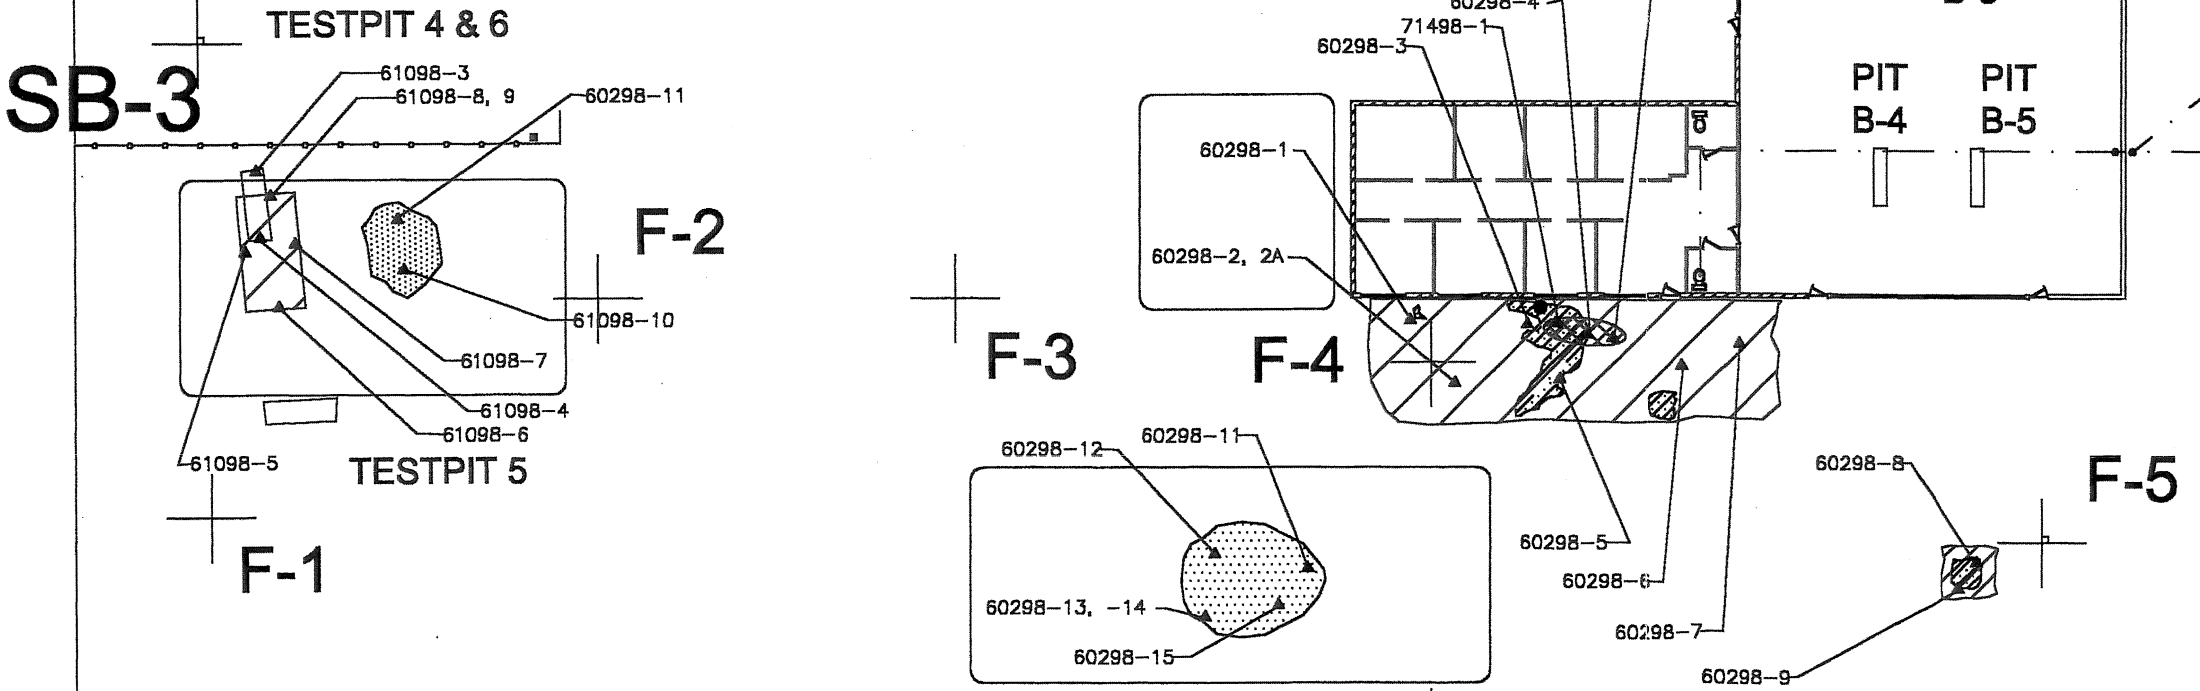
AREA 1:
WASTE OIL / FUEL
SURFACE SPILLS / STAINS

BDL = Below method detection limit
NT = Sample not analyzed for these compounds

Area 1 is described as a parking pad adjacent to the south end of the shop building. The "spill response" of the July 1998 report title refers to the cleanup of this area, as the contamination in the area was attributed to recent site use and releases. The report describes the origin of the contamination as "drips from leaking hydraulic and engine oil systems, draining of contaminated fuel and crankcase oil, etc., resulted in stains over an approximately 20 by 80 ft area." Soil samples collected in situ and from the stockpile after excavation were sampled, and analyses found mixtures of uncontaminated lubricating oil and diesel fuel. Priority metals found in the samples were consistent with background values in Anchorage area mineral soils, and no halogenated compounds were found in the samples in concentrations above method detection limits.
