Re: DEC Decision Document – FAA Station – Fairbanks International Airport, Alaska

**Decision Document**  
**FAA Station – Fairbanks International Airport, Alaska**  
**September 4, 2015**

**Hydrocarbon Risk Calculator Report  
Fairbanks FAA Station, Alaska**

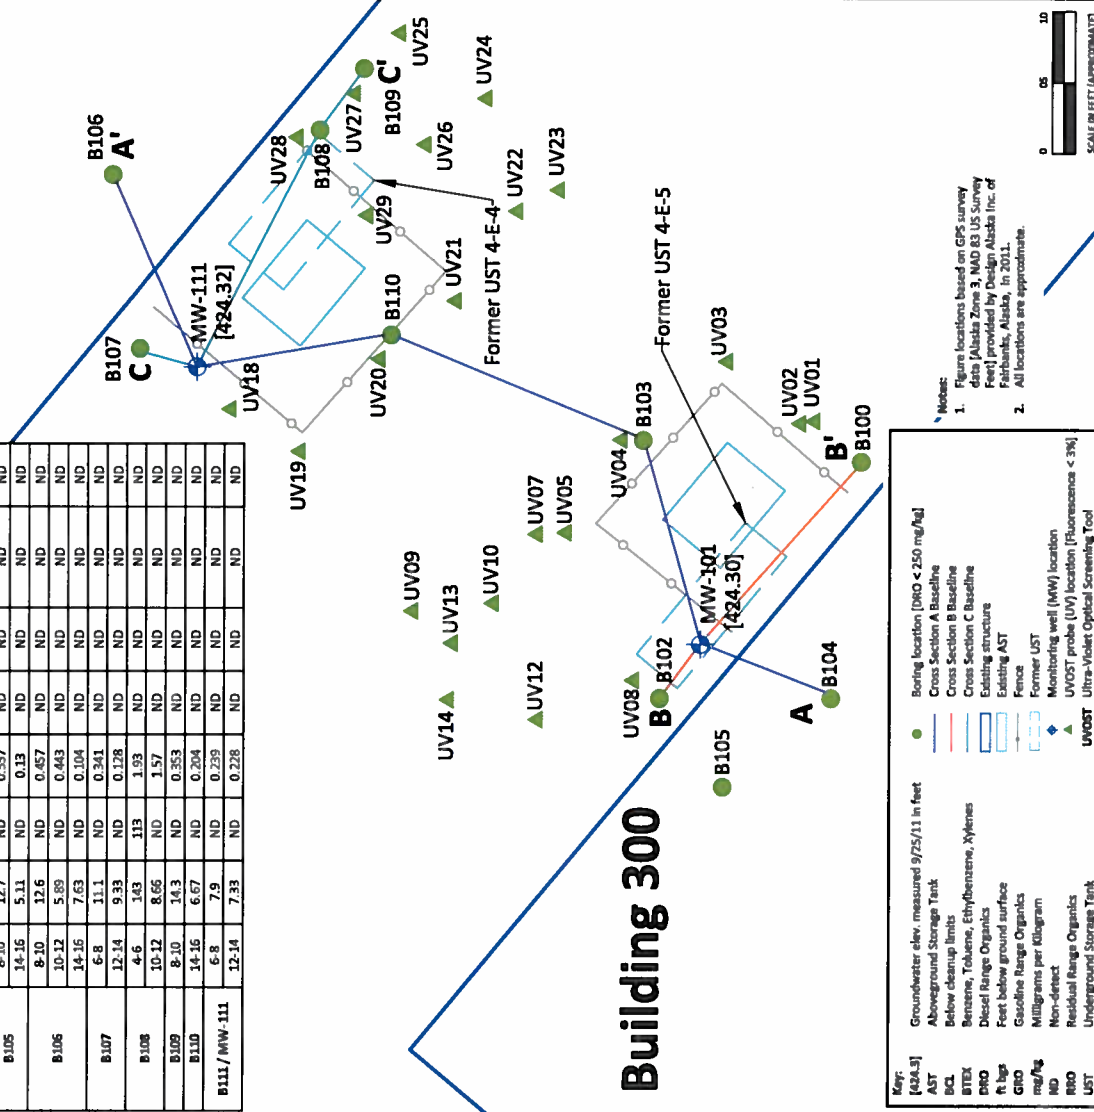
#### Buildings 207 and 300, Former USTs 4-E-4 and 4-E-5 - 2011 Soil Data

Boring Number	Depth (ft bgs)	DRO (mg/kg)	RRO (mg/kg)	GRO (mg/kg)	Benzene (mg/kg)	Toluene (mg/kg)	Ethylbenzene (mg/kg)	Xylenes (mg/kg)
B100	8-10	8.75	ND	3.56	ND	ND	ND	ND
B101 / MW-101	6-8	31.6	ND	0.267	ND	ND	ND	ND
	14-16	6.06	ND	0.308	ND	ND	ND	ND
	10-12	8.62	ND	0.308	ND	ND	ND	ND
B102	12-14	ND	ND	0.113	ND	ND	ND	ND
	6-8	10.1	ND	0.788	ND	ND	ND	ND
B104	14-16	8.18	ND	0.312	ND	ND	ND	ND
	8-10	12.7	ND	0.557	ND	ND	ND	ND
B105	14-16	5.11	ND	0.13	ND	ND	ND	ND
	8-10	12.6	ND	0.457	ND	ND	ND	ND
B106	10-12	5.89	ND	0.443	ND	ND	ND	ND
	14-16	7.63	ND	0.104	ND	ND	ND	ND
B107	6-8	11.1	ND	0.341	ND	ND	ND	ND
	12-14	9.33	ND	0.128	ND	ND	ND	ND
B108	4-6	14.3	113	1.93	ND	ND	ND	ND
	10-12	8.66	ND	1.57	ND	ND	ND	ND
B109	8-10	14.3	ND	0.353	ND	ND	ND	ND
	14-16	6.67	ND	0.204	ND	ND	ND	ND
B110 / MW-111	6-8	7.9	ND	0.239	ND	ND	ND	ND
	12-14	7.33	ND	0.226	ND	ND	ND	ND

- Notes:**
- Figure locations based on GPS survey data (Alaska Zone 3, NAD 83 US Survey Feet) provided by Design Alaska Inc. of Fairbanks, Alaska, in 2011. All locations are approximate.
  -

Uncharacterized contamination evidently extends under Building 202. Sampling near the building's foundation indicate DRO is present at concentrations exceeding the DEC Method 2 under 40 inch zone Migration to Groundwater Cleanup Levels.

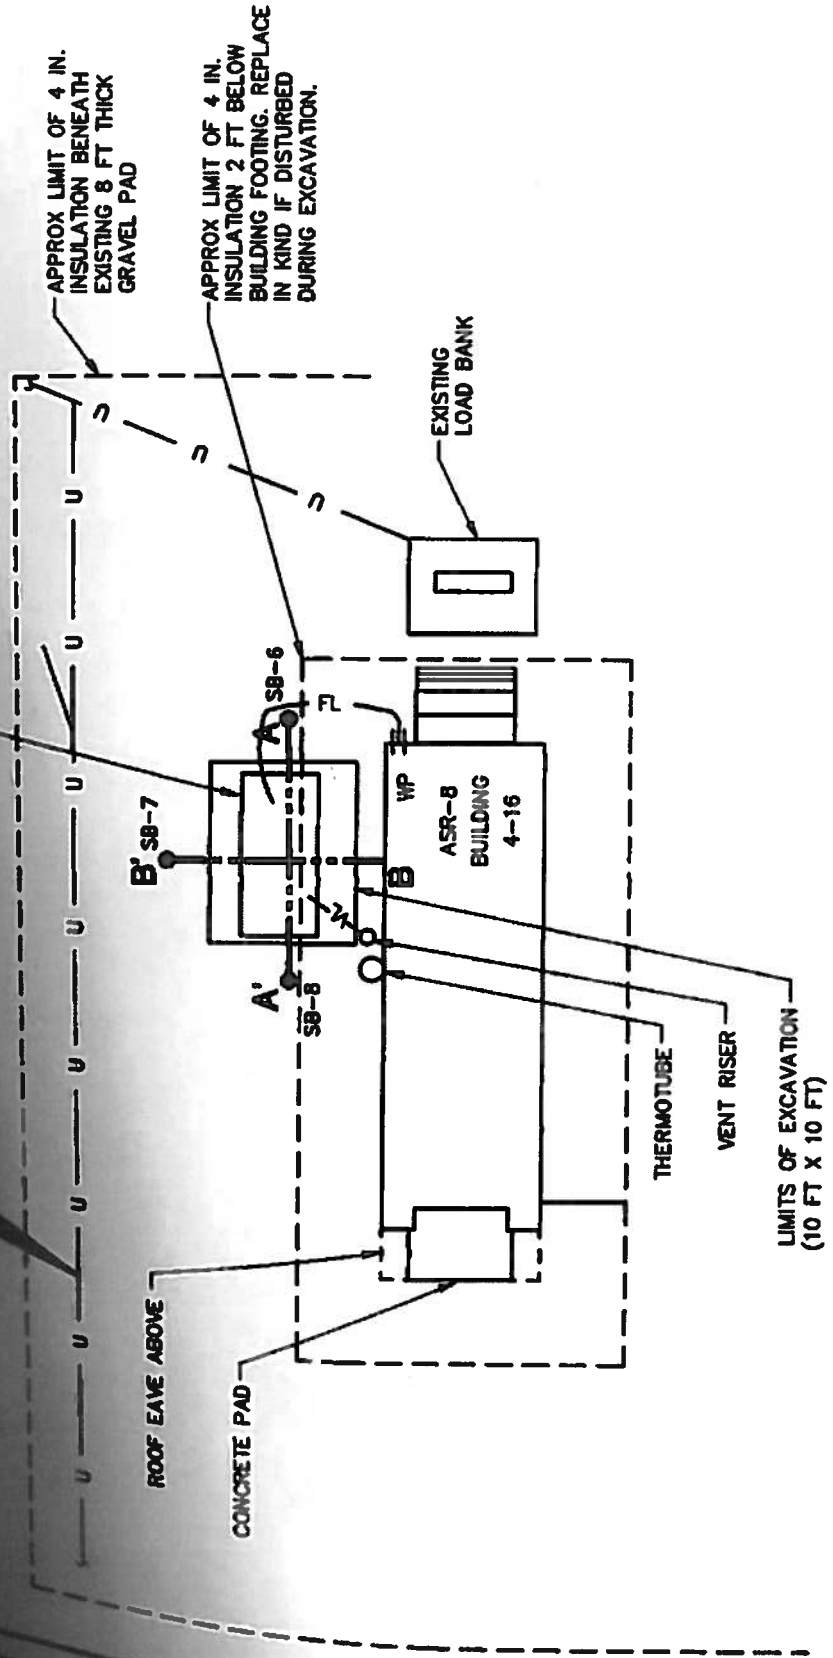
Figure 4

1000-GAL EMERGENCY GENERATOR  
UNDERGROUND DIESEL FUEL STORAGE  
TANK 4-B-1 (REMOVED)

CONFIRMATION SAMPLE LOCATION AT EXCAVATION FOR UST EE-4B1  
 FAIRBANKS INTERNATIONAL AIRPORT ASR-8 GENERATOR BUILDING  
 FAIRBANKS, ALASKA

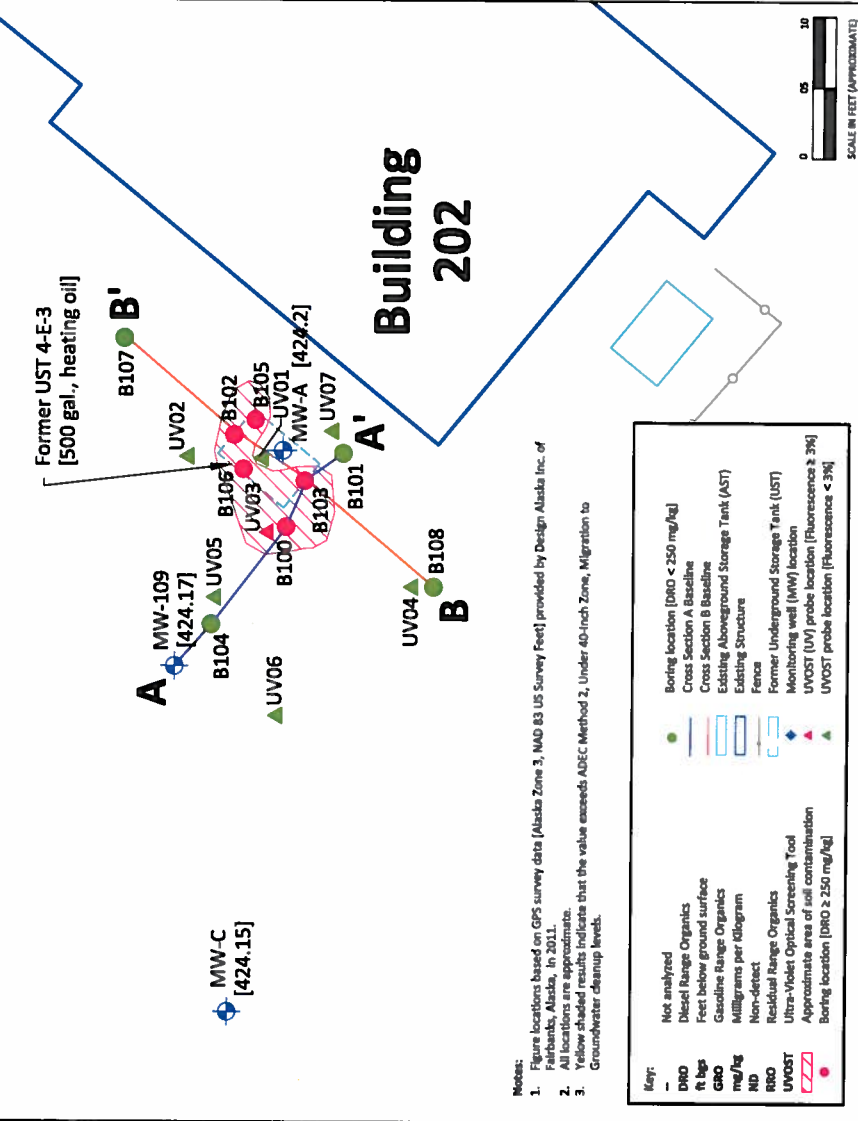
Boring Number	Depth (ft bgs)	DRD (mg/kg)	RRO (mg/kg)	GRO (mg/kg)	Benzene (mg/kg)	Toluene (mg/kg)	Ethylbenzene (mg/kg)	Xylenes (mg/kg)
B100	8-10	19000	75	42	ND	ND	ND	ND
	10-12	230	15	1.2	ND	ND	ND	ND
	14-16	5.7	ND	--	--	--	--	--
B101	8-12	1500	200	1.3	ND	ND	ND	ND
	10.5-12	630	17	1.1	ND	ND	ND	ND
	12-14.5	1700	11	21	ND	ND	ND	ND
B102	14.5-16	13	ND	0.91	ND	ND	ND	ND
	18	2.7	ND	ND	ND	ND	ND	ND
	8-9	2100	44	1.9	ND	ND	ND	ND
B103	10-12	3.6	ND	ND	ND	ND	ND	ND
	12-14	2.8	ND	ND	ND	ND	ND	ND
B104	12-14	4000	15	40	ND	ND	ND	ND
	12-14	1100	ND	30	ND	ND	ND	ND
B105	8-10.5	12	54	0.25	ND	ND	ND	ND
	12-14	3.4	ND	ND	ND	ND	ND	ND

- Figure locations based on GPS survey data (Alaska Zone 3, NAD 83 US Survey Feet) provided by Design Alaska Inc. of Fairbanks, Alaska, in 2011.
- Approximate area of soil contamination.
- Yellow shaded results indicate that the value exceeds ADEC Method 2, Under 40-inch Zone, Migration to Groundwater cleanup levels.
