Re: Decision Document: NPS Denali Nat'l Park Bus Barn
Cleanup Complete Determination – Institutional Controls

Denali Bus Barn Soil Sampling 2016
Denali National Park and Preserve, Alaska

Ahtna
Engineering Services, LLC

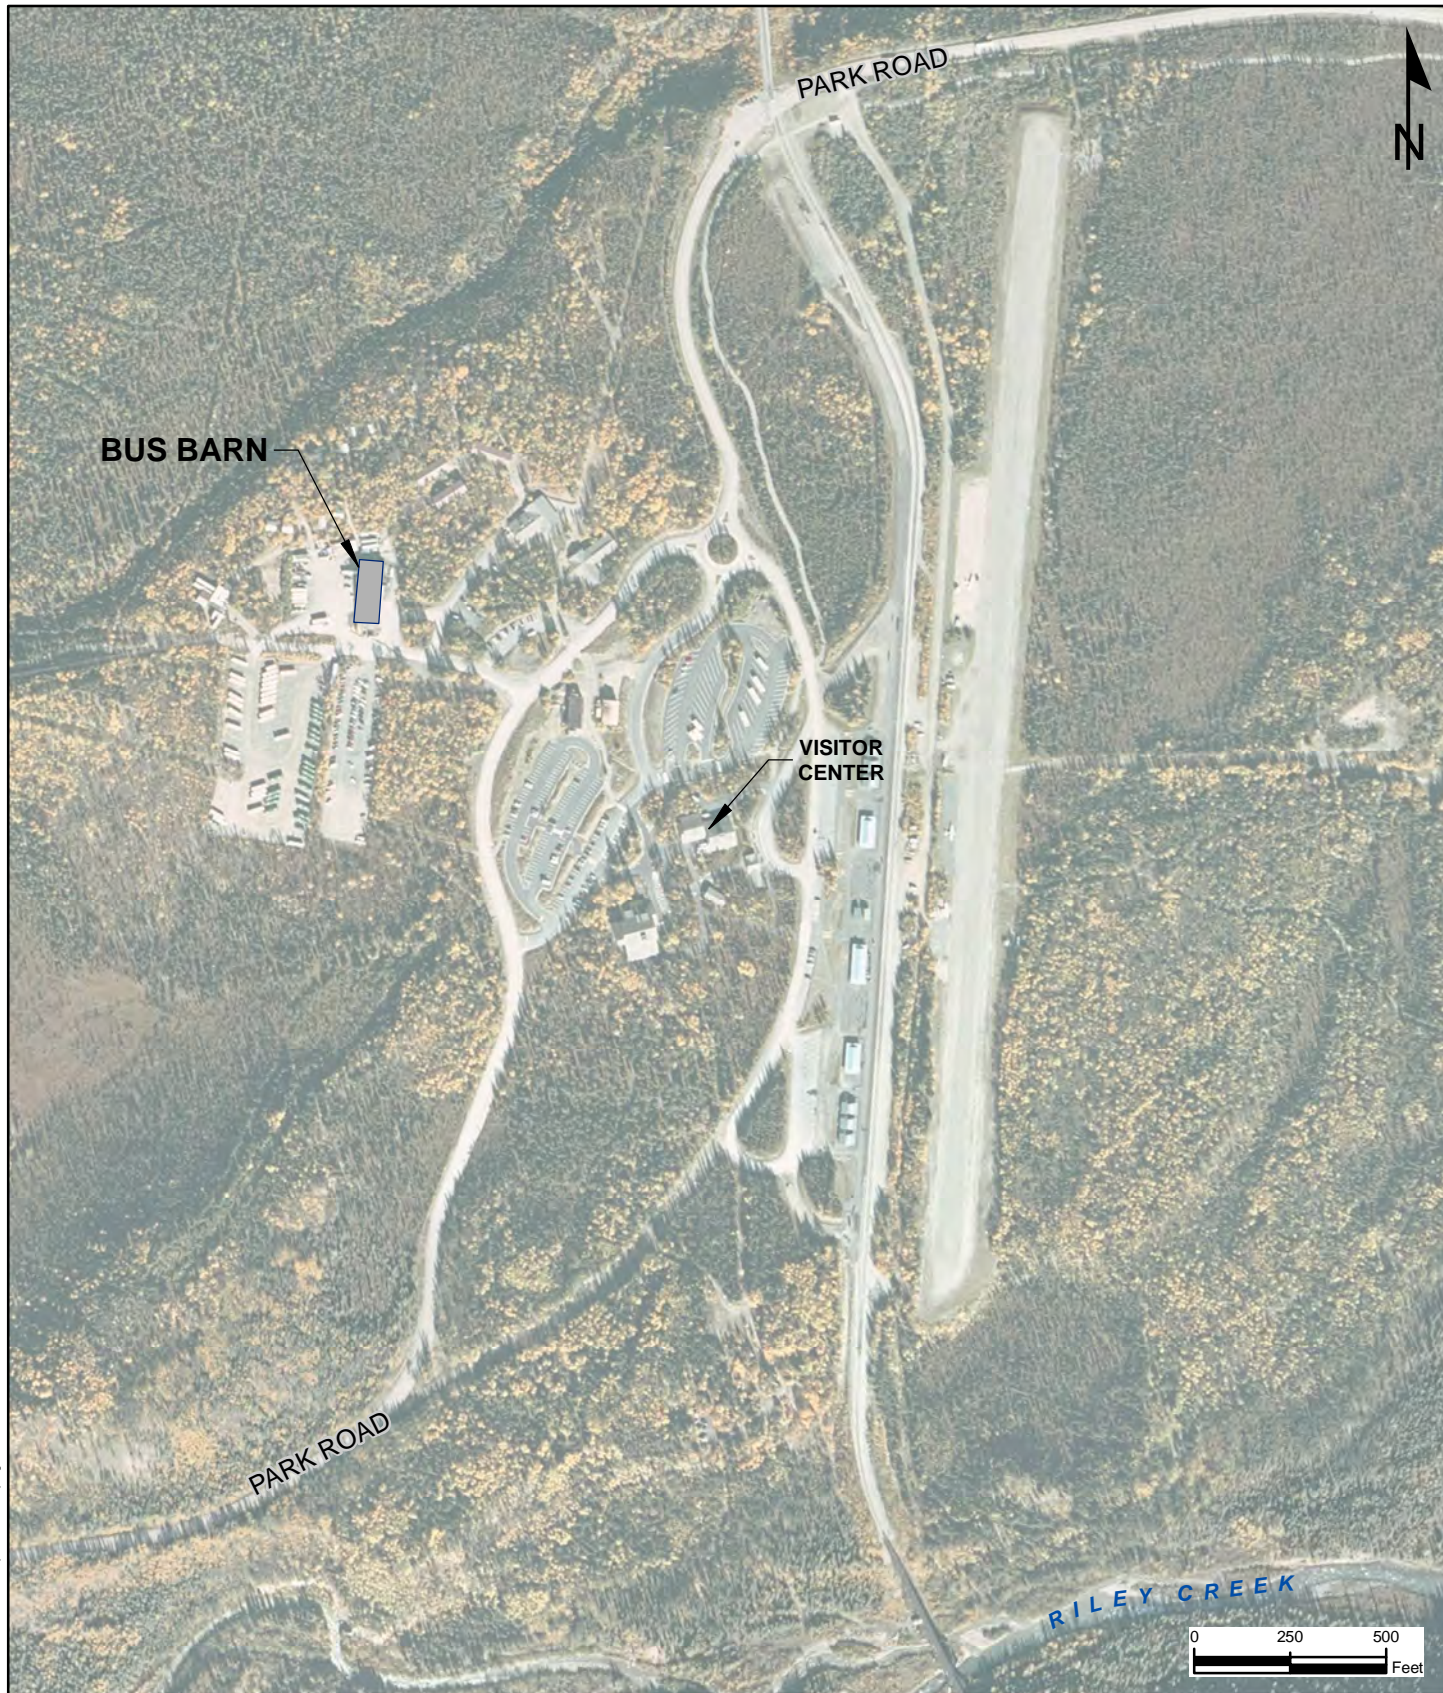
Project Number: 20297.002	Figure Number: 2
Date: 8/26/2016	
Drafted By: R.F.

SITE VICINITY
