**PACIFIC AIR FORCES
REGIONAL SUPPORT CENTER**

**EXPLANATION OF SIGNIFICANT
DIFFERENCES, PORT HEIDEN RADIO
RELAY STATION**

PORT HEIDEN, ALASKA

**FINAL
MAY 2017**

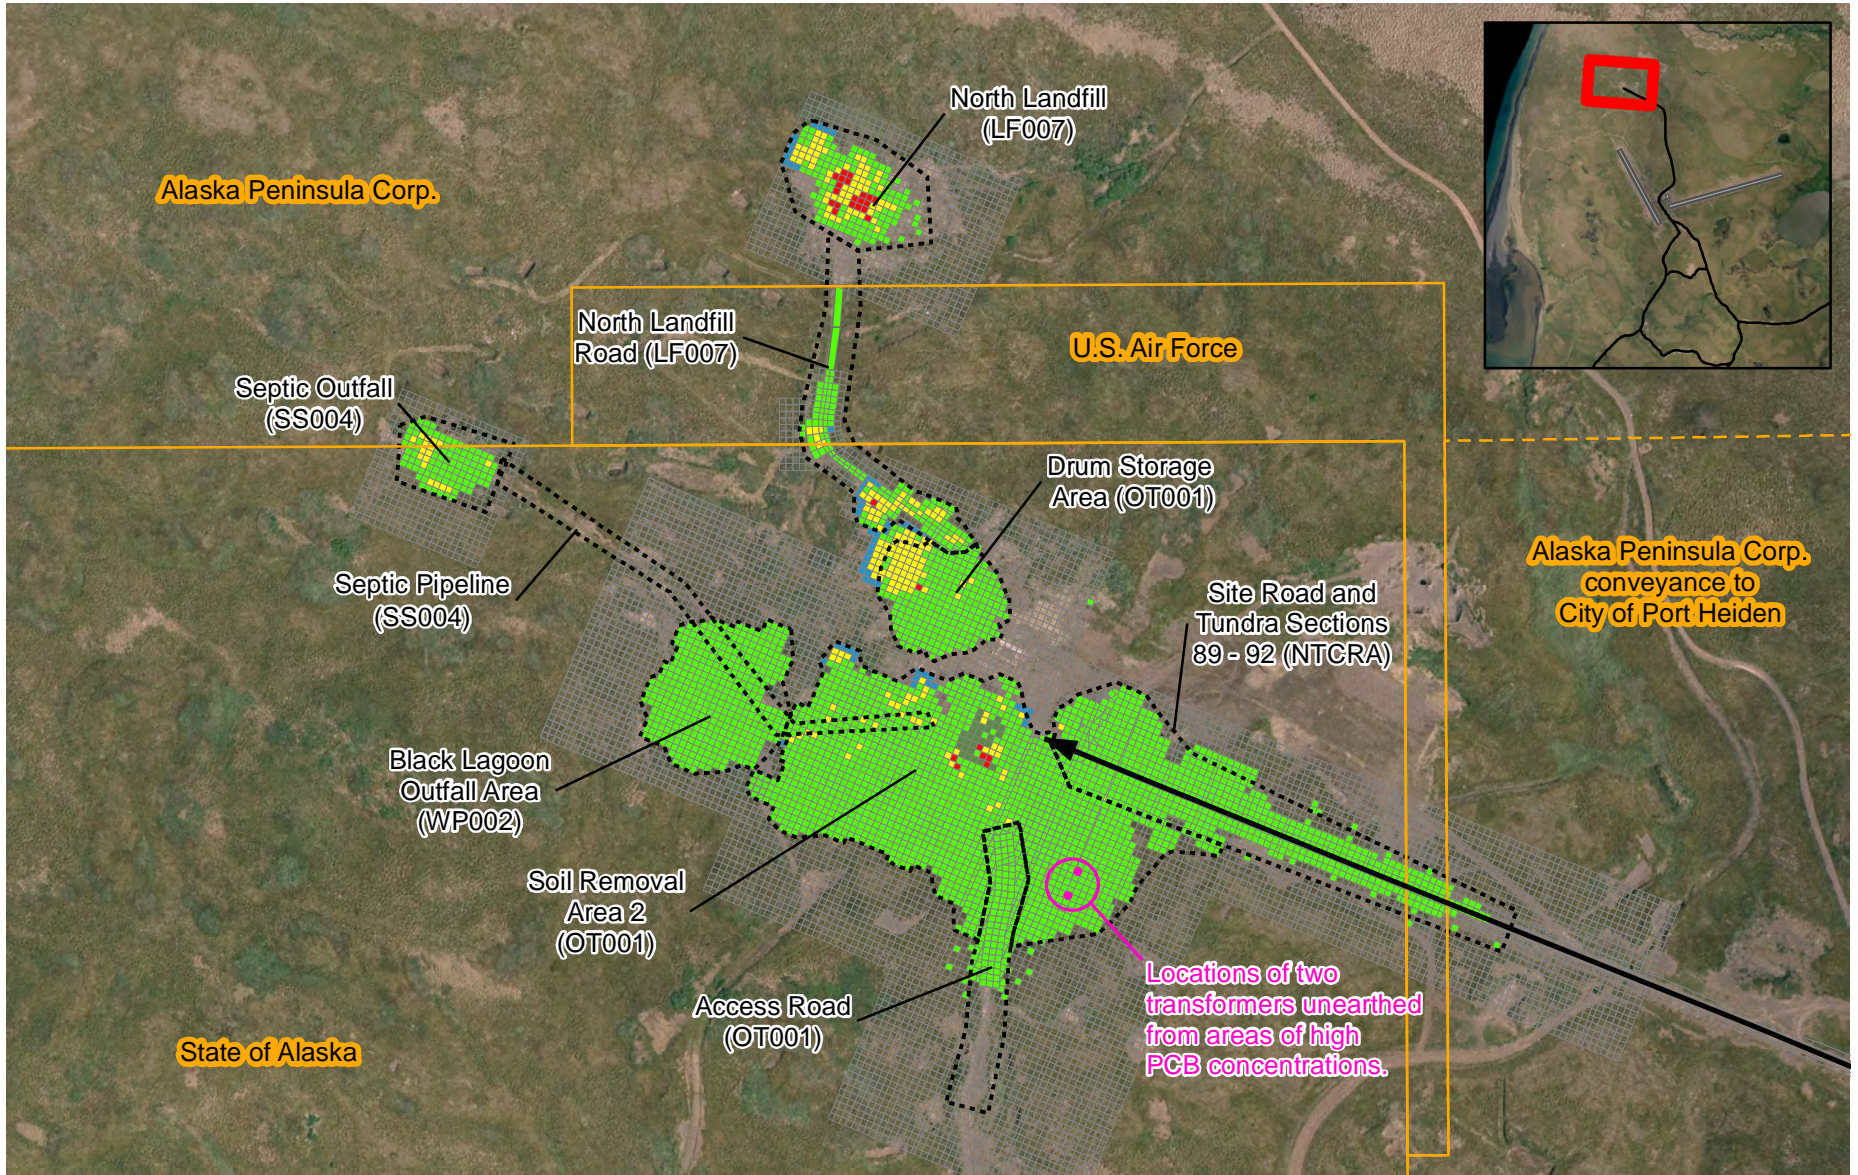
- Awaiting sample results
- 'Clean' Weston Backfill Grids
- Below Cleanup, <1 mg/kg
- non-TSCA, 1-50 mg/kg
- TSCA, >50 mg/kg

- Land Ownership Boundary
- Approx. Ownership Boundary
- Uncharacterized
- RRS Areas
- ▶ Site Road

During remedial and removal actions at the RRS and Site Road during 2015 and 2016, additional quantities of PCB-contaminated soil were identified outside the previously defined boundary of contamination. During the 2016 RRS remedial action, two electrical transformers were found in the southeast portion of the RRS where PCB concentrations were reported up to 4,010 mg/kg, the highest concentrations recorded to date at the RRS. The transformers are currently stored on site in overpack drums awaiting disposal during 2017 field activities; the surrounding soil has been disposed of in permitted landfills. During 2015, 2,157.11 tons of TSCA PCB-contaminated soil and 8,482.1 tons of non-TSCA PCB-contaminated soil were containerized and barged offsite for disposal at permitted landfills. During 2016, approximately 3,235 tons of TSCA PCB-contaminated soil and 8,896 tons of non-TSCA PCB-contaminated soil were containerized and barged offsite for disposal at permitted landfills.

2.	19 of the PDF	Fig. 3-1	<p>Radio Relay Station Overview Please indicate to the reader on the figure where the two transformers were found with the highest PCB soil contamination levels recorded to date at the RRS.</p>	<p>Amended – Locations will be added to figure 3-1.</p>
