## GROUNDWATER MONITORING WELL DECOMMISSIONING REPORT

CHEVRON-BRANDED SERVICE STATION 90932  
2200 WEST DIMOND BOULEVARD  
ANCHORAGE, ALASKA  
FILE ID: 2100.26.064

DECEMBER 13, 2012  
REF. NO. 060349 (19)

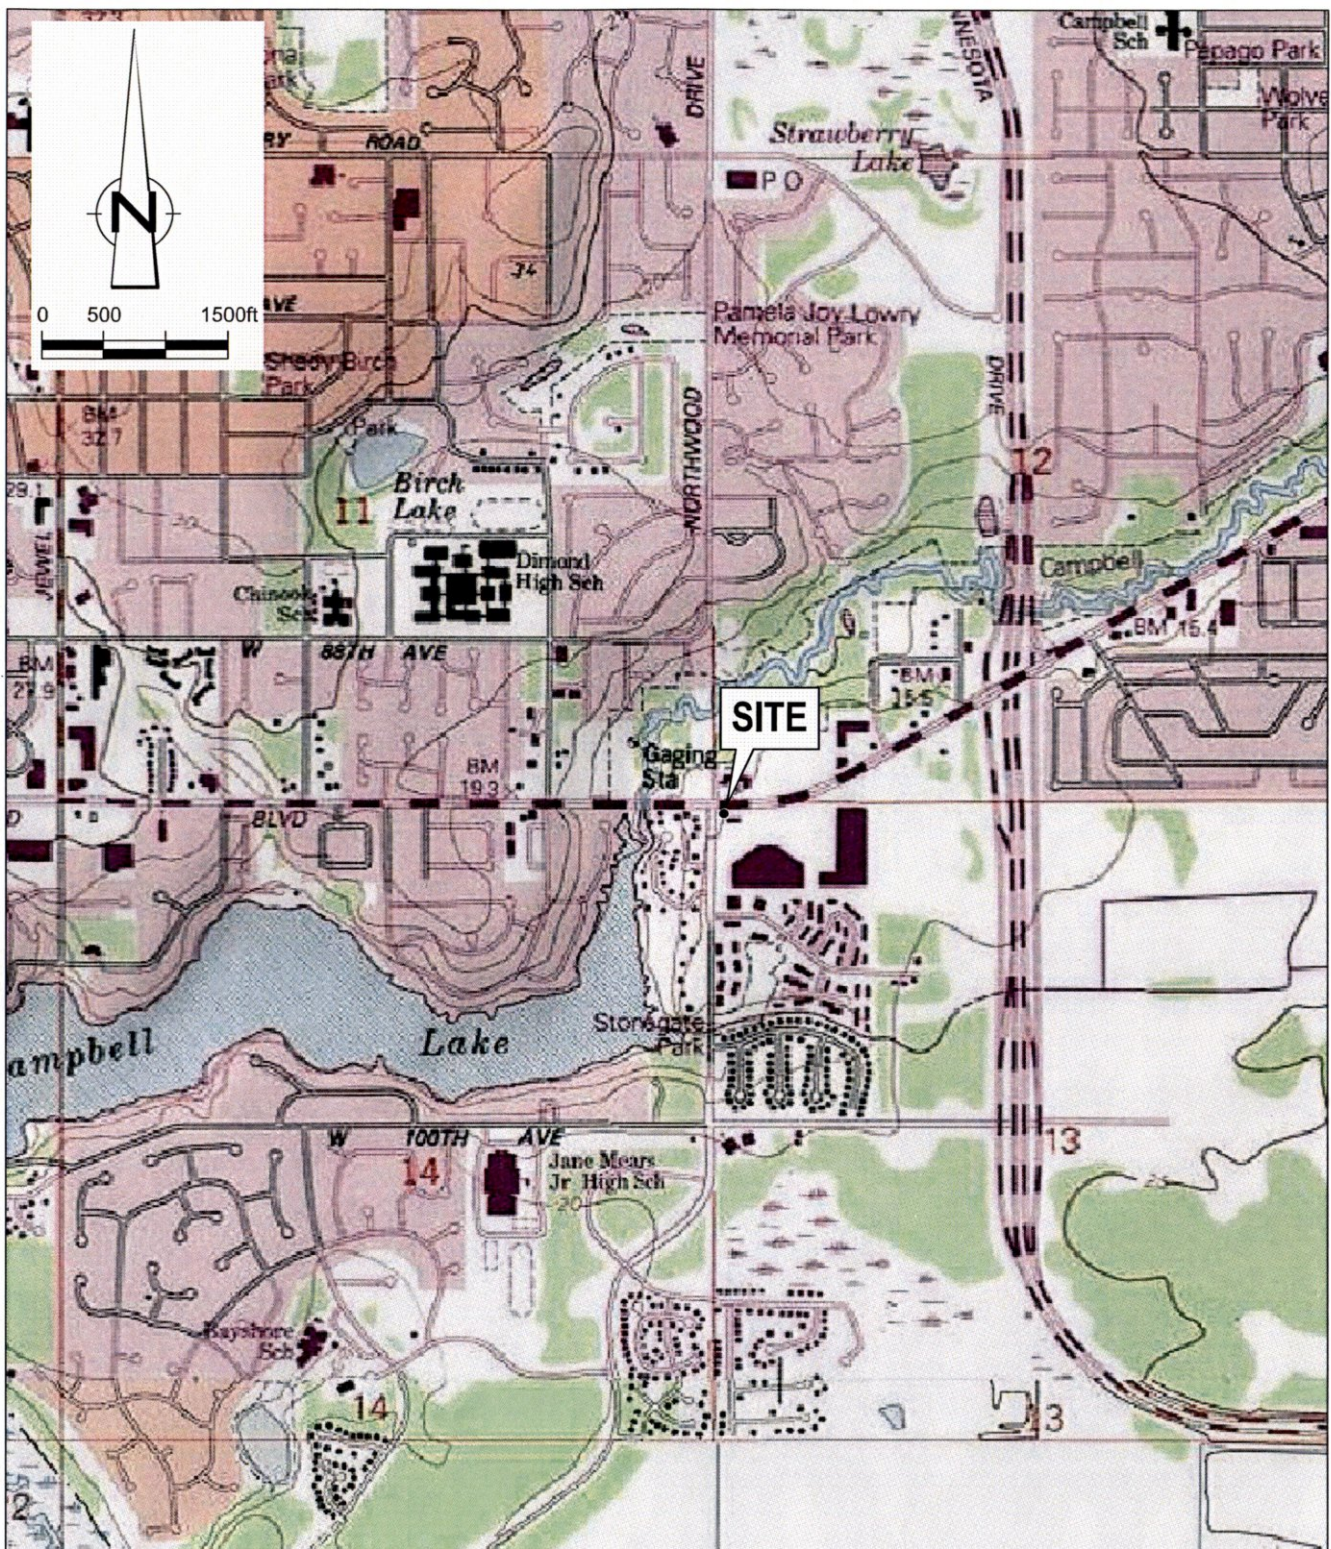
Figure 1

VICINITY MAP  
 CHEVRON SERVICE STATION 9-0932  
 2200 WEST DIMOND BOULEVARD  
 Anchorage, Alaska

The site is an active Chevron-branded service station located at 2200 West Dimond Boulevard on the southeast corner of West Dimond Boulevard and Victor Road in Anchorage, Alaska (Figure 1). The property legal description is Lakeview Terrace TR-A1. The site latitude and longitude are 61.137344° North and 149.920493° West. The site consists of a station building, three underground storage tanks (USTs), four product dispenser islands, and associated piping. Six onsite groundwater monitoring wells are gauged and five are sampled semiannually (Figure 2). Site photographs are presented as Appendix A. The site environmental history is presented as Appendix B.
