**UNITED STATES AIR FORCE
CAPE NEWENHAM LRRS, ALASKA**

INSTALLATION RESTORATION PROGRAM

DECISION DOCUMENT FOR UPPER CAMP (SS07)

FINAL

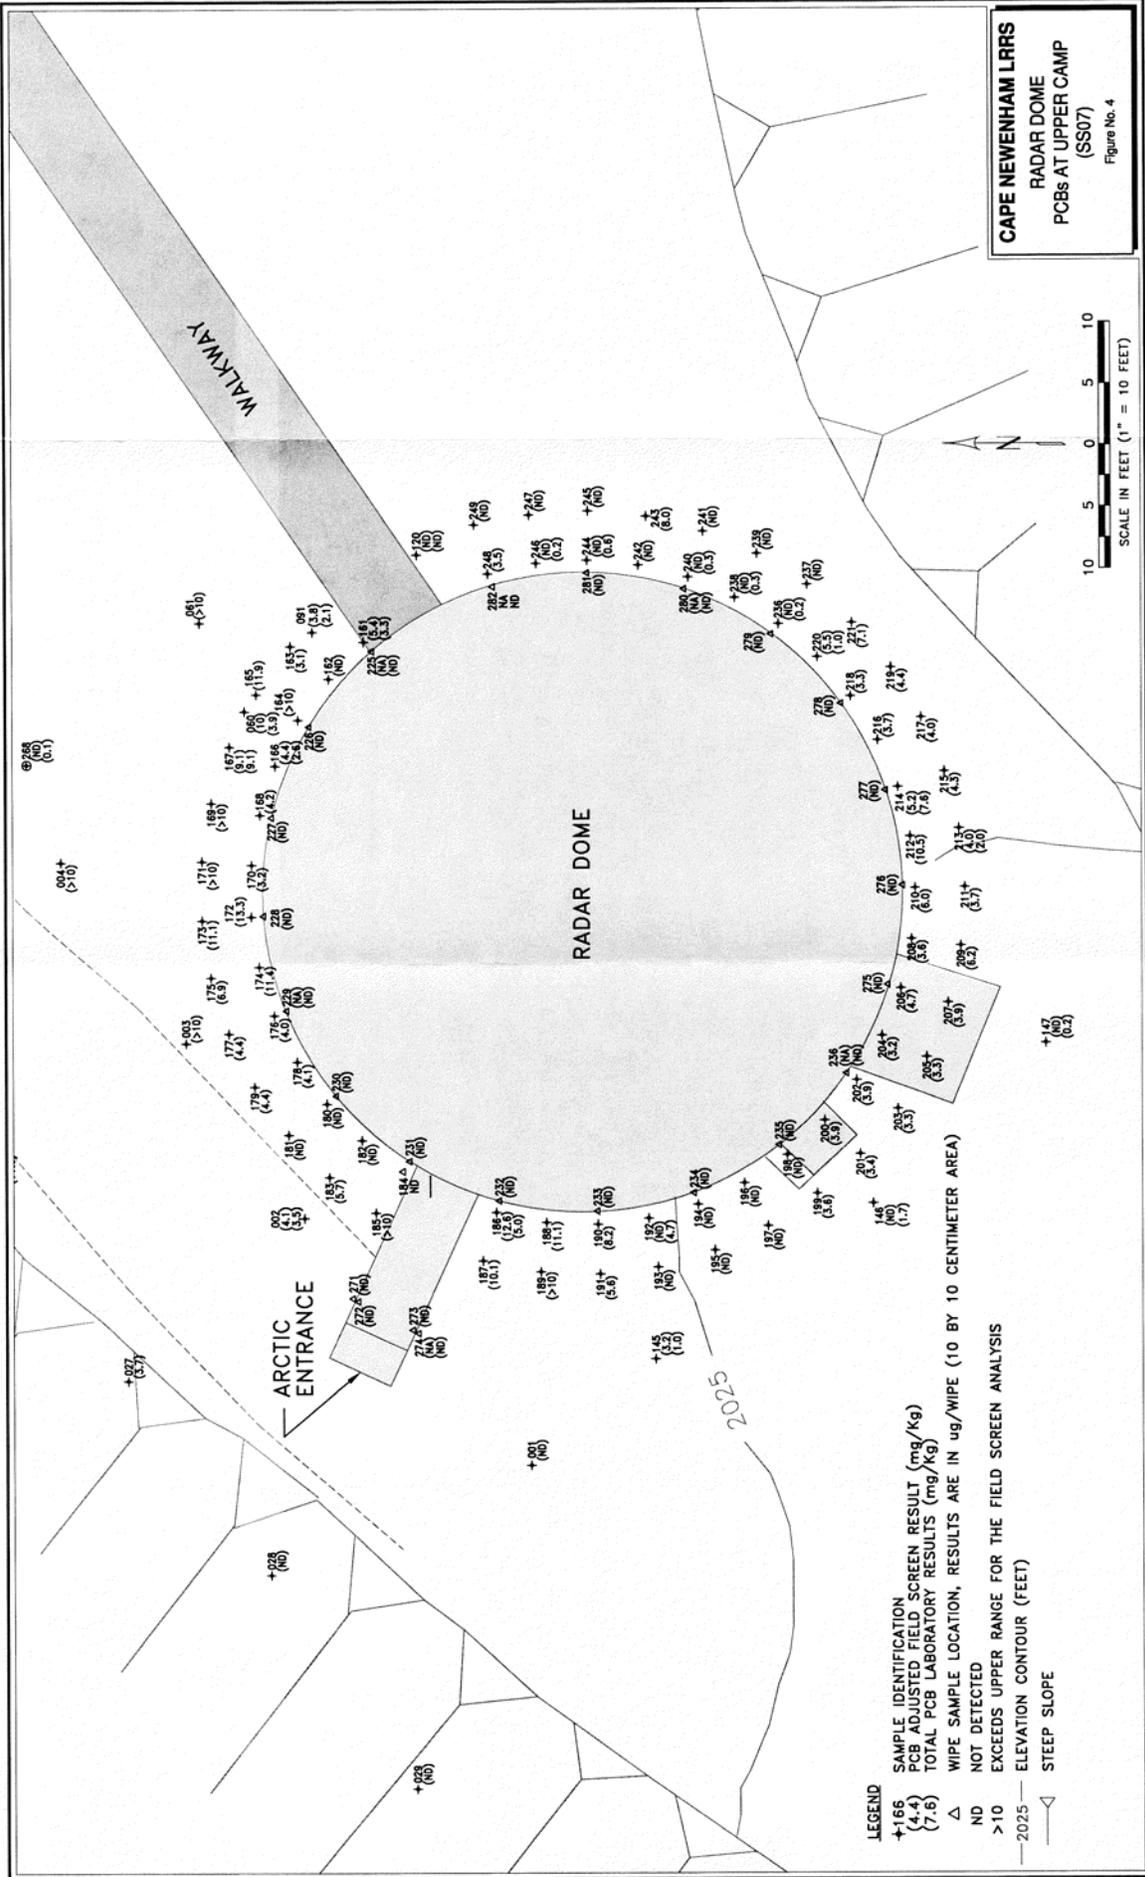
- +166 SAMPLE IDENTIFICATION
- (4.4) PCB ADJUSTED FIELD SCREEN RESULT (mg/Kg)
- (7.6) TOTAL PCB LABORATORY RESULTS (mg/Kg)
- △ WIPE SAMPLE LOCATION, RESULTS ARE IN ug/WIPE (10 BY 10 CENTIMETER AREA)
- ND NOT DETECTED
- >10 EXCEEDS UPPER RANGE FOR THE FIELD SCREEN ANALYSIS
- 2025 ELEVATION CONTOUR (FEET)
- △ STEEP SLOPE

The objective for this RI was to provide a more accurate delineation of the aerial extent of PCB-contamination in the surface soil, assess if subsurface or overland migration of PCBs had occurred, and determine the extent of contamination on the outer building surfaces. The investigation divided SS07 into five study areas: the main area, radar dome, electrical substation, walkway, and the pond. The main area included the flat area east of the radar dome and substation building and extended east-northeast down the mountain side. The radar dome is an active facility at the easternmost edge of SS07. Sampling at

the radar dome focussed on determining the presence of PCBs on building surfaces and their immediate surroundings. The walkway connects the radar dome with the upper tramway building. Sampling in this area was also to confirm if PCBs were present in building materials and the structure foundation. The electrical substation had a dirt floor foundation, and samples were collected to determine if PCBs were present in the floor, in building materials, and its immediate vicinity. The pond is located approximately 1.5 miles down-gradient from SS07. Sampling at the pond was conducted to evaluate migration of contaminants off-site. No PCBs were detected in sediments at the pond (Air Force, 1996b).
