Division of Spill Prevention and Response Contaminated Sites Program

BADGER CHEVRON

Database Name: Chevron - Badger Service

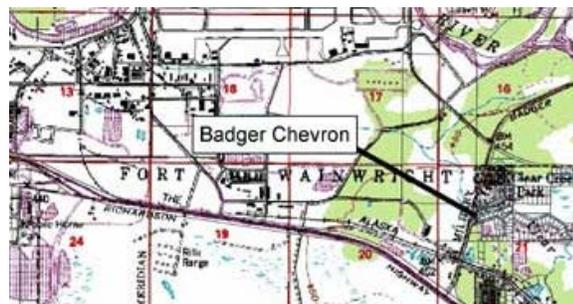
Following the removal action, a new 5,000-gallon, double walled AST was installed with new pumps, dispenser island, total containment piping, and a leak detection system. A 12,000-gallon tri-compartment UST was installed in July 1996, replacing the 5,000-gallon AST. Approximately 840-cubic yards of petroleum contaminated soils were excavated and stockpiled on-site during the 1993 and 1995 tank removal activities. A site assessment was performed in 1995 and reviewed/rewritten in 1996. A release investigation was performed in 2001 to determine the nature and extent of soil and groundwater contamination. Included as part of the investigation were drinking water sampling, groundwater sampling, and segregation and treatment of the stockpiled soil. Stockpile segregation, sampling, excavation and removal took place during 2001 and 2002. A total of 721.1 tons of petroleum contaminated soil was transported off-site and thermally remediated.
