ASPHALT SEEPS

The Asphalt Seeps site likely resulted from disposal of excess asphalt during runway paving activities following World War II. In addition, drums, some of which contain liquids other than asphalt, are buried in three areas across the site. Two drum trenches and several areas of exposed asphalt lie north of Lake Burns. Drums are also buried at Bury Pit No. 2, a permitted landfill east of Lake Burns.

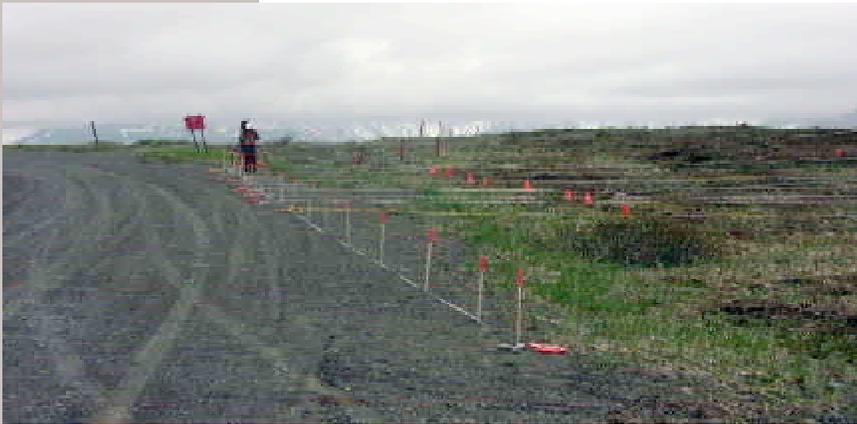
Photo: Geophysical surveys at the Asphalt Seeps. Note the grid laid out on the ground surface was used to track locations and ensure uniform data coverage.

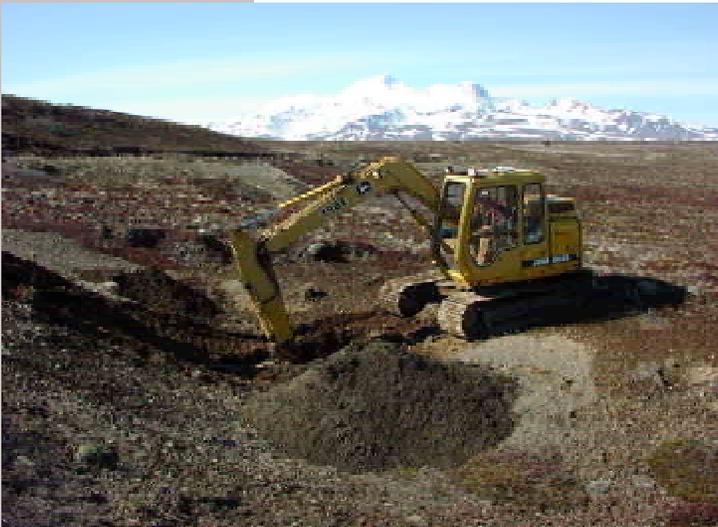
Photo: Excavating test pits in the Stapp Creek area. Photo taken looking toward the south, with Mount Frosty in the background.
