Division of Spill Prevention and Response Contaminated Sites Program

ANIAK WHITE ALICE SITE

Database Name: Aniak White Alice Site/Middle School

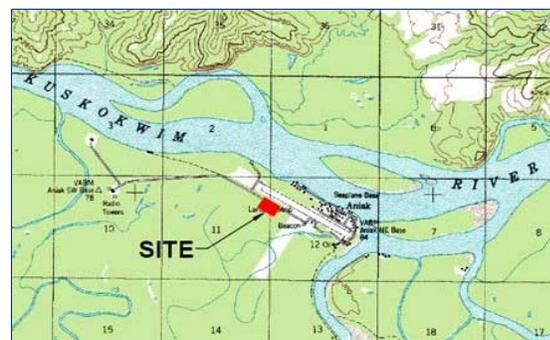
The site of the Joe Parent School building is marked in red, at the southwestern edge of the airport.

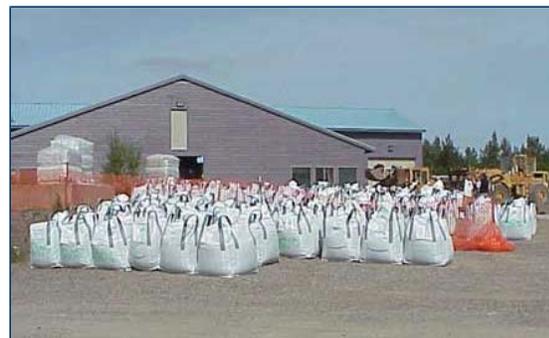
Super sacks filled with contaminated soil outside the Joe Parent School building await shipment to an off-site permitted disposal facility. (Shannon and Wilson photo)

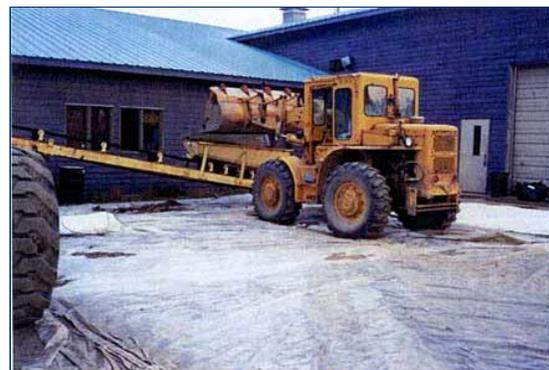
The excavation and removal of PCB-contaminated soil is shown outside the Joe Parent School building in 2001. (Shannon and Wilson photo)

Between 1998 and 2001, DEC hired contractors to better characterize the extent and location of remaining PCB contamination adjacent to the wood shop and to clean up a portion of the site. Roughly 870 tons of PCB-contaminated soil were excavated and shipped off-site for disposal. The PCB-contaminated soil that remained in the area was under the temporary cap (a liner and clean soil); therefore, there was no current exposure to it. ([See report below](#), "PCB Cleanup, Aniak Middle School," Shannon and Wilson, December 2001.)

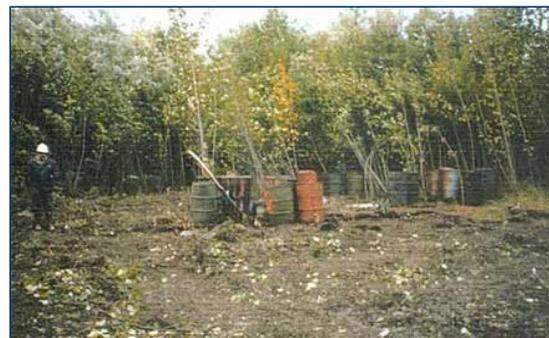
Drums on the site as they appeared before the U.S. Army Corps of Engineers removed them in August 1998.

In 1994, DEC was notified of additional drums and possible contamination at the site. DEC staff inspected the site in 1996 and observed about 60 drums in alders between the former WACS building, now the Joe Parent School building, and the airport runway. The U.S. Army Corps of Engineers tested the ground beneath the drums and documented petroleum contamination. Since the land was used but no longer owned by the military, the Army Corps of Engineers assumed responsibility for the military's portion of the contamination under the "Formerly Used Defense Site Program."

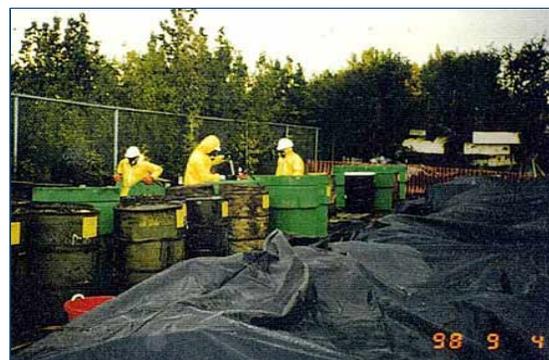
Workers prepare drums during a U.S. Army Corps of Engineers' removal in August 1998.

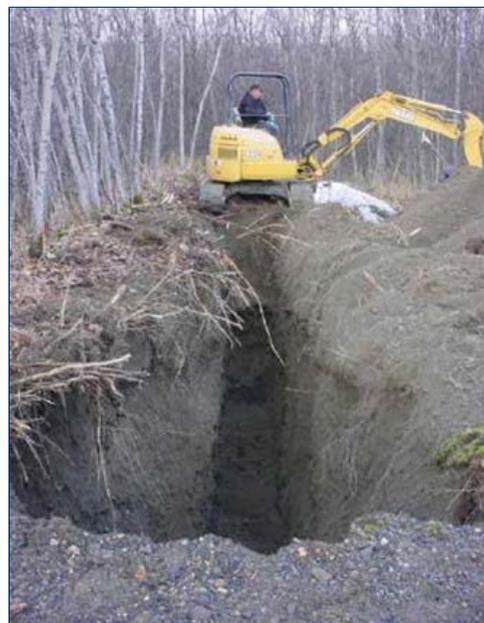
A septic trench is dug in Aniak in October 2006 to allow for sampling. The trench was backfilled after sampling.

In October 2006, DEC's contractor sampled the contents of the former WACS septic system, soil around the septic system and soil near a former drum storage area. The results showed concentrations of PCBs, arsenic, chromium and trichloroethylene (TCE) above cleanup levels in the septic system and in soil, thus expanding the area of concern and contaminants that warrant cleanup. ([See report below](#), "Septic System and Area F Characterization," May 2007.)
