ALASKA DEPARTMENT OF ENVIRONMENTAL CONSERVATION  
Division of Spill Prevention and Response  
Prevention and Emergency Response Program  
**SITUATION REPORT**

## Kulluk Tow Incident

SITREP #: 11

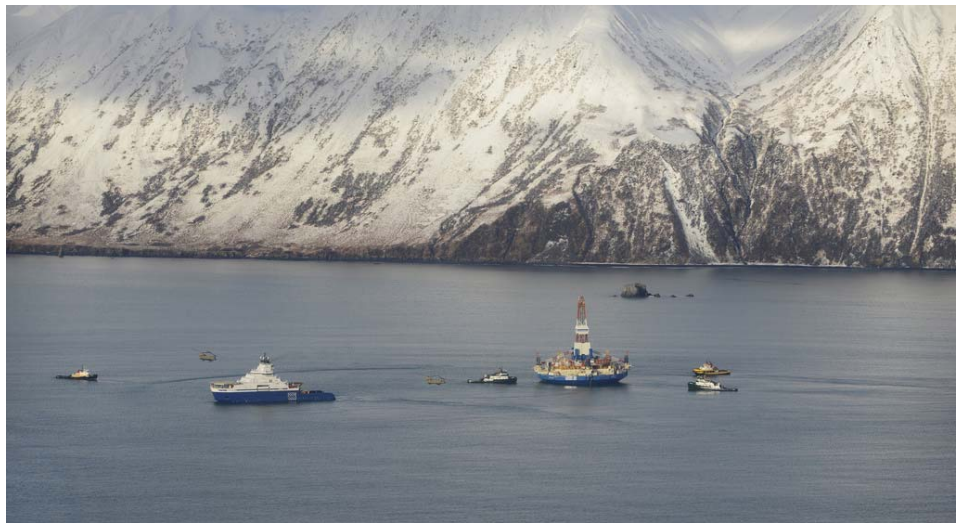
The CDU *Kulluk*, towed by the anchor-handling vessel M/V *Aiviq*, heads to its safe harbor location in Kiliuda Bay. (Photo courtesy of Shell Alaska)

RESPONSE ACTION: Spill response plans have been developed for the specific areas near the *Kulluk* and the plan is being updated daily based on weather and operations. At approximately 10:10 p.m. on January 6, 2013, the CDU *Kulluk* was refloated from its Sitkalidak Island position under tow by the M/V *Aiviq*. There were no reported injuries during this operation. The M/V *Aiviq* towed the CDU *Kulluk* to Kiliuda Bay, accompanied by the fleet of support and spill response vessels. The M/V *Nanuq* crew, utilizing infrared equipment, reported that there were no signs of a discharge and no visible fuel trailed the CDU *Kulluk* while en route to Kiliuda Bay. The M/V *Warrior* conducted soundings of the sea floor for potential obstructions at the Kiliuda Bay anchorage location. **The CDU *Kulluk* anchored in Kiliuda Bay shortly after noon on January 7. The M/V *Lauren Foss*, M/V *Corbin Foss*, and the M/V *Ocean Wave* are currently tethered to the CDU *Kulluk* and are standing by to assist as needed. Five additional salvage members were placed onboard the CDU *Kulluk* yesterday, and the one Shell representative who had been onboard was removed, leaving 15 personnel aboard the CDU *Kulluk*. A 150**

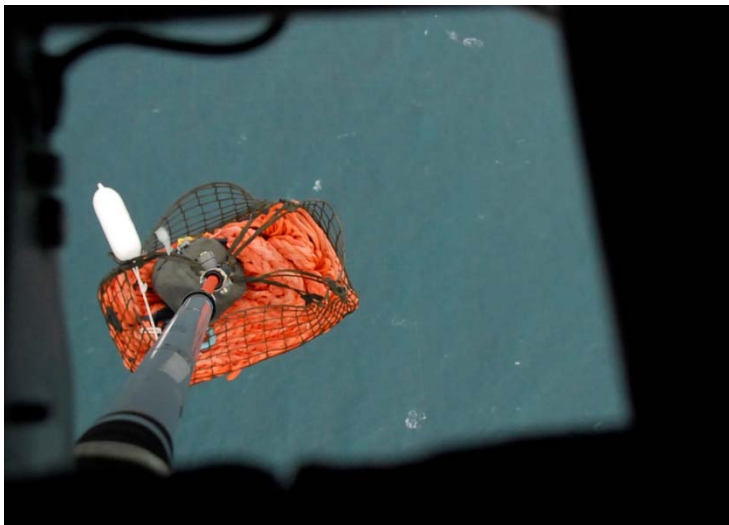
Sling loading the ADEC emergency tow system onto the CDU *Kulluk* (Photo courtesy of USCG)
