Total Maximum Daily Load (TMDL) for
Residues
in the Waters of
Herring Cove of Silver Bay, Alaska

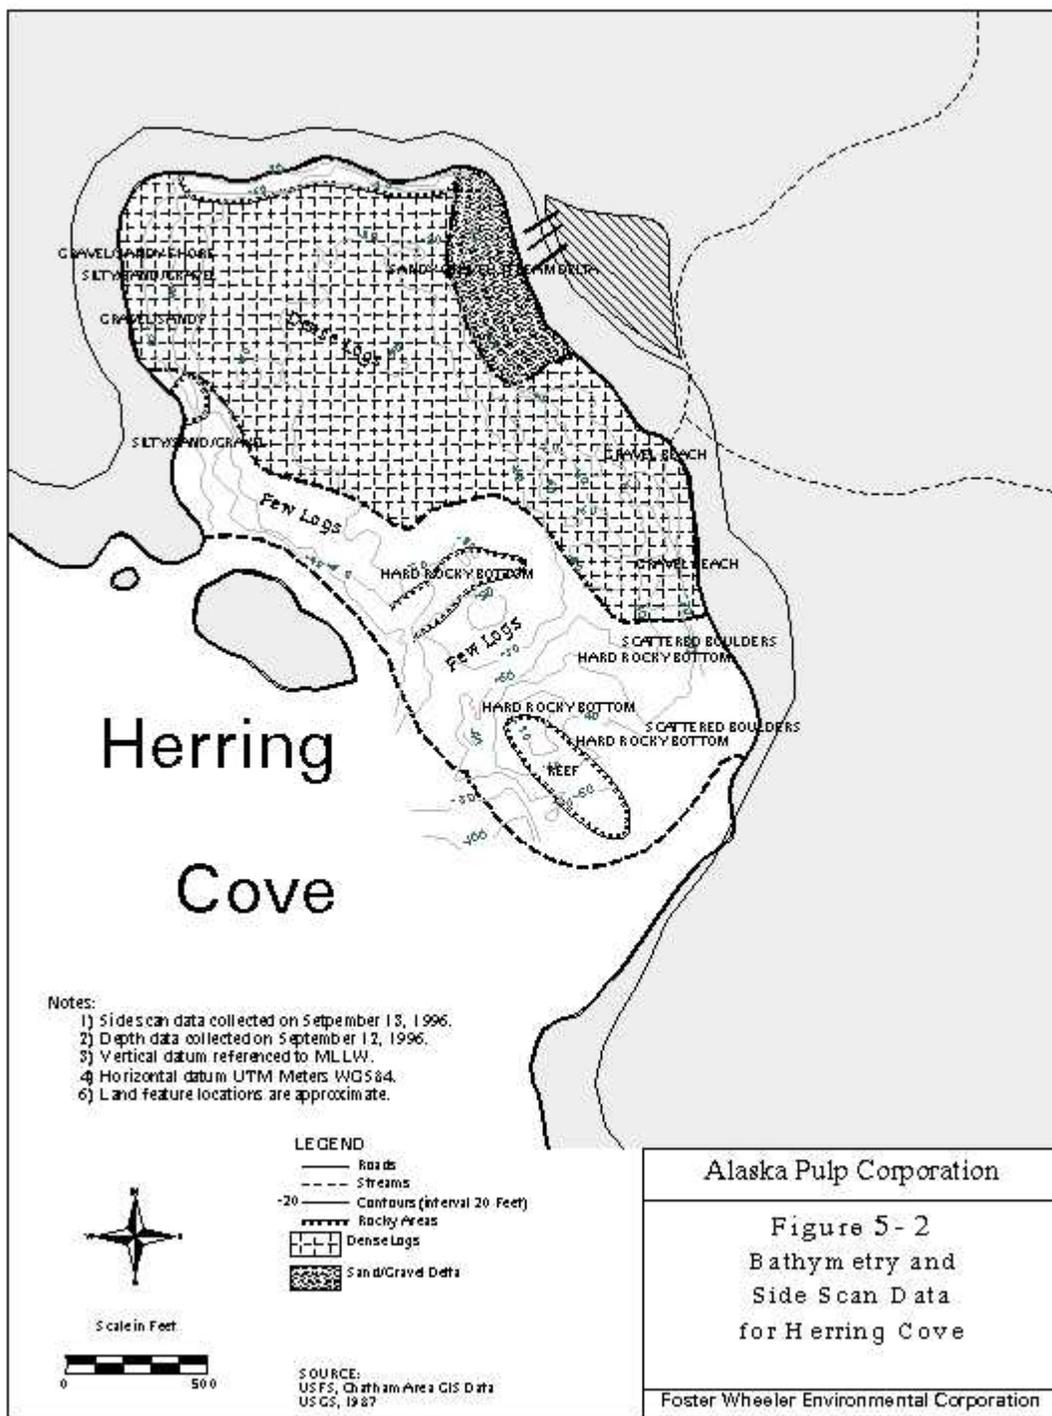
The results of side scan sonar mapping conducted in Herring Cove as part of the Remedial Investigation and Feasibility study are depicted in Figure 5-2. The figure indicates that the majority of the cove bottom, excluding the shallow reef area at the southwestern end, is covered with sunken logs. This is consistent with the historical practices of unbanding rafts of log bundles in the cove to reconstruct single layer rafts for transport to the mill at Sawmill Cove. There is no evidence of processed wood solids debris (i.e., pulp process wood residue from the mill outfall) within Herring Cove, it is logs and bark that are prevalent throughout the cove. Bark and woody debris from pulp mill activities (log transfer, storage and rafting) have created a deposit of 102 acres in area of varying thickness on the bottom of the cove.
