## **Fairview Manor Site Record of Decision (ROD)**

### **Introduction**

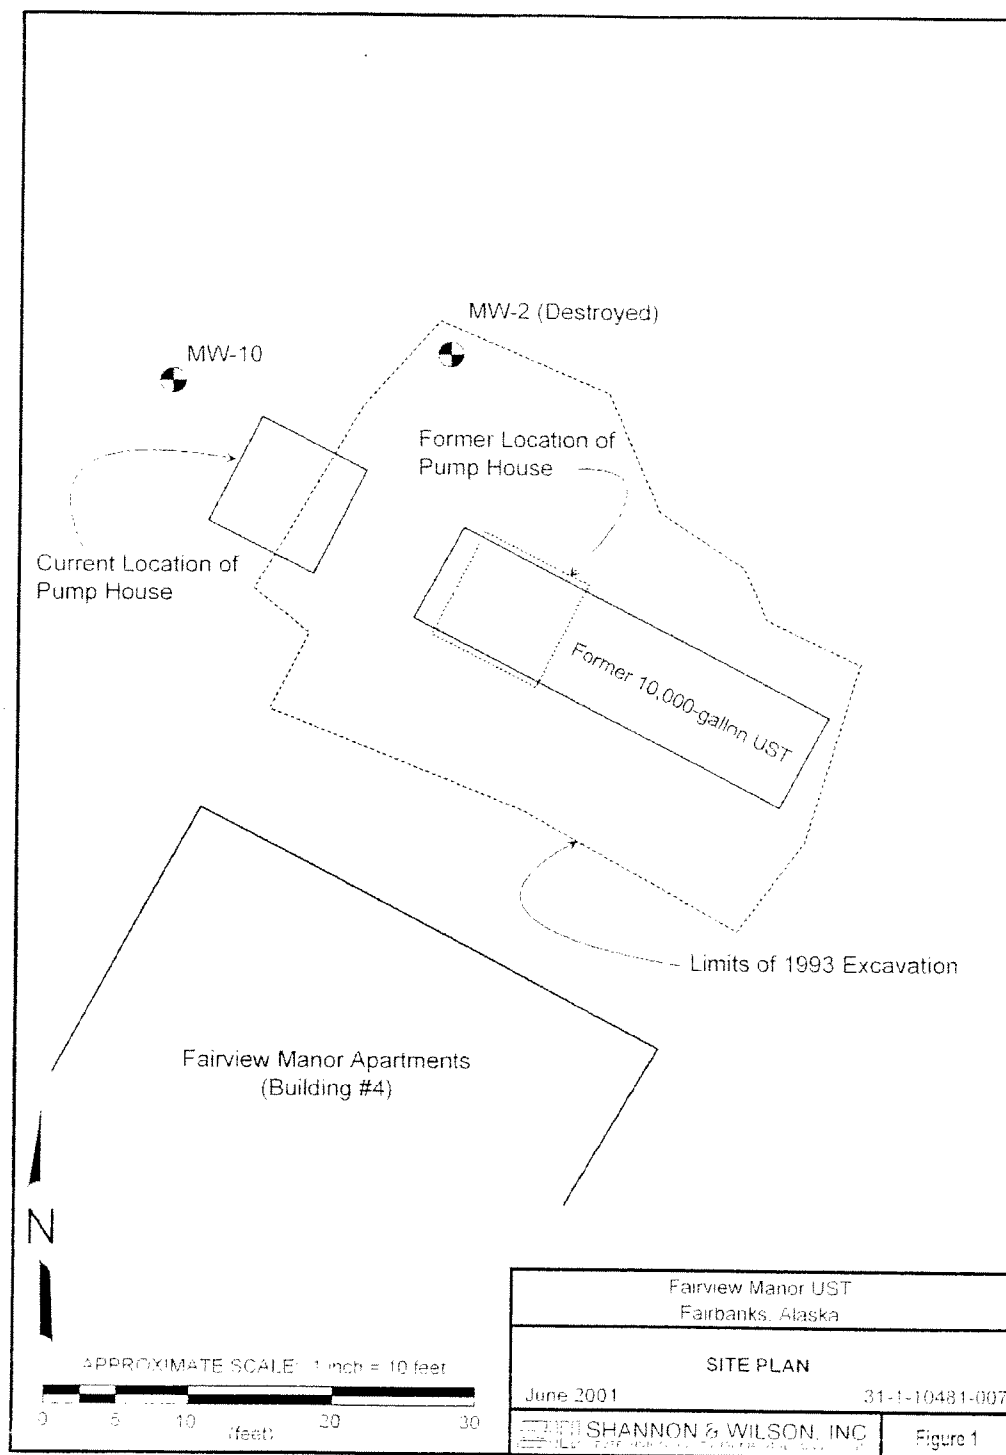
Figure 2. UST Excavation and Monitoring Well Locations.

The former 10,000-gallon underground storage tank (UST) used for heating fuel near the northeast edge of the property was removed in June 1993. It was reportedly in good condition and not leaking. The suspected sources of petroleum contamination at this site were leaking pipes and probable spills and releases.
