STATE OF ALASKA

**DEPARTMENT OF ENVIRONMENTAL CONSERVATION
DIVISION OF SPILL PREVENTION AND RESPONSE
CONTAMINATED SITES PROGRAM**

Re: DEC Approval of *Field Report for Feather River Dumpsite, 2011 Hazardous Materials and Solid Waste Removal near Nome, Alaska*
DEC Approval of *2011 Monitoring Report, Feather River Landspread near Nome, Alaska*
Summary of Evaluations and Determinations for BLM sites at Feather River

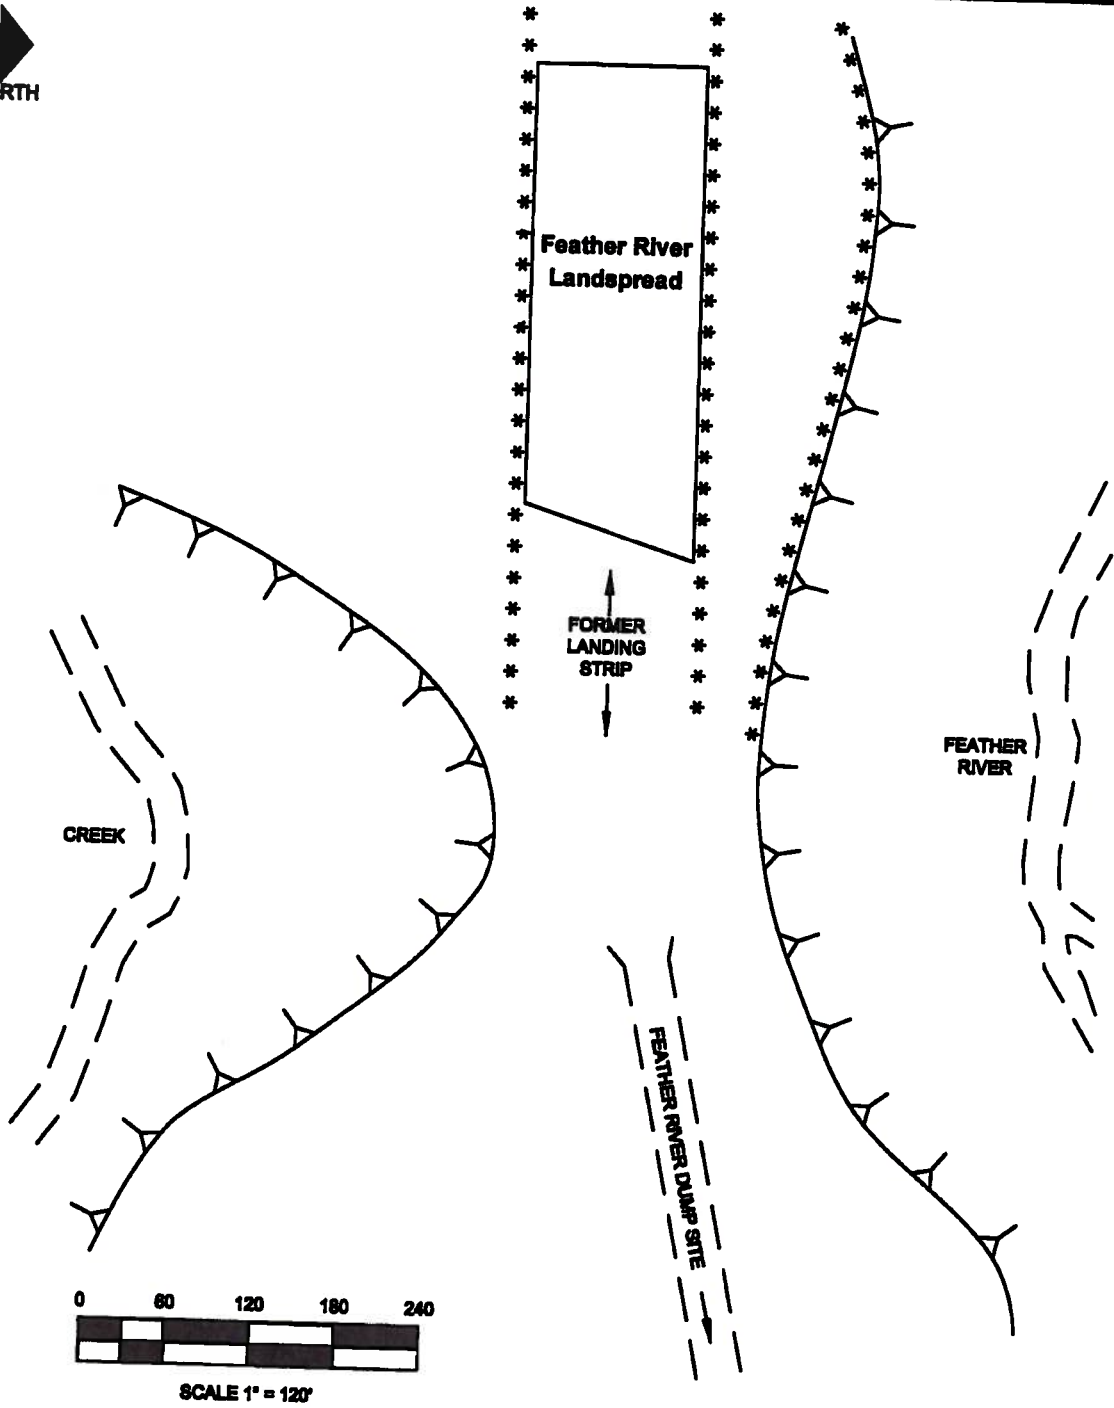
Figure from 12/9/09 MACTEC Report
Altered by EMI 2/20/12

Figure 2
Feather River Site Layout
Near Nome, Alaska

Attachments: Feather River Dump Site General Site Location Map
Feather River Dump Site map
Feather River Site Layout map
