**Department of Environmental
Conservation**

Division of Spill Prevention and Response
Contaminated Sites Program

Re: Corrective Action Complete Determination, Federal Building Motor Pool Equipment Building

Federal Building Motor Pool Equipment Building
101 12th Avenue
Fairbanks, AK 99701

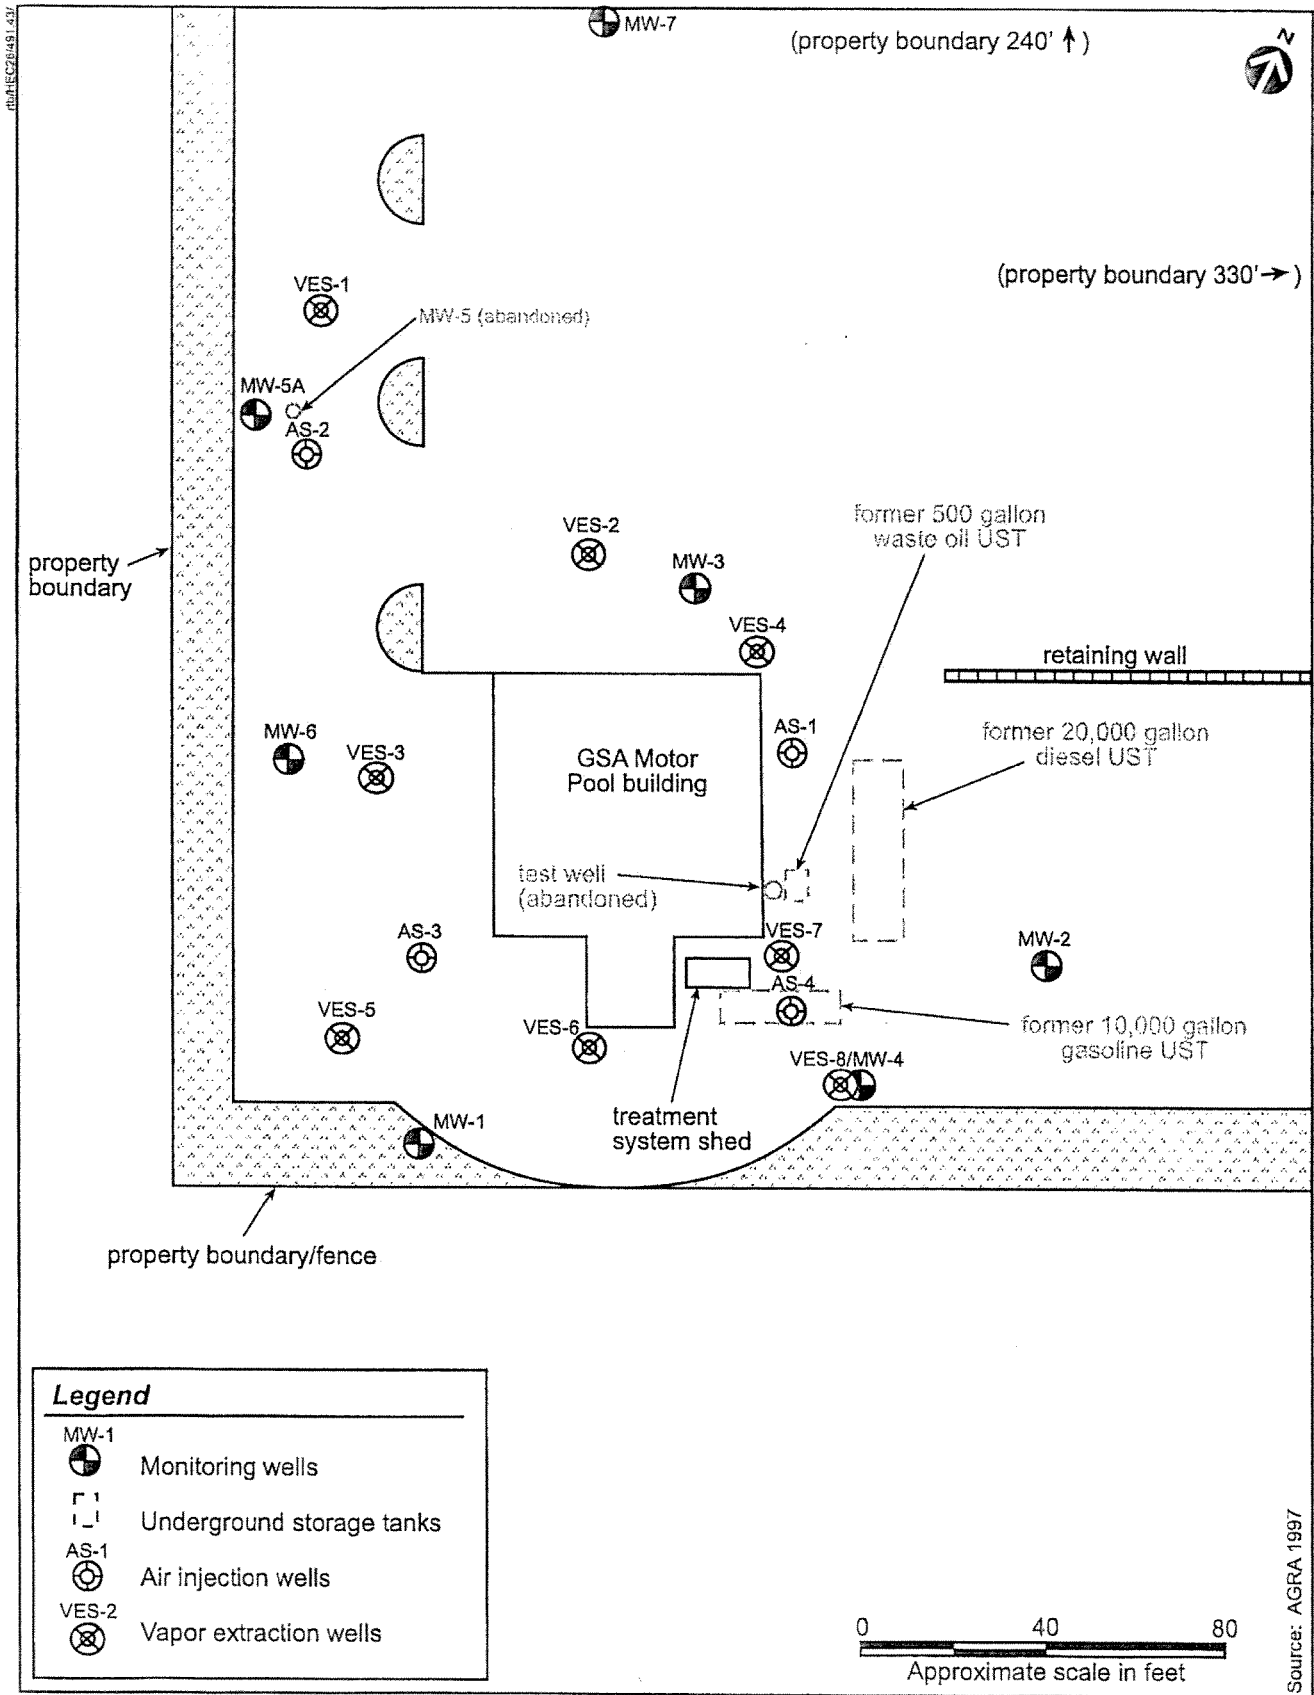
Site map of former Fleet Management Center (Motor Pool Building), Fairbanks, Alaska.

Federal Building Motor Pool Equipment Building
101 12th Avenue, Fairbanks, AK
