**Department of Environmental
Conservation**

DIVISION OF SPILL PREVENTION & RESPONSE
Contaminated Sites Program

Re: Decision Document: Galena AFS/Airport - SS017 UST 1556-2
Cleanup Complete Determination

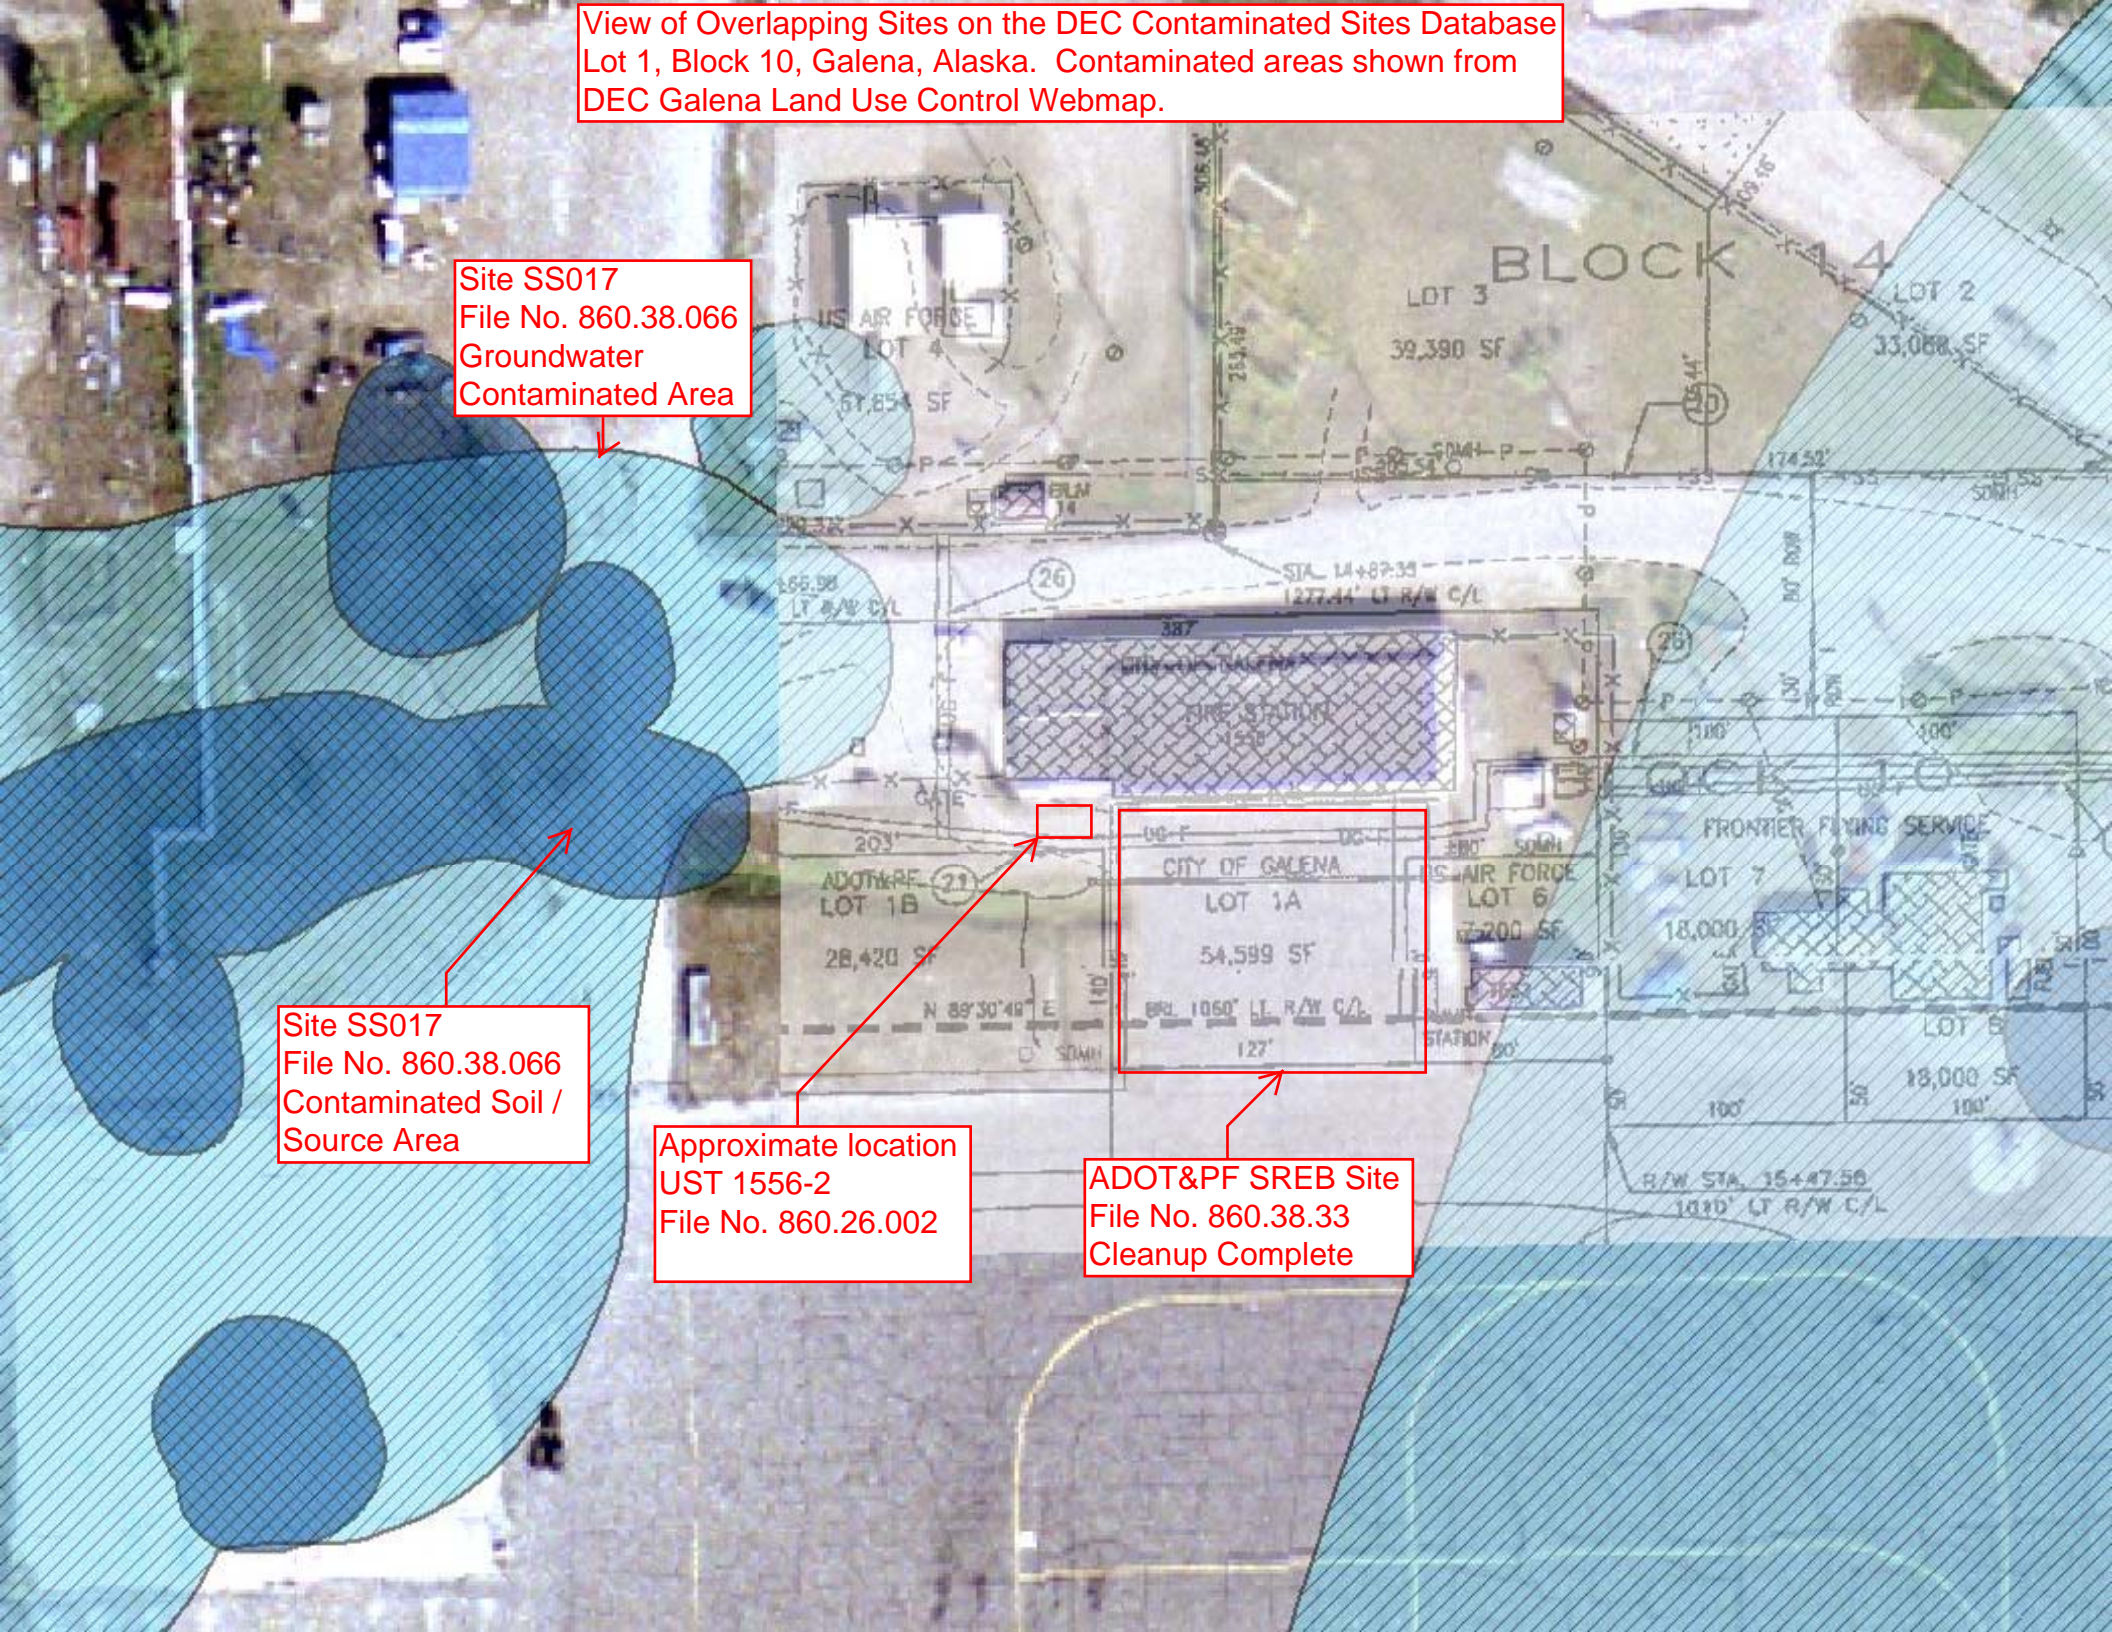
View of Overlapping Sites on the DEC Contaminated Sites Database
Lot 1, Block 10, Galena, Alaska. Contaminated areas shown from
DEC Galena Land Use Control Webmap.

Site SS017
File No. 860.38.066
Groundwater
Contaminated Area

Site SS017
File No. 860.38.066
Contaminated Soil /
Source Area

Approximate location
UST 1556-2
File No. 860.26.002

ADOT&PF SREB Site
File No. 860.38.33
Cleanup Complete
