**NOTICE OF ENVIRONMENTAL CONTAMINATION**

**VAPOR MITIGATION SYSTEM  
MONITORING, MAINTENANCE, AND  
REPAIR PLAN**

The vapor mitigation system at 710 East 3rd Avenue is a passive system consisting of plastic vapor barrier in the crawlspace areas installed over perforated vent piping. Additionally, three 2-inch diameter sub-slab vapor wells are installed through the floor of the basement area. The perforated piping and the vapor wells are connected to 4-inch diameter conveyance piping that leads to exhaust stacks on the east and west side of the structure. A site diagram of the system is shown at the end of this plan.

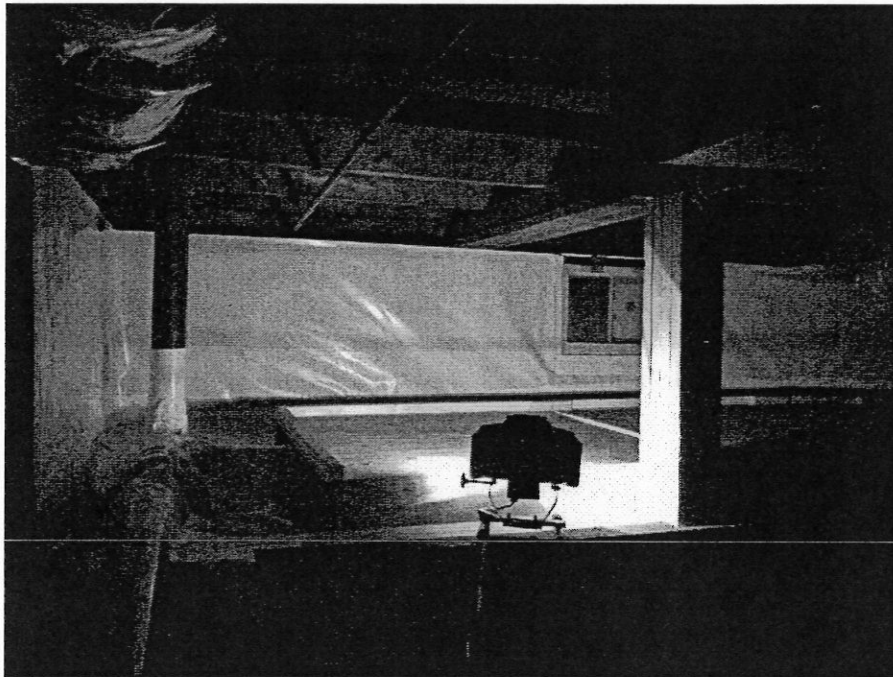
The vapor barrier is secured to the concrete walls of the crawlspace using a vapor barrier tape and plastic anchor plugs and is designed to seal the structure off from the contaminant vapors in the soil. The perforated piping was installed beneath the vapor barrier in the crawlspaces to remove accumulated volatile contaminants that build up beneath the barrier as shown in Photograph 1.

Photograph 1: Vapor barrier in crawlspace with wooden framing over the plastic barrier and the perforated piping to enable storage in the crawlspace area.

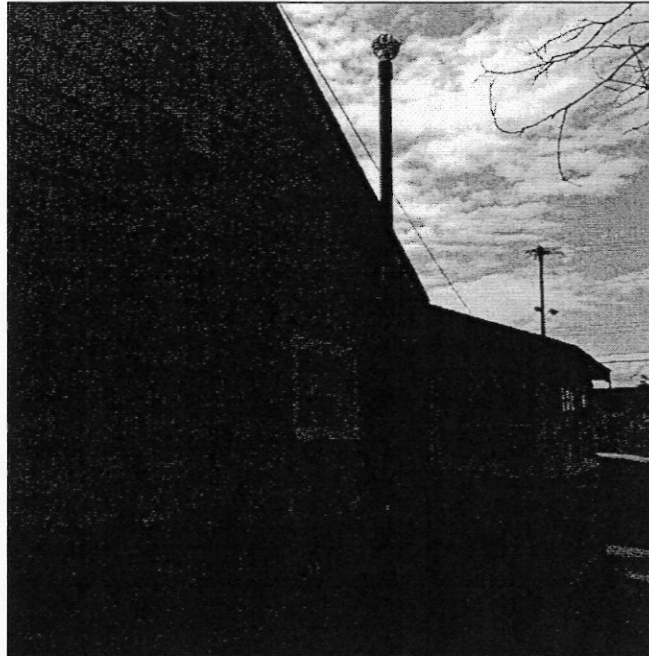
Wind-driven ventilation fans were installed on top of the exhaust stacks to draw the contaminant vapors into the depressurization lines as shown in Photograph 2.

Photograph 2: Exhaust stack piping on west side of the residential building.
