Department of Environmental Conservation

**Re: Decision Document: NPS Denali Nat'l Park HQ Bldg 27, NPS Denali Nat'l Park HQ Bldg 28, and NPS Denali Nat'l Park HQ Bldg 34
Cleanup Complete Determination – Institutional Controls**

NPS Denali National Park HQ Bldgs 27, 28, & 34
Denali National Park Headquarters
Denali Park, AK 99755

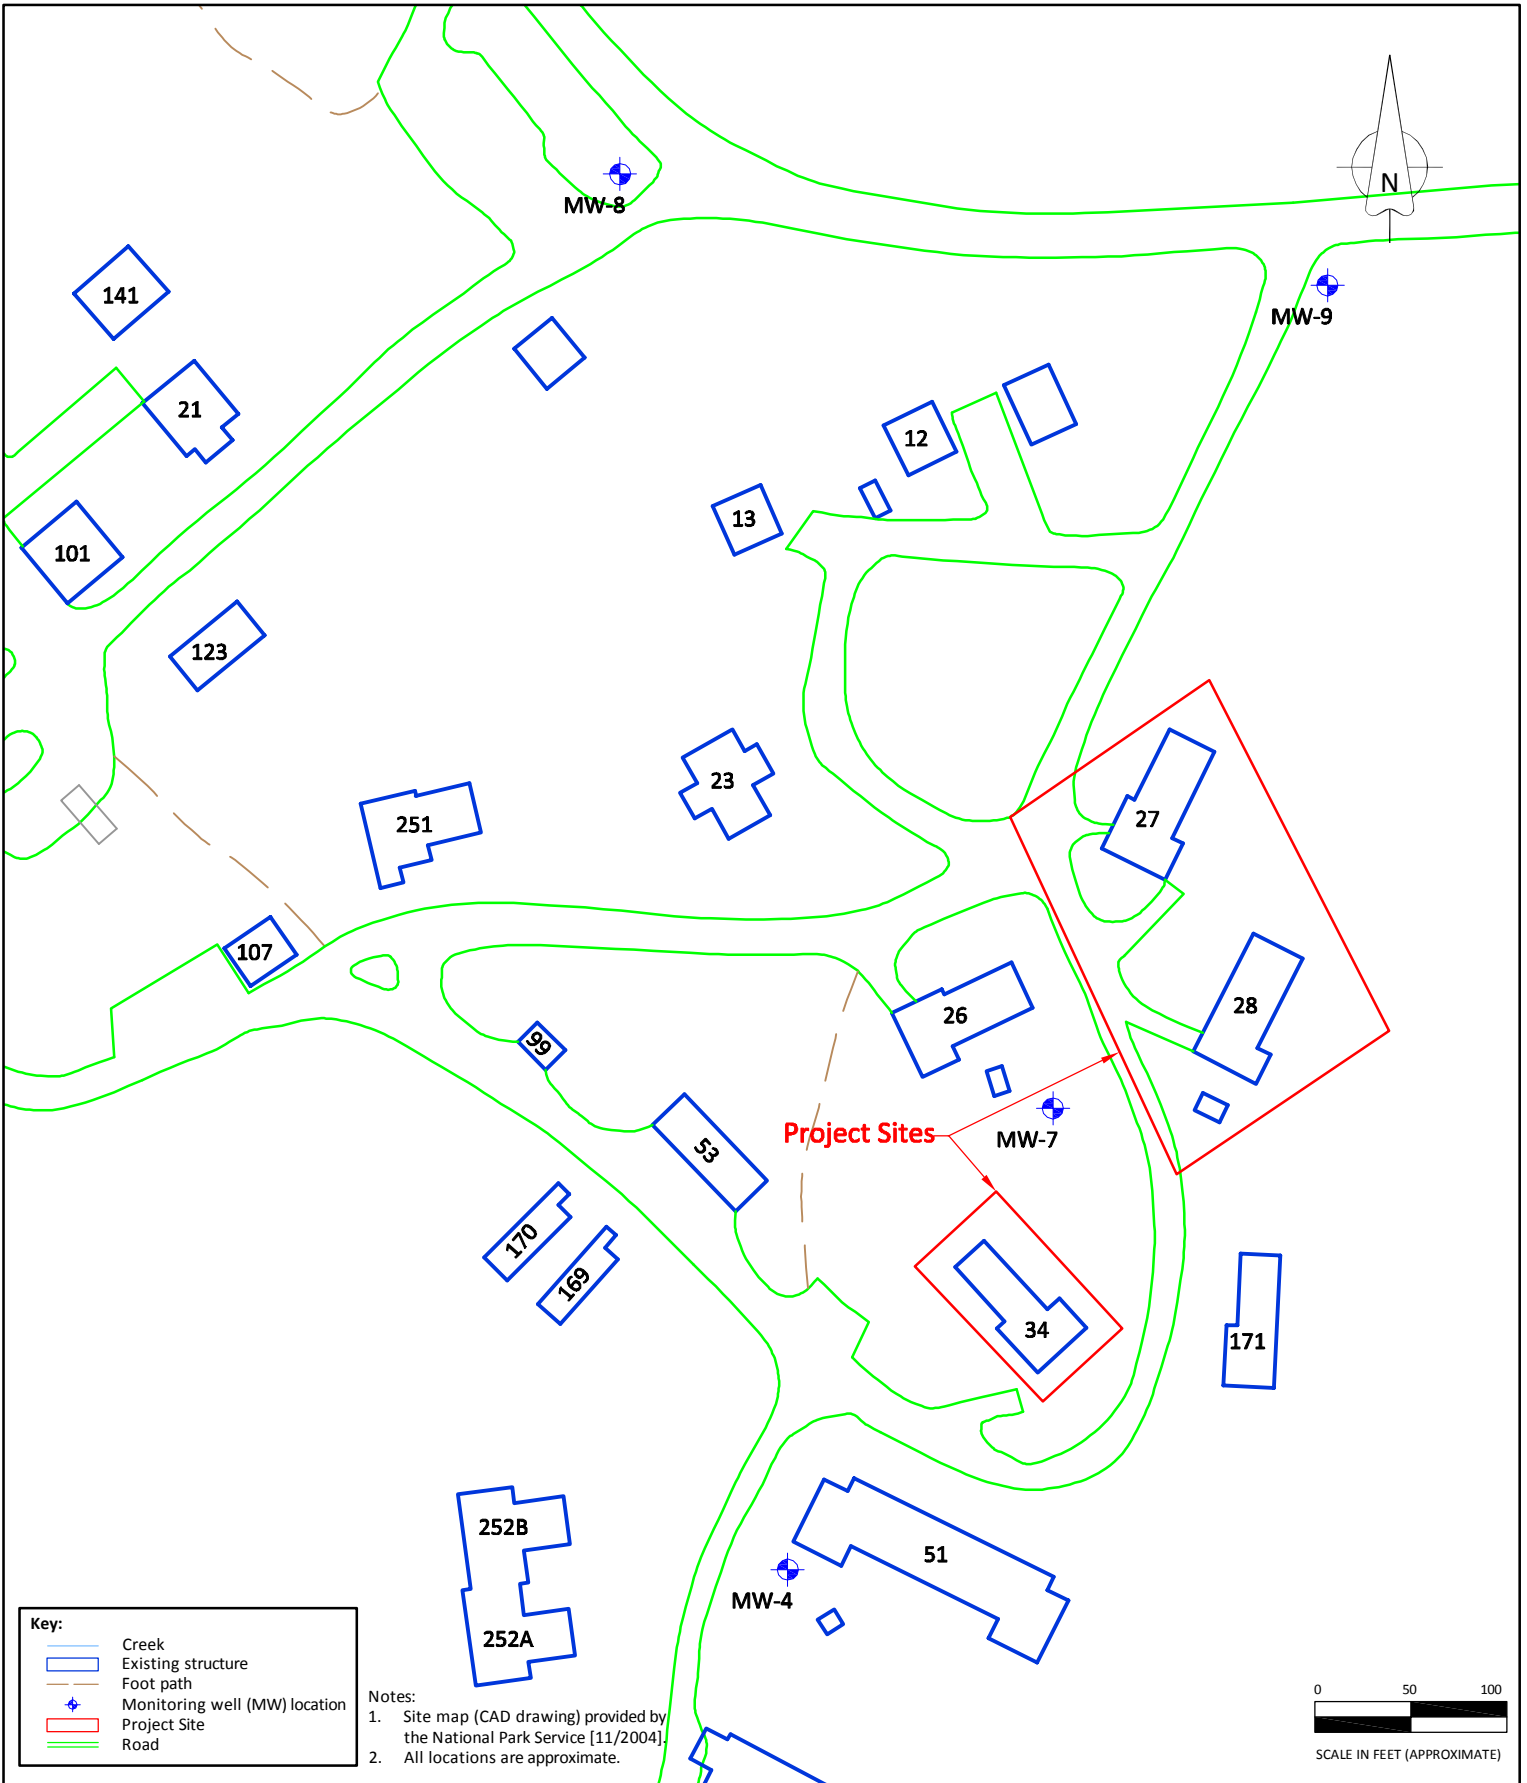
Site Plan

Headquarters Buildings 27, 28 and 34 - Vapor Intrusion Work Plan
Denali National Park and Preserve, Alaska

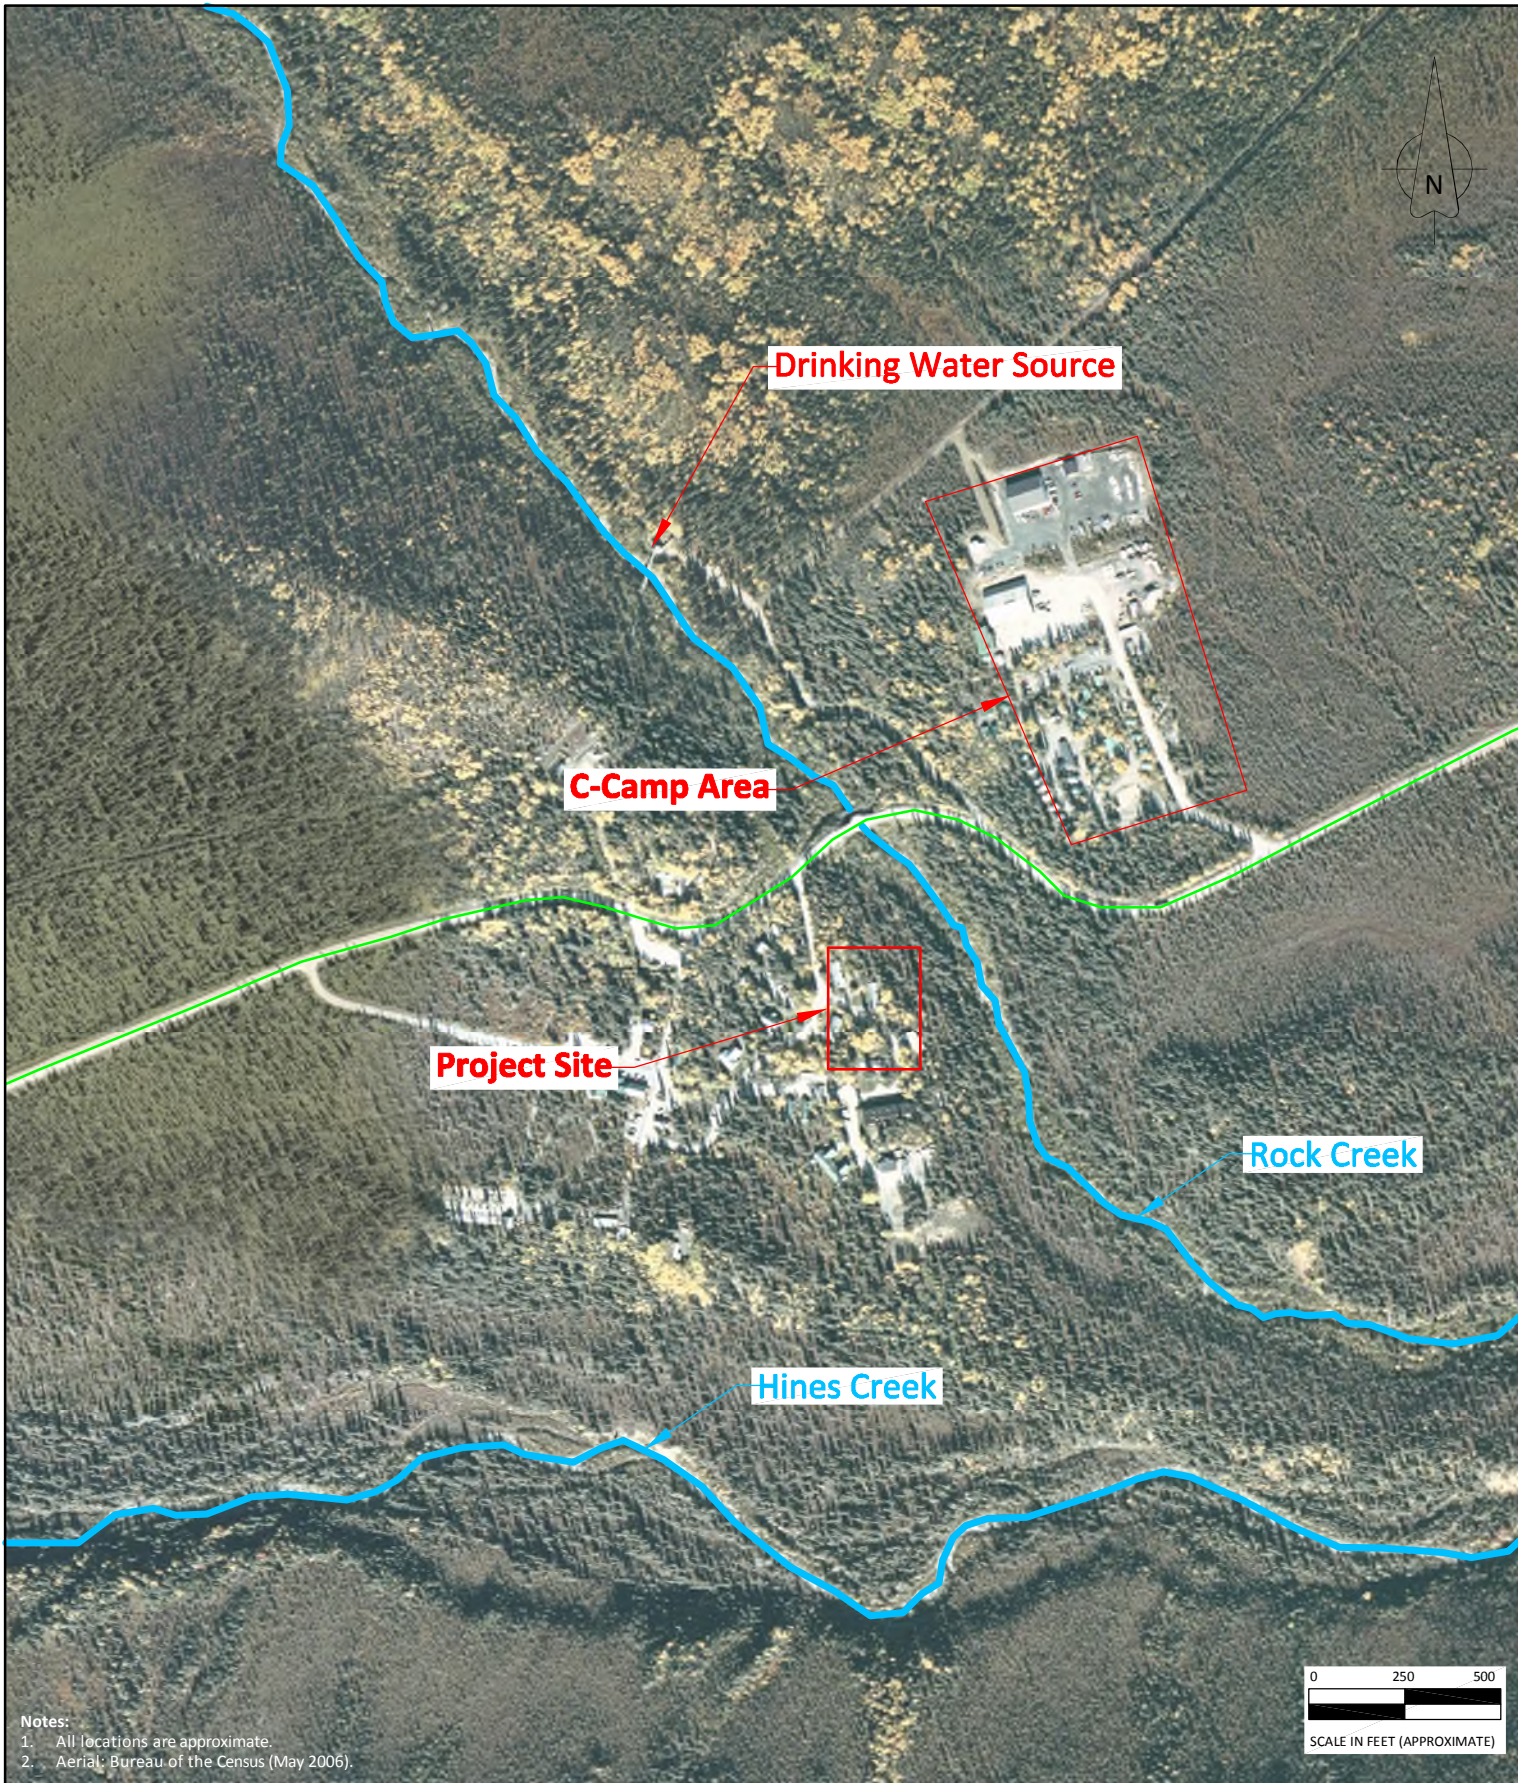
Water Bodies

- Notes:
1. All locations are approximate.
2. Aerial: Bureau of the Census (May 2006).

Headquarters Buildings 27, 28 and 34 - Vapor Intrusion Work Plan Denali National Park and Preserve, Alaska

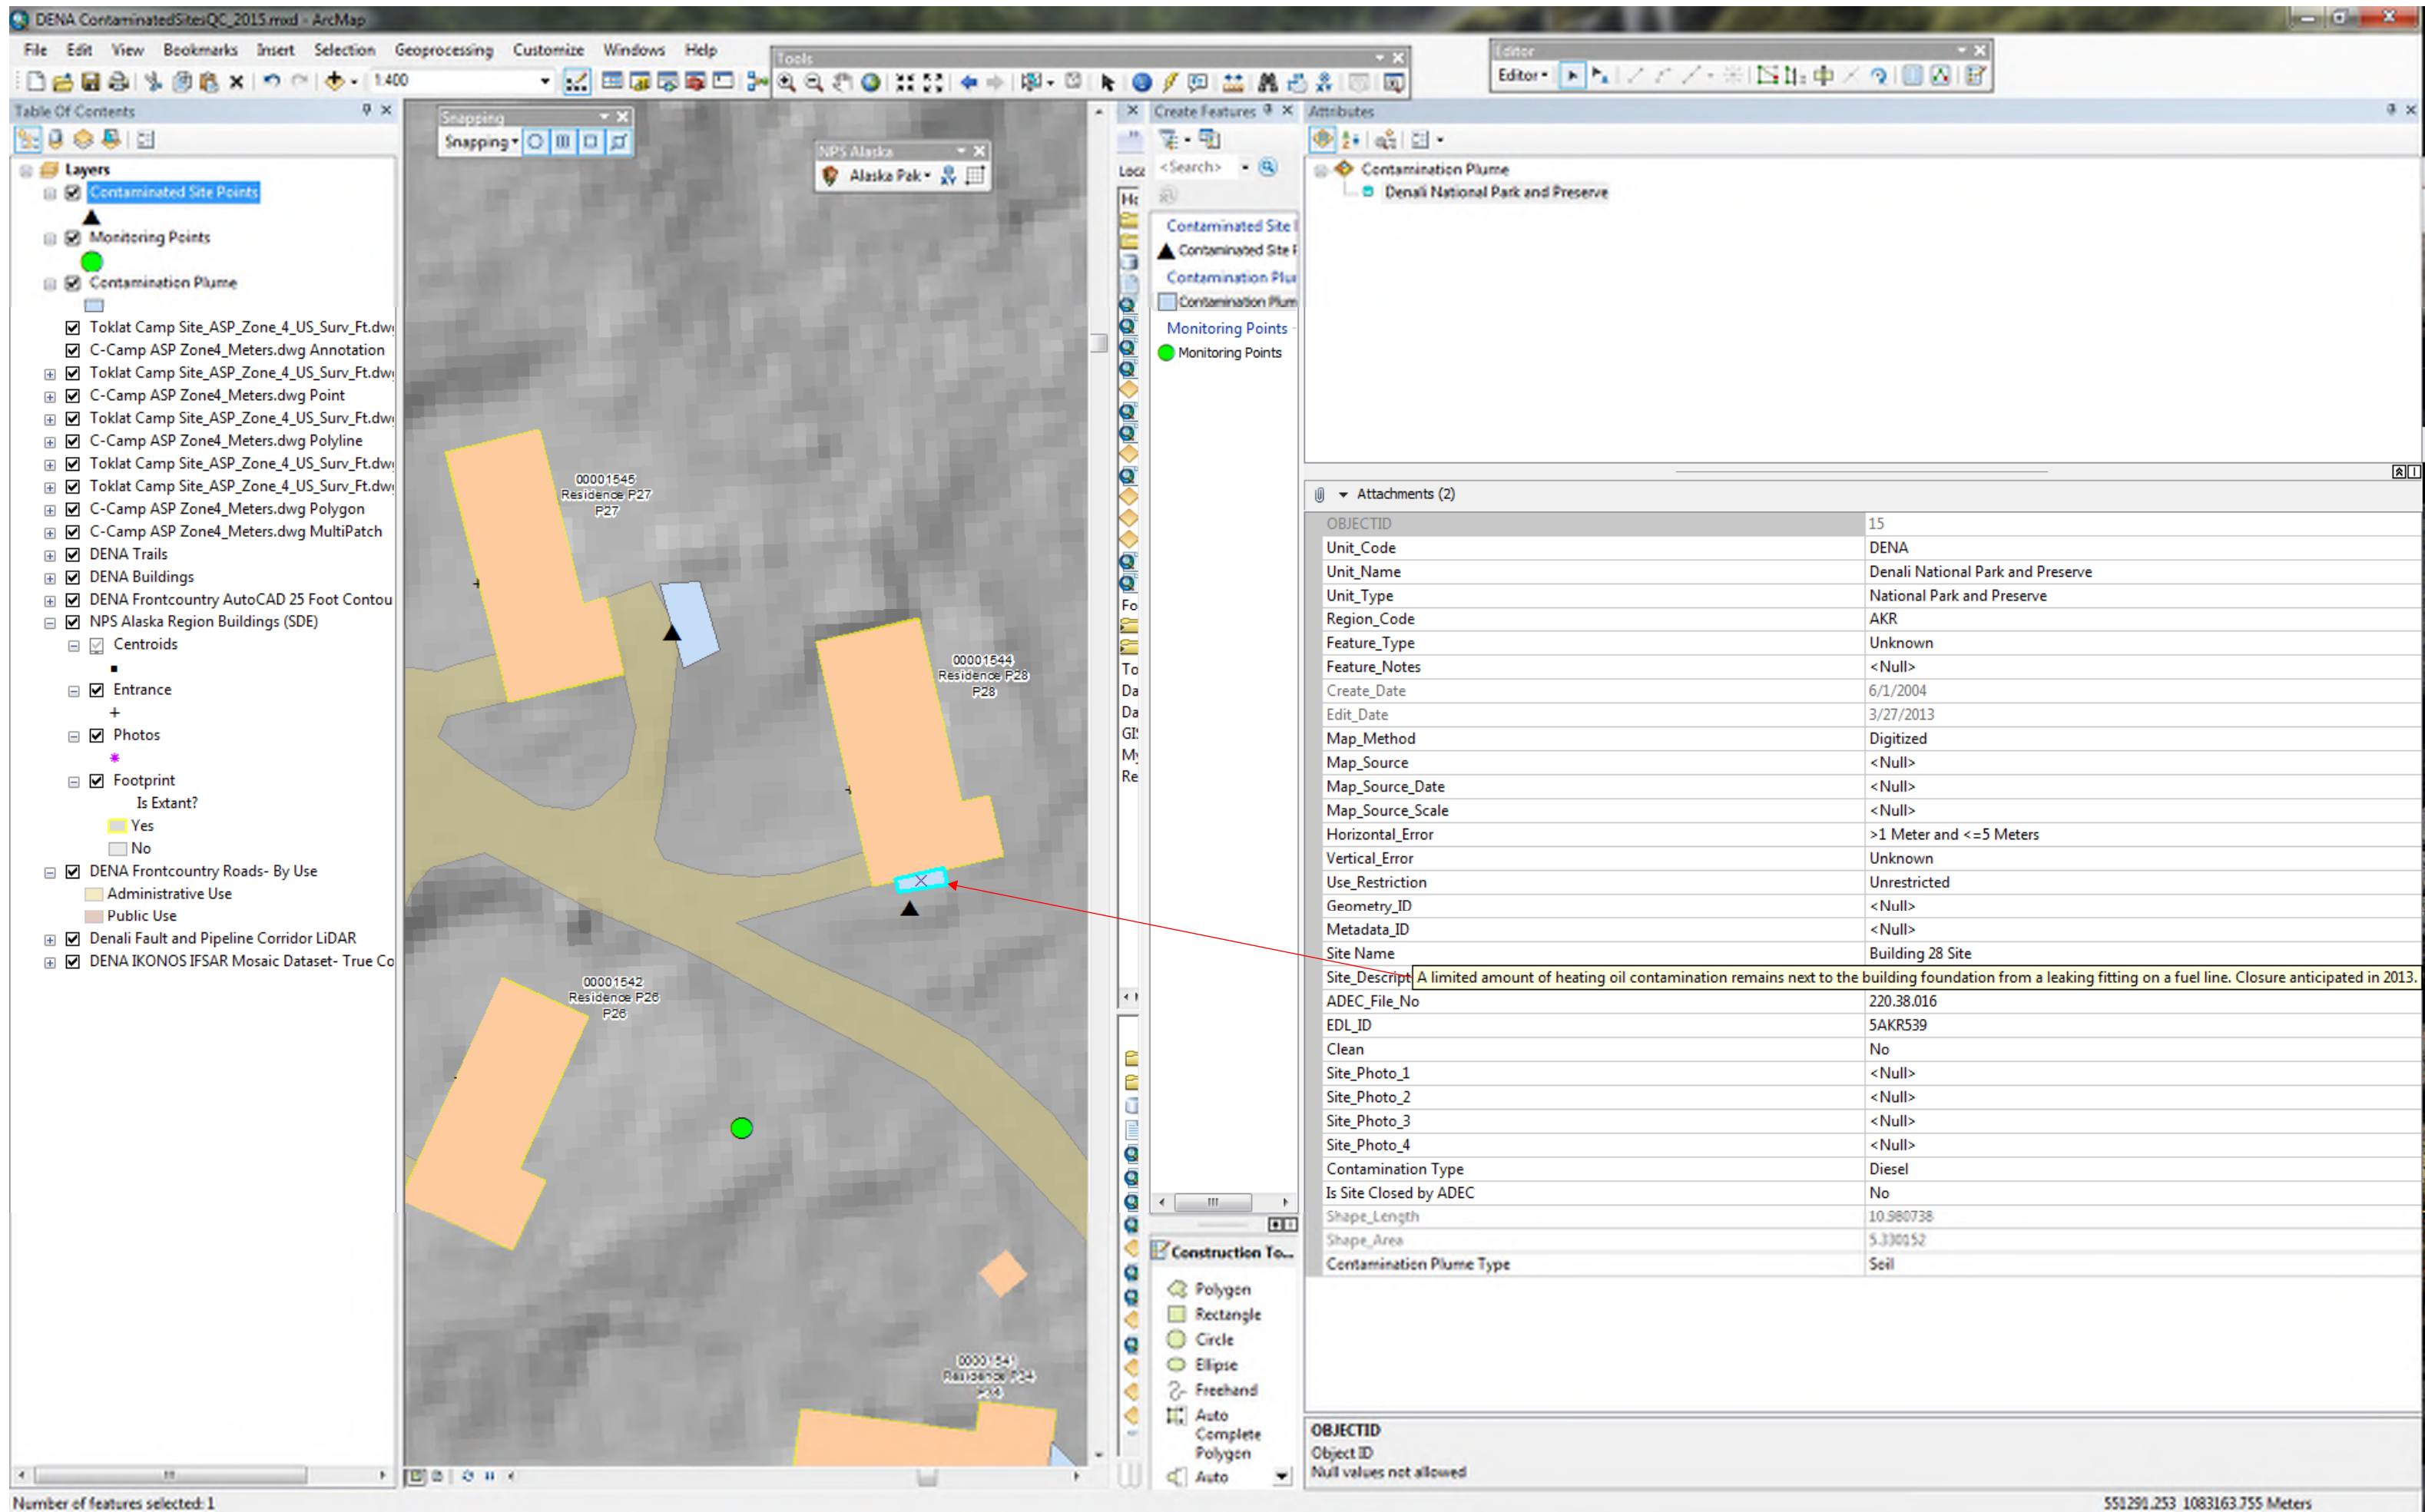
Heating oil in the soil may remain next to the foundation on the south side of the residence. Proper PPE is required when excavating in this area. Refer to contaminated site reports to determine location and extent of contamination.

NPS Figure 7. Denali Building 28 Soil Contamination Plume Screenshot from GIS

An additional 10 cy of petroleum contaminated soil was removed from where the former piping from the AST entered Building 28. Not all contaminated soil could be removed due to the location of the building. Confirmation samples were analyzed for DRO and BTEX. One sidewall sample collected from near the building foundation at a depth of 3 feet contained DRO at 1,900-mg/kg. All other sample results were below cleanup levels.

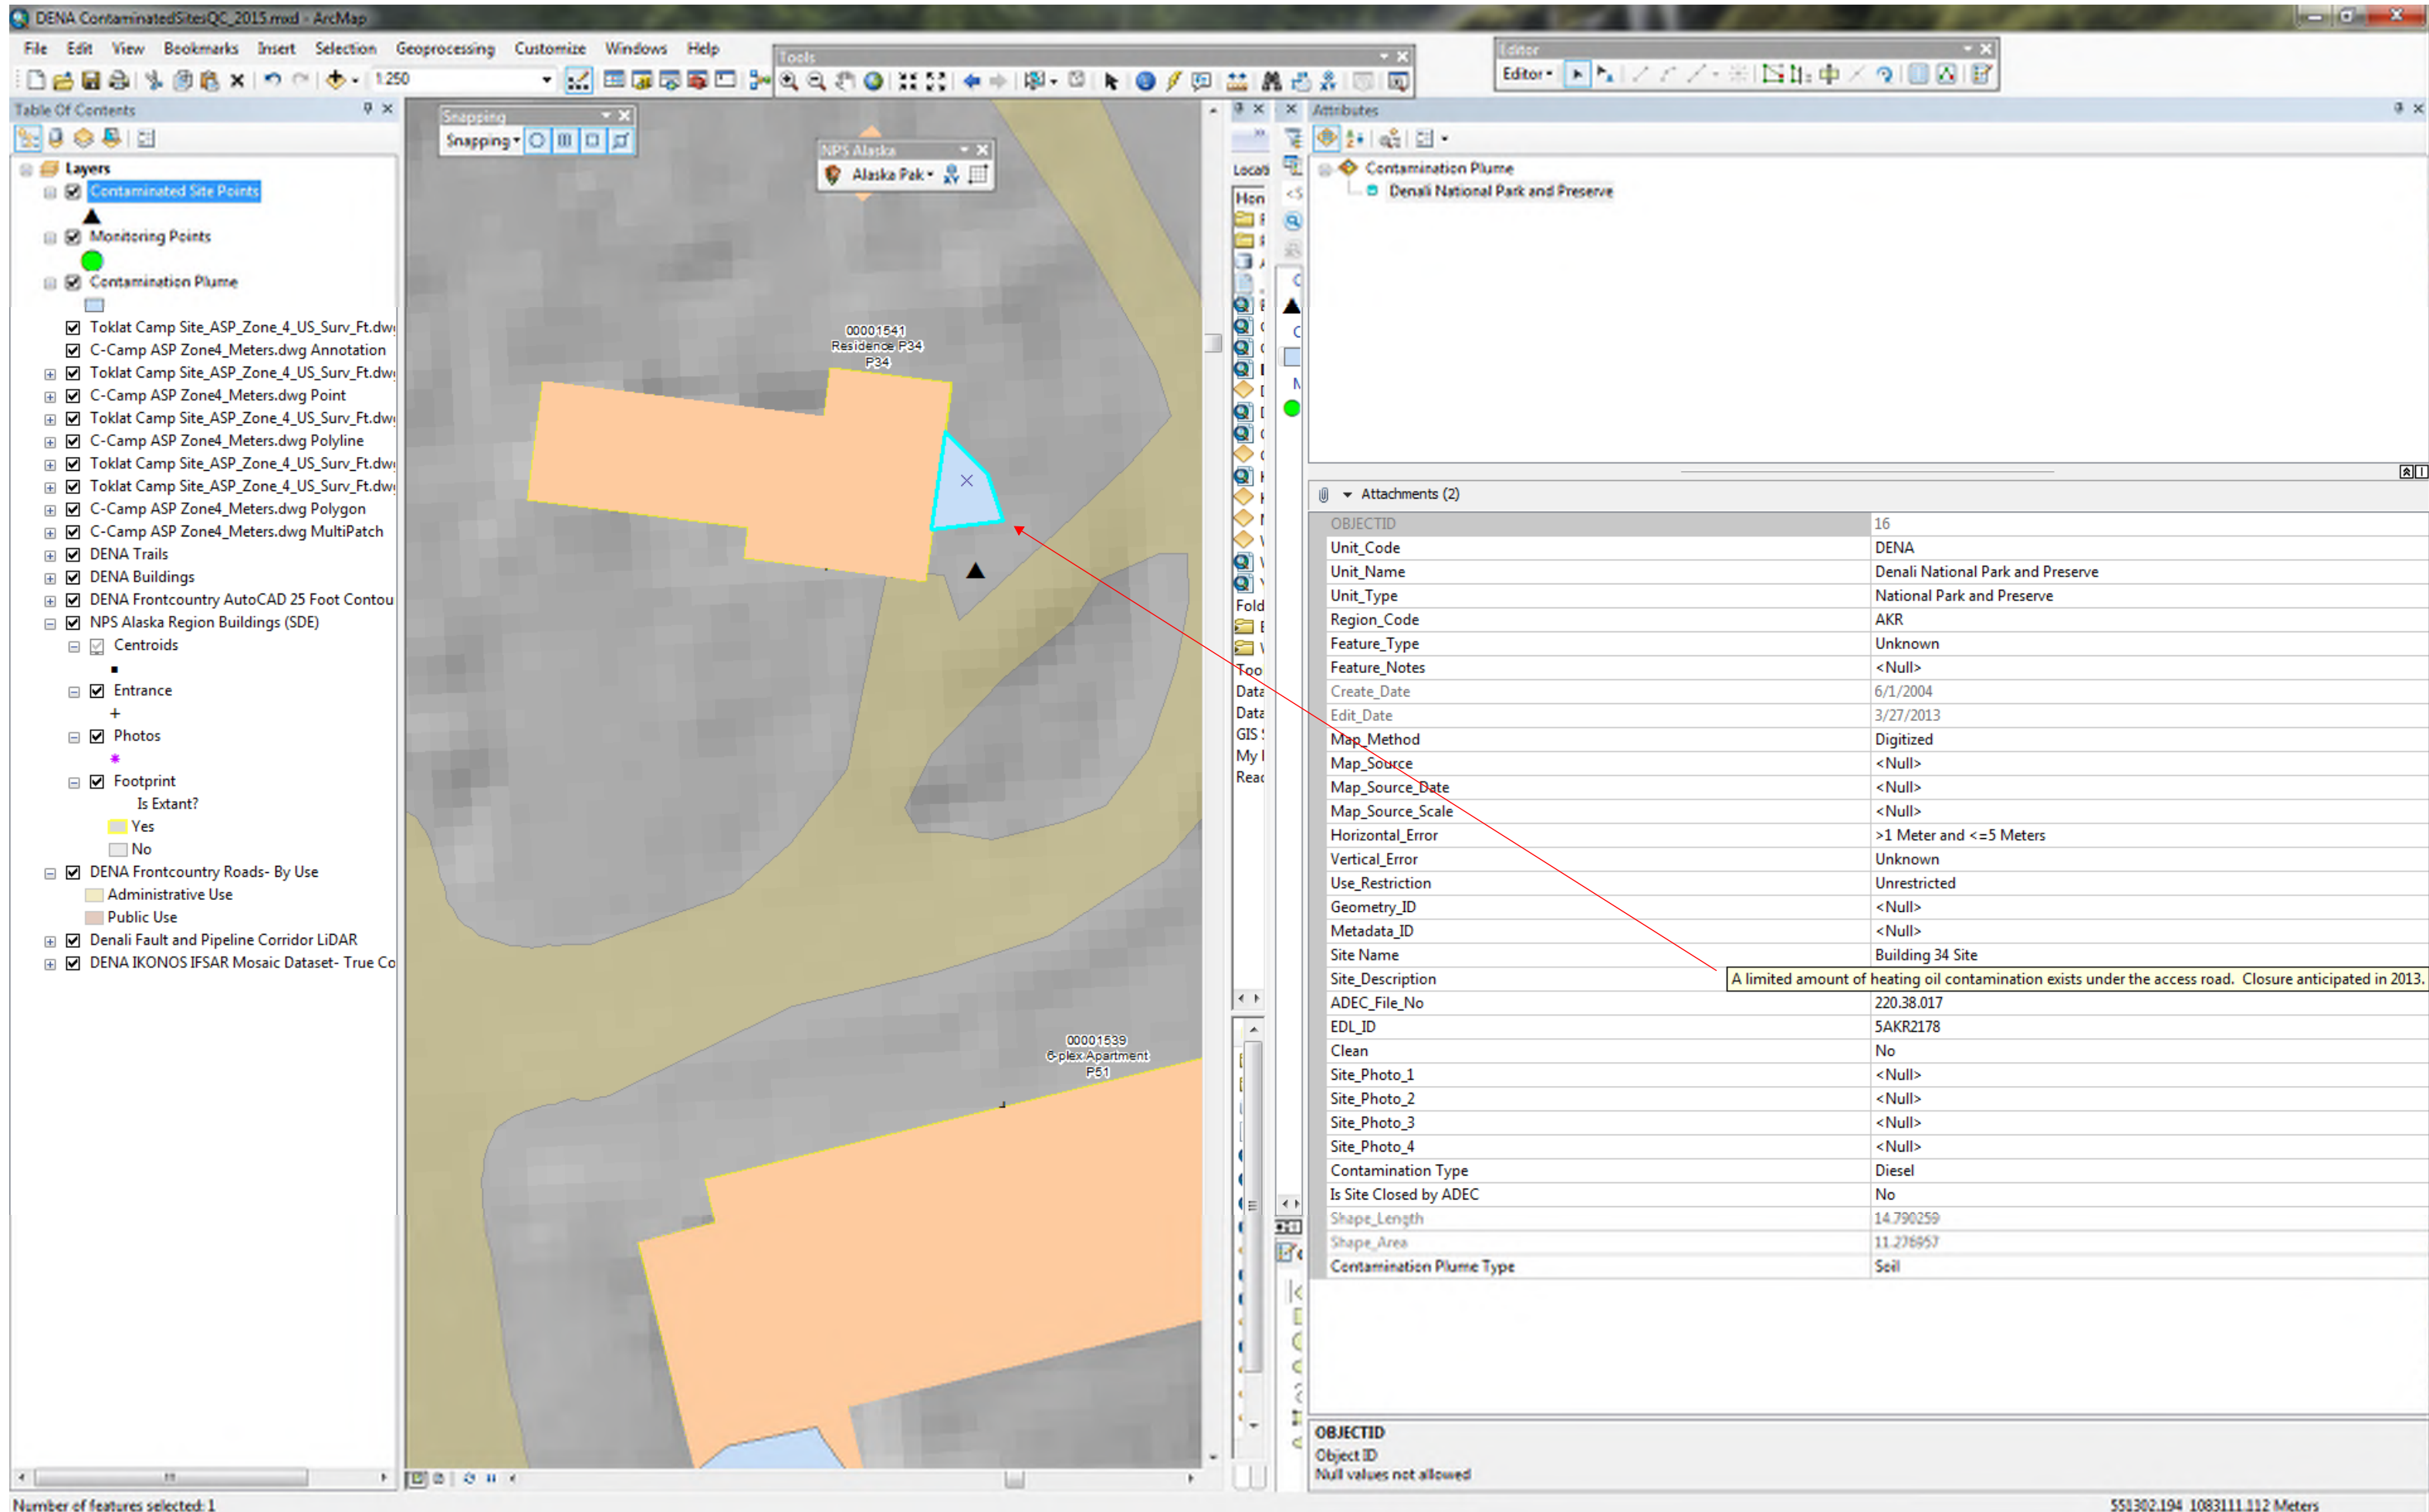
- Map Text:** A text box at the bottom of the map area reads: "Heating oil in the soil may be encountered to the east of the building adjacent to the driveway. Proper PPE should be used. Refer to contaminated site reports to determine location and extent of contamination."

NPS Figure 9. Denali Building 34 Soil Contamination Plume Screenshot from GIS
