**Department of Environmental
Conservation**

DIVISION OF SPILL PREVENTION AND RESPONSE
Contaminated Sites Program

Re: Baker Oil Tools - Delores Drive ADEC Hazard ID: 25935
Data Gap Review and Site characterization Work Plan
Baker Oil Tools – Delores Drive
ADEC Work Plan Comments

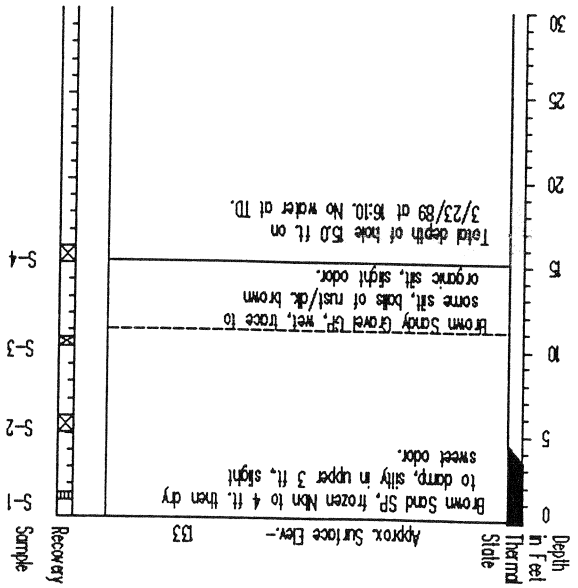
Boring Log P-5

Total PCB Field GC (ppb) 130

Total PCB EPA 8010 (ppb) ND

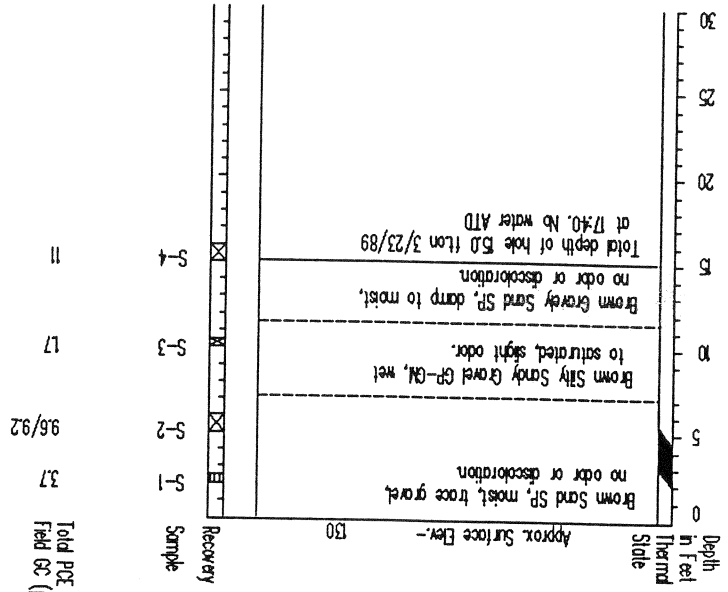
Boring Log P-6

Total PCB Field GC (ppb) 96/92

Total PCB EPA 8010 (ppb) 3.7

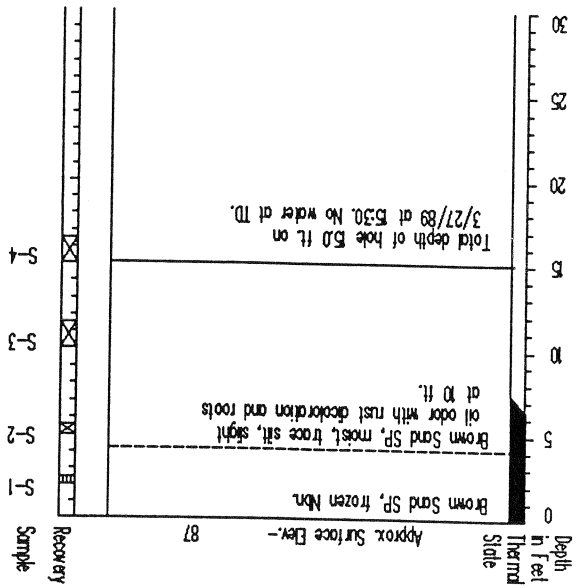
Boring Log P-7

Total PCE
Field GC (ppb) NO

Total PCE
EPA 8010 (ppb) NO

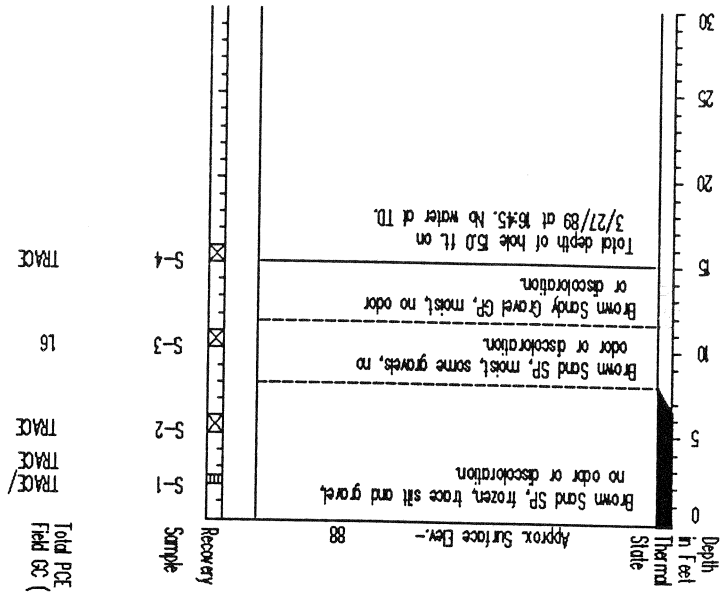
Boring Log P-8

Total PCE
Field GC (ppb) NO

Total PCE
EPA 8010 (ppb) NO

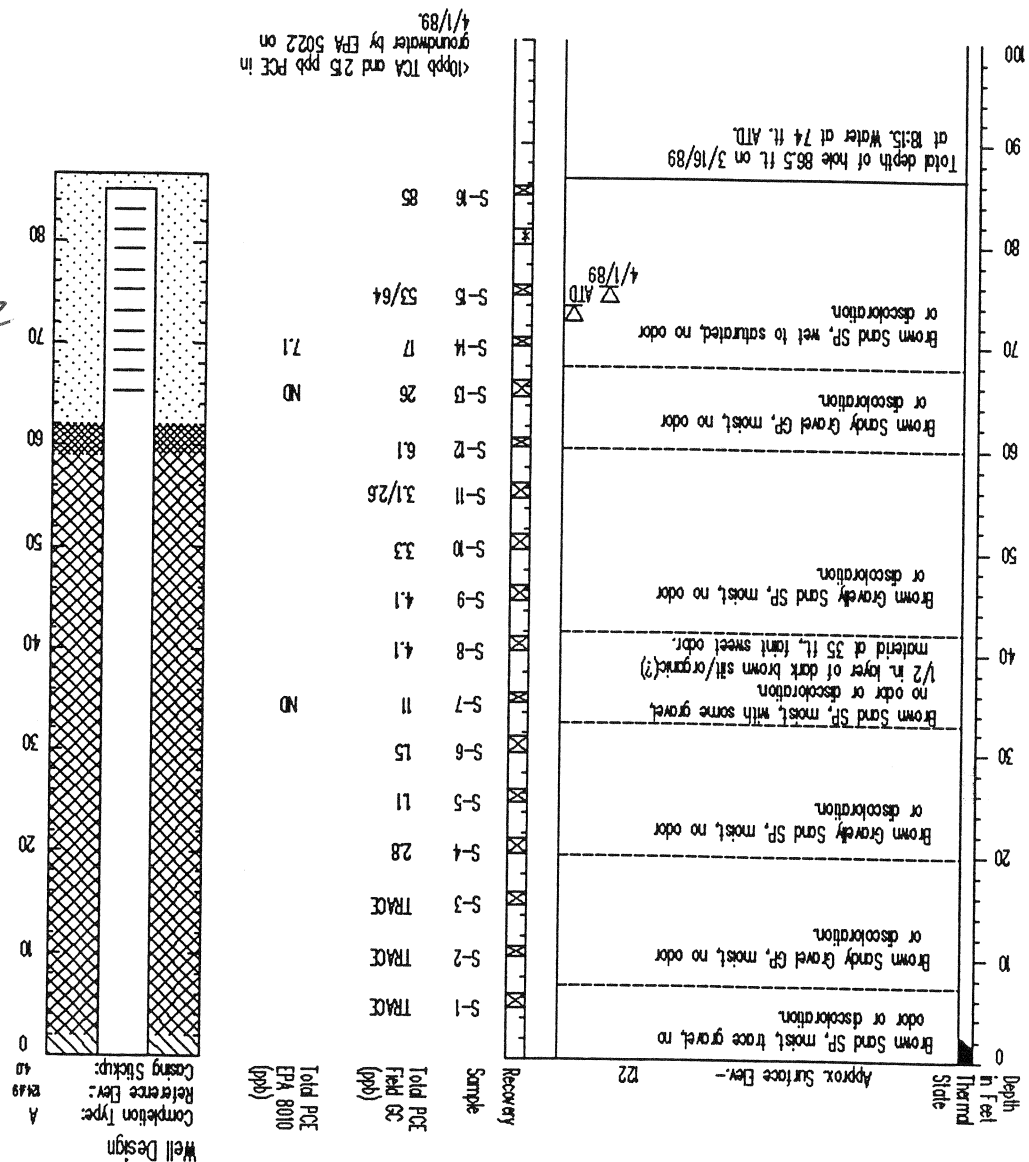
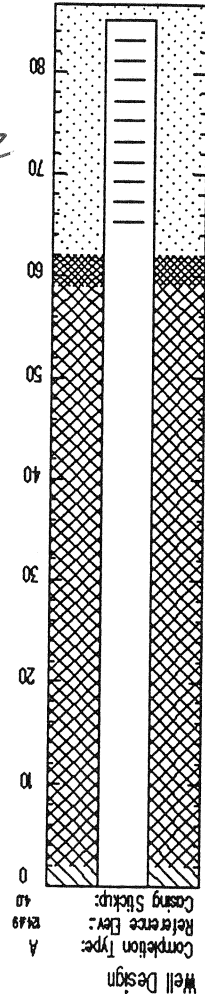
HARTCROWSER
A-8143 July 1989
Figure A-6

Boring Log and Construction Data for Well MW-1

20' SS Screen

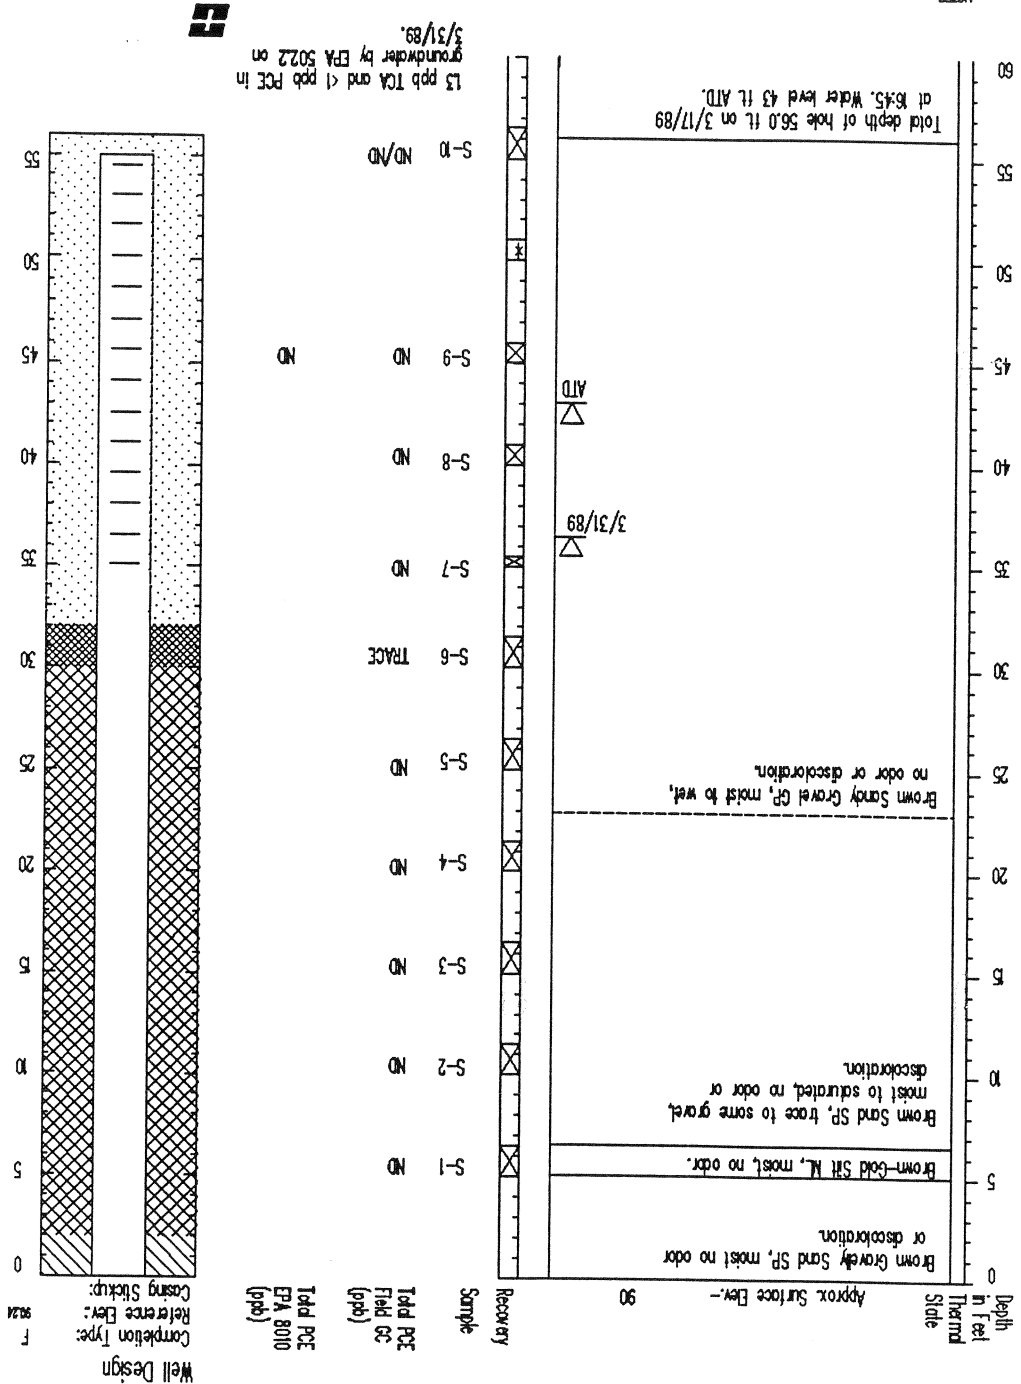
HARTCROWSER
 A-8143 July 1989
 Figure A7

Boring Log and Construction Data for Well MW-2

13 ppb TCA and <1 ppb PCE in groundwater by EPA 5022 on 3/31/89.

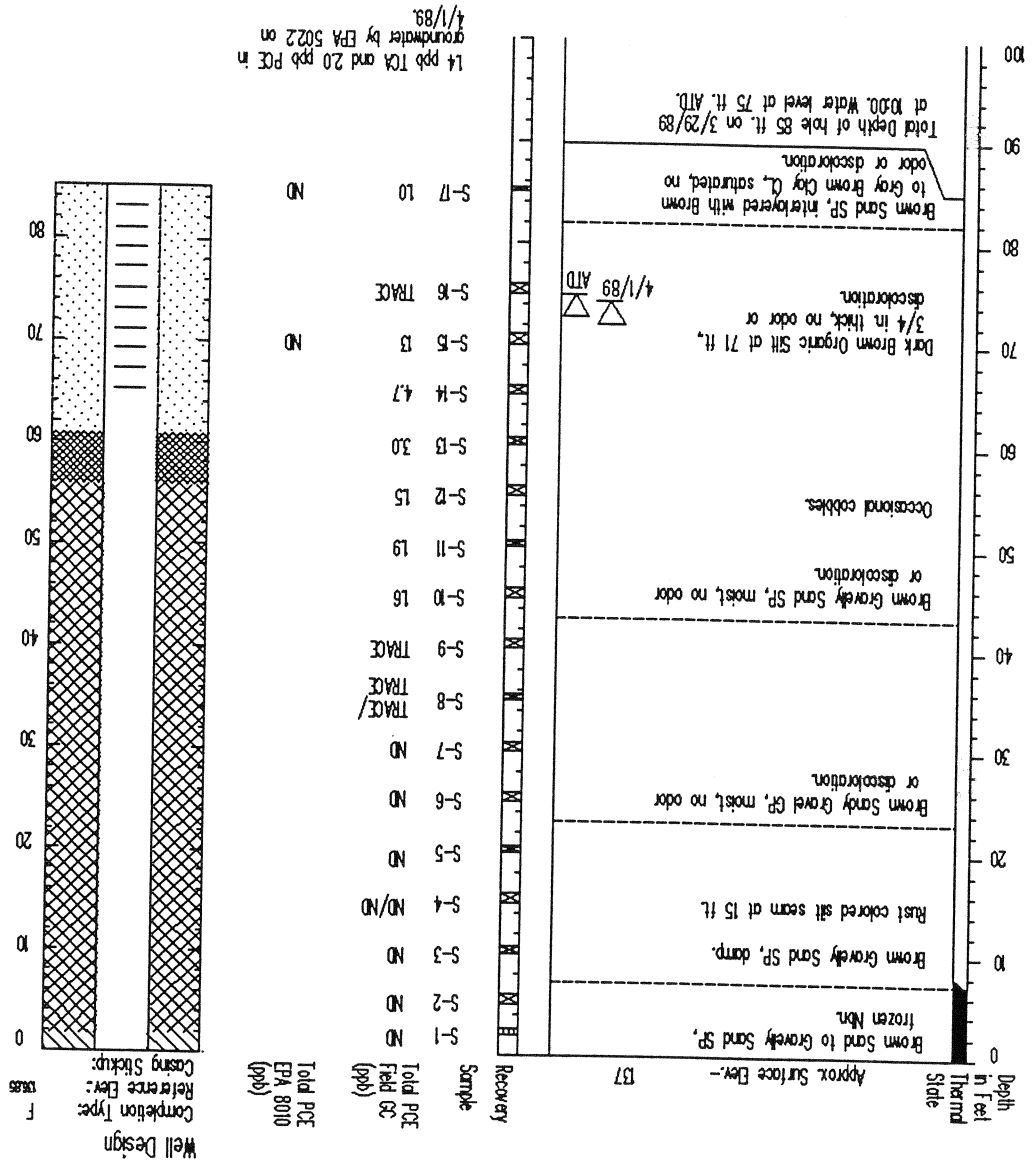
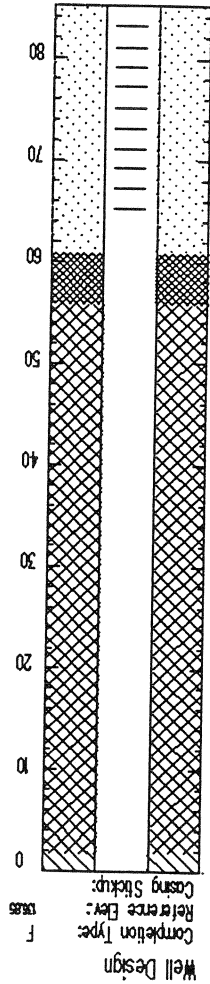
A-8143 July 1989
Figure A-8

Boring Log and Construction Data for Well TH-2

14 ppb TCA and 20 ppb PCE in groundwater by EPA 502.2 on 4/1/89.

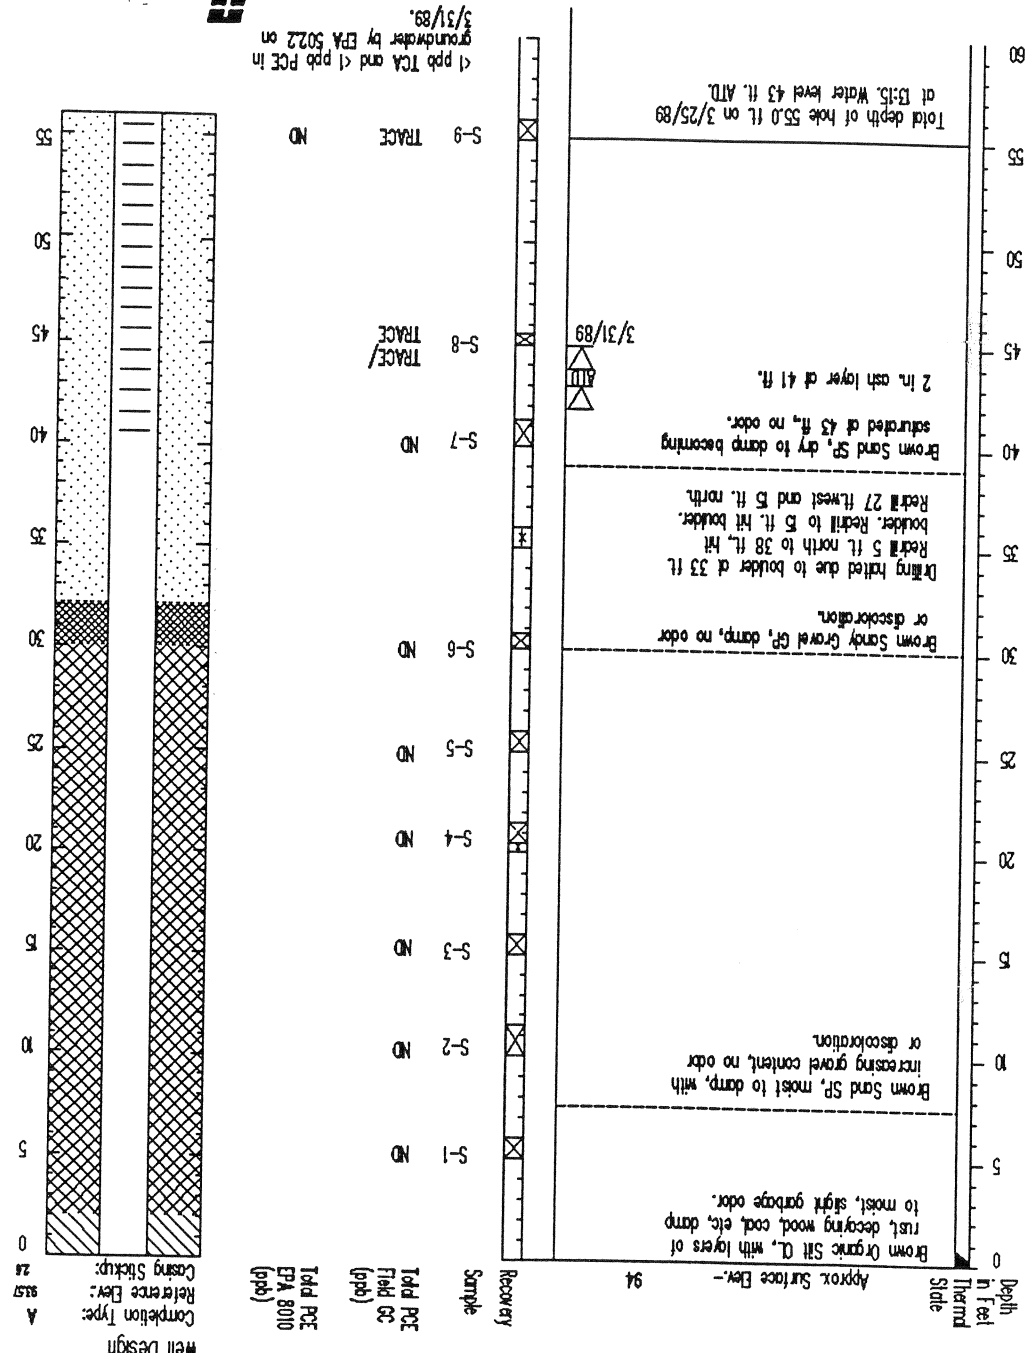
HARTCROWSER
 A-8143 July 1989
 Figure A-9

Boring Log and Construction Data for Well MW-4

< 1 ppb TCA and < 1 ppb PCE in groundwater by EPA 502.2 on 5/31/89.

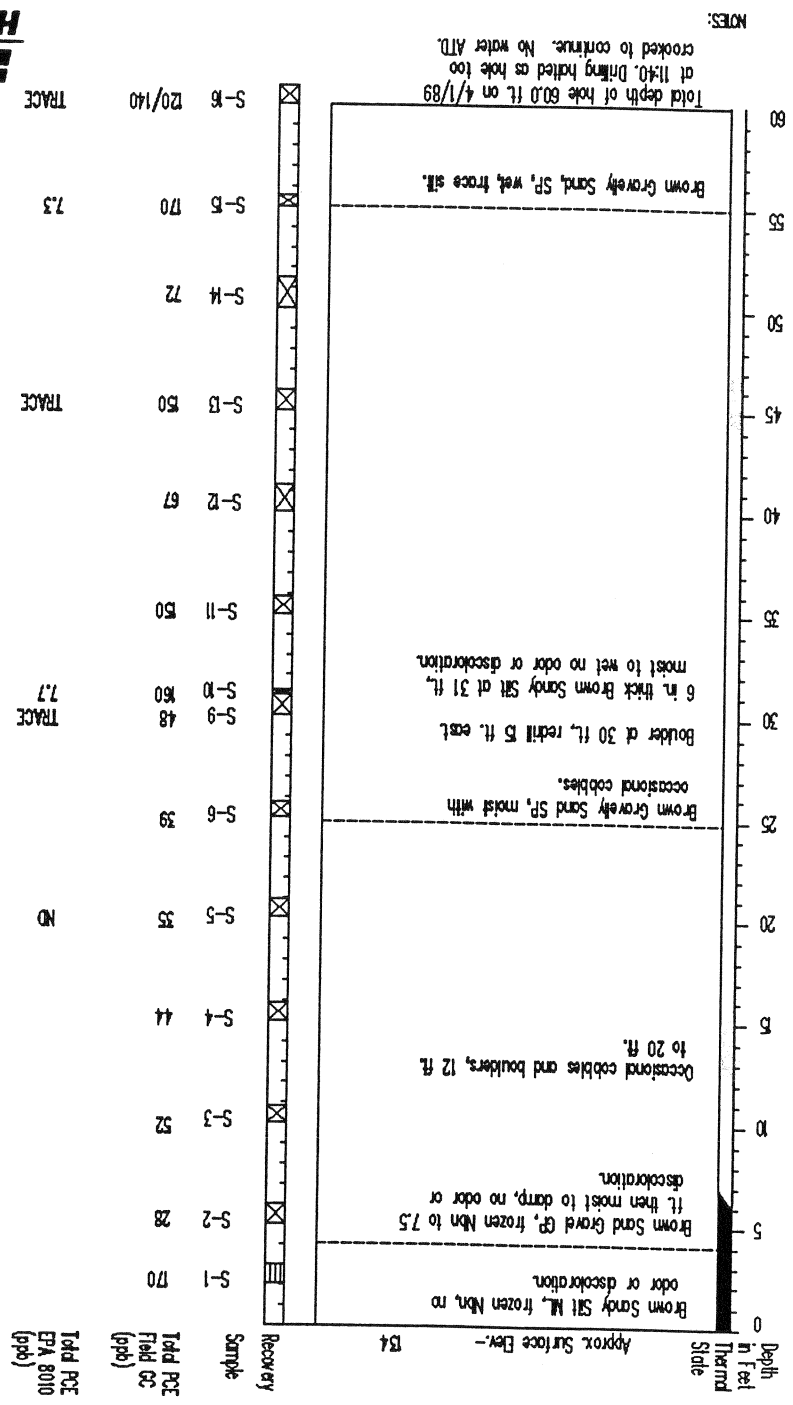
HARTCROWSER
 A-8143 July 1989
 Figure A-13

Boring Log TH-4

NOTES:
 1. Soil descriptions are interpretive and actual changes may be gradual.
 2. Water level is for date indicated and may vary with time of year. (ATD - At Time of Drilling)
 Total depth of hole 60.0 ft on 4/1/89 at 11:40. Drilling halted as hole too crooked to continue. No water ATD.
