# **Eielson Air Force Base Operable Units 3, 4, and 5**

## **Declaration of the Amended Record of Decision**

Operable Units 3, 4, and 5  
Eielson Air Force Base, Alaska

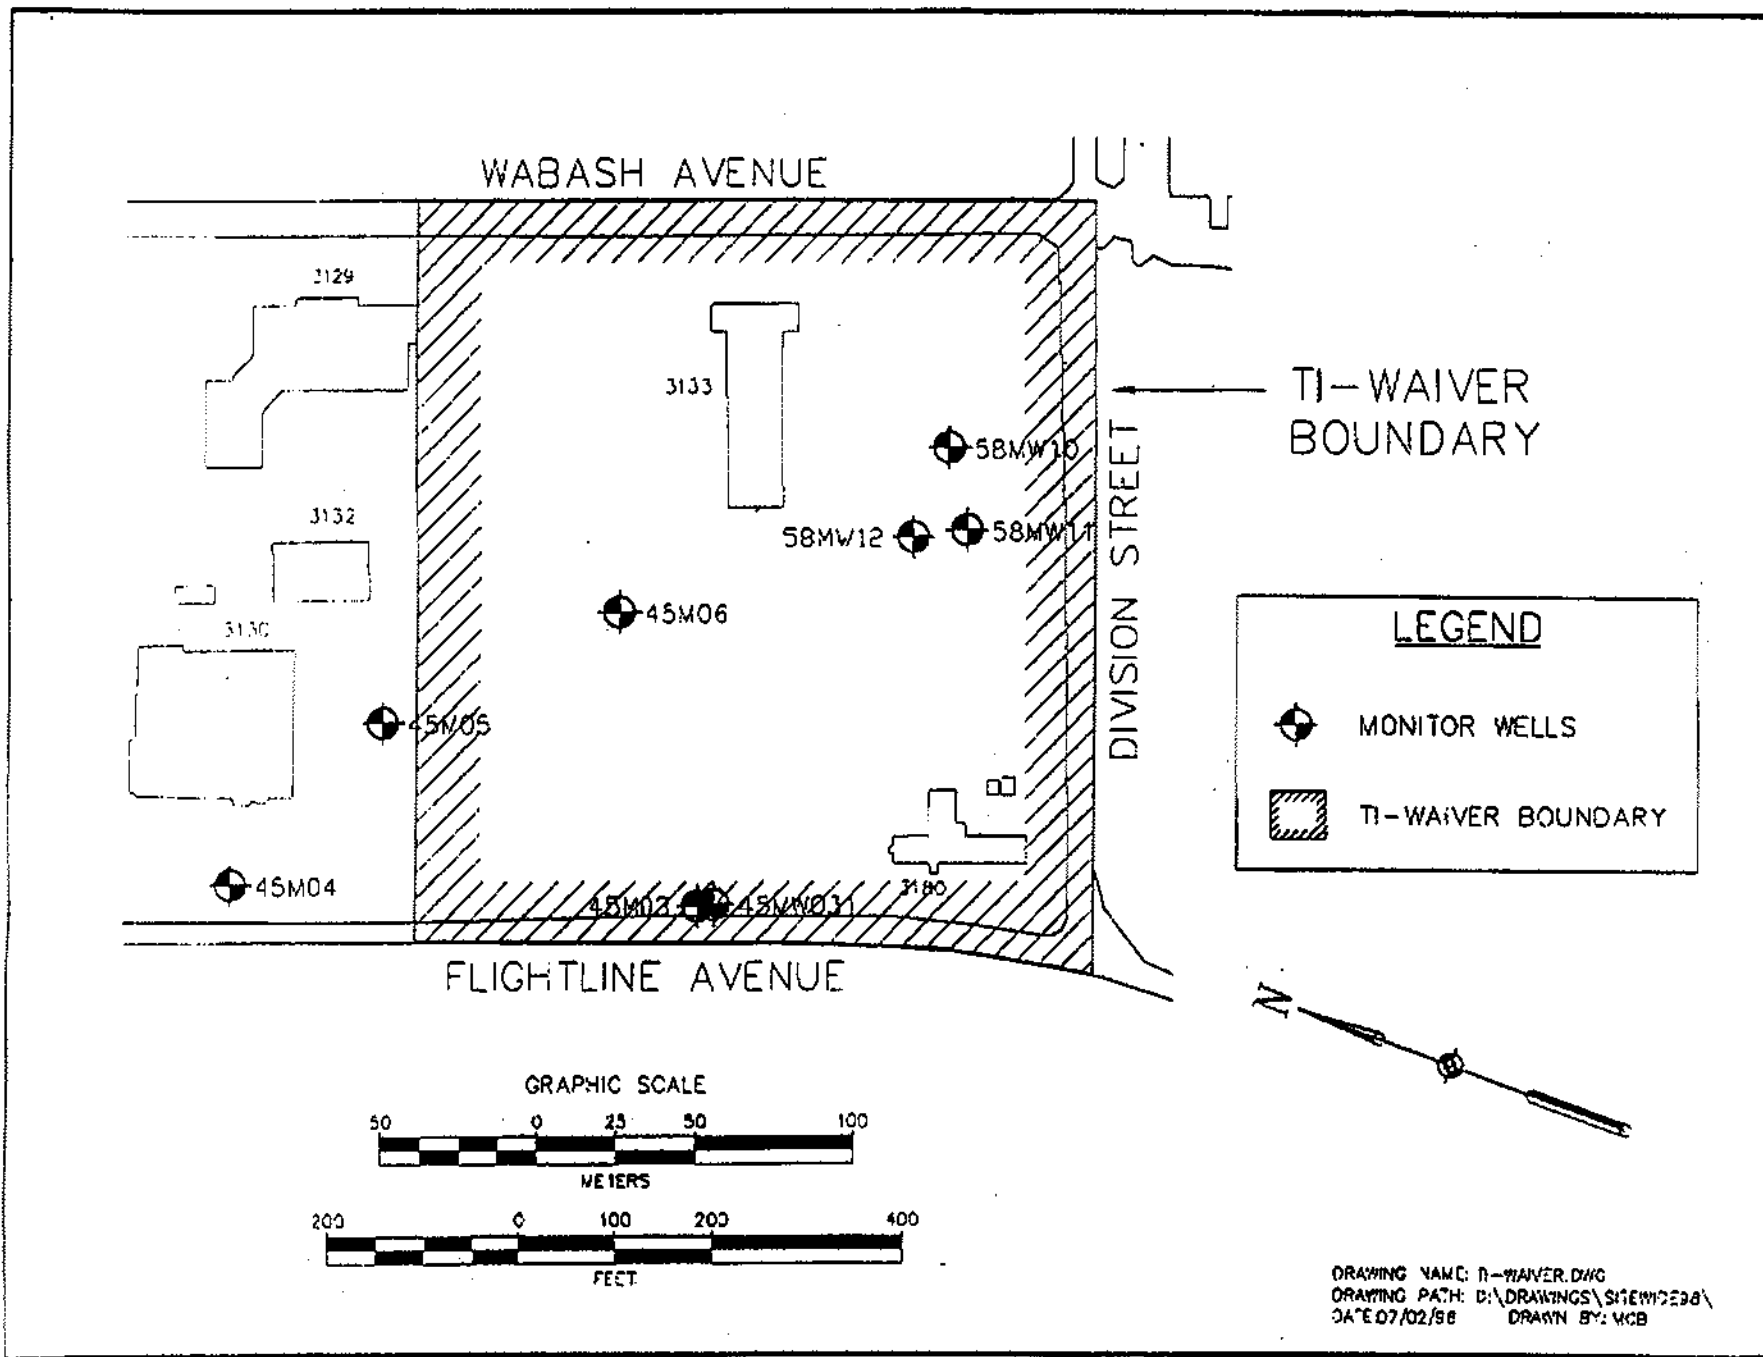
ST58: TI-Waiver Boundary, Eielson AFB, Alaska

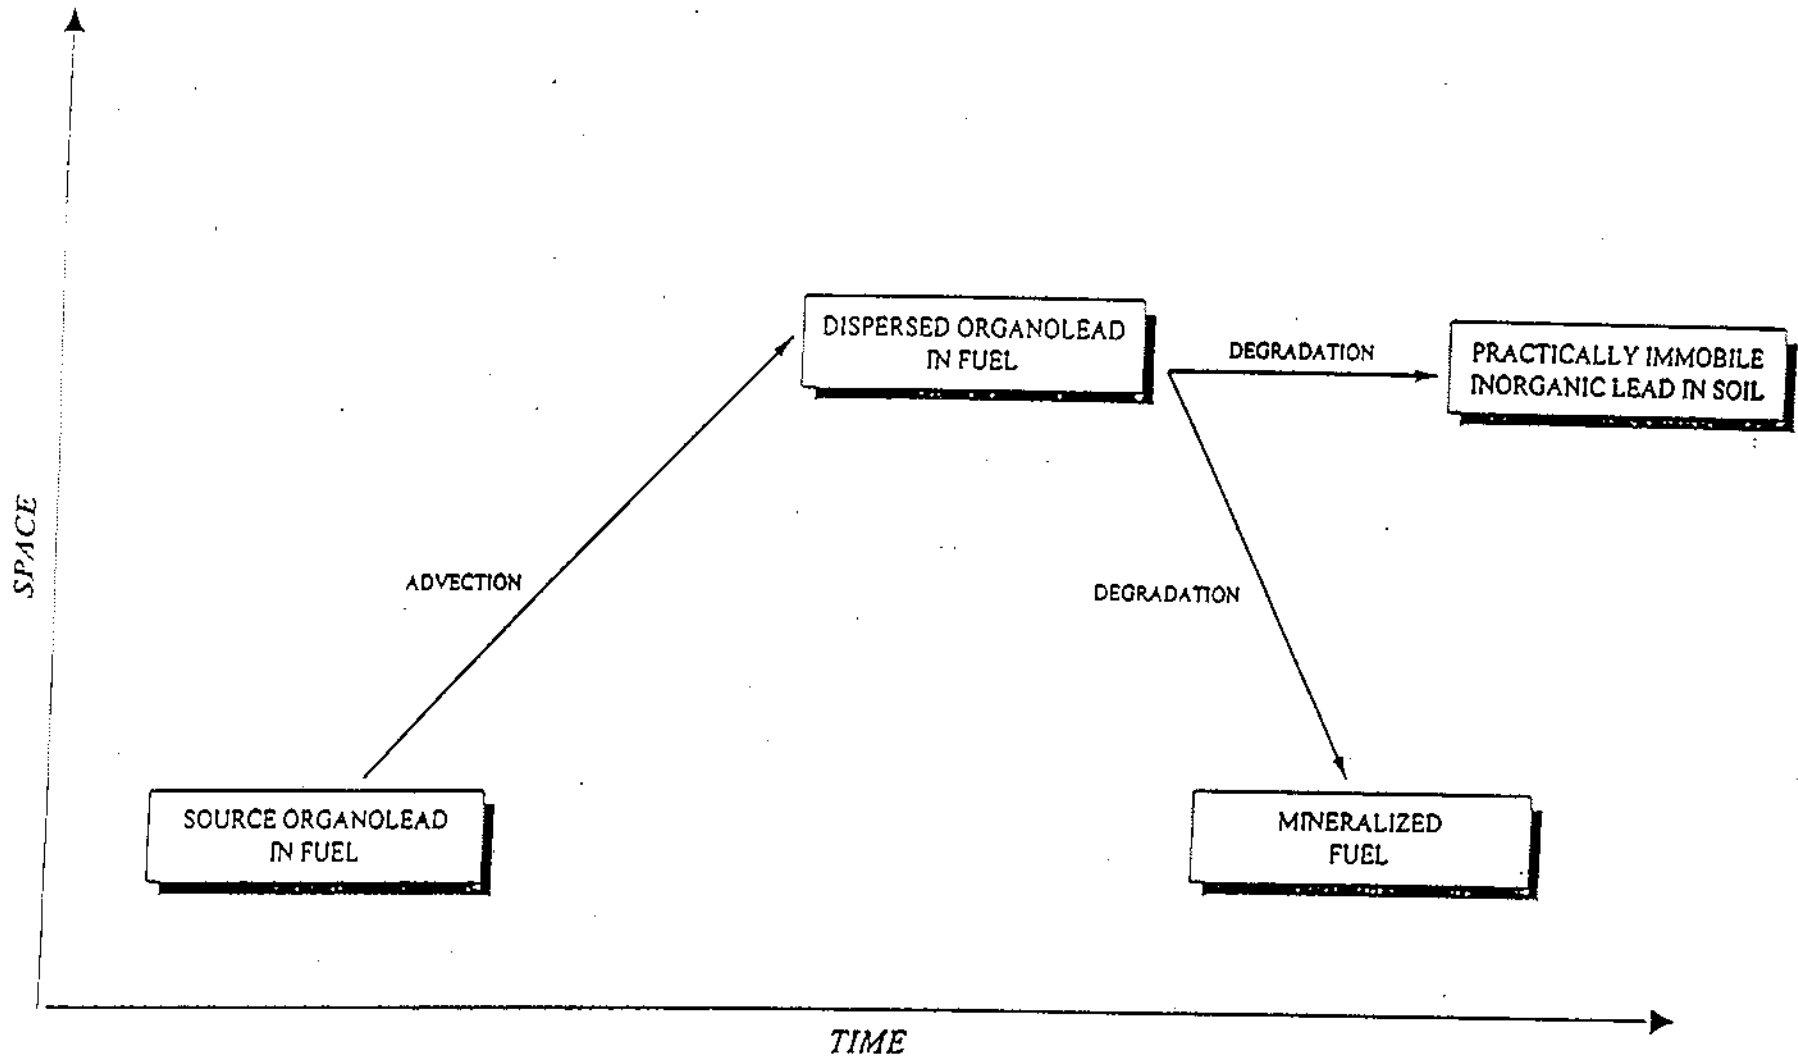
FIGURE 1  
CONCEPTUAL SITE MODEL  
EIELSON AIR FORCE BASE

# CONCEPTUAL SITE MODEL
