**THE UNITED STATES AIR FORCE  
INSTALLATION RESTORATION PROGRAM**

**FIVE-YEAR ROD REVIEW REPORT**

**EIELSON AIR FORCE BASE, ALASKA**

**SEPTEMBER 2008**

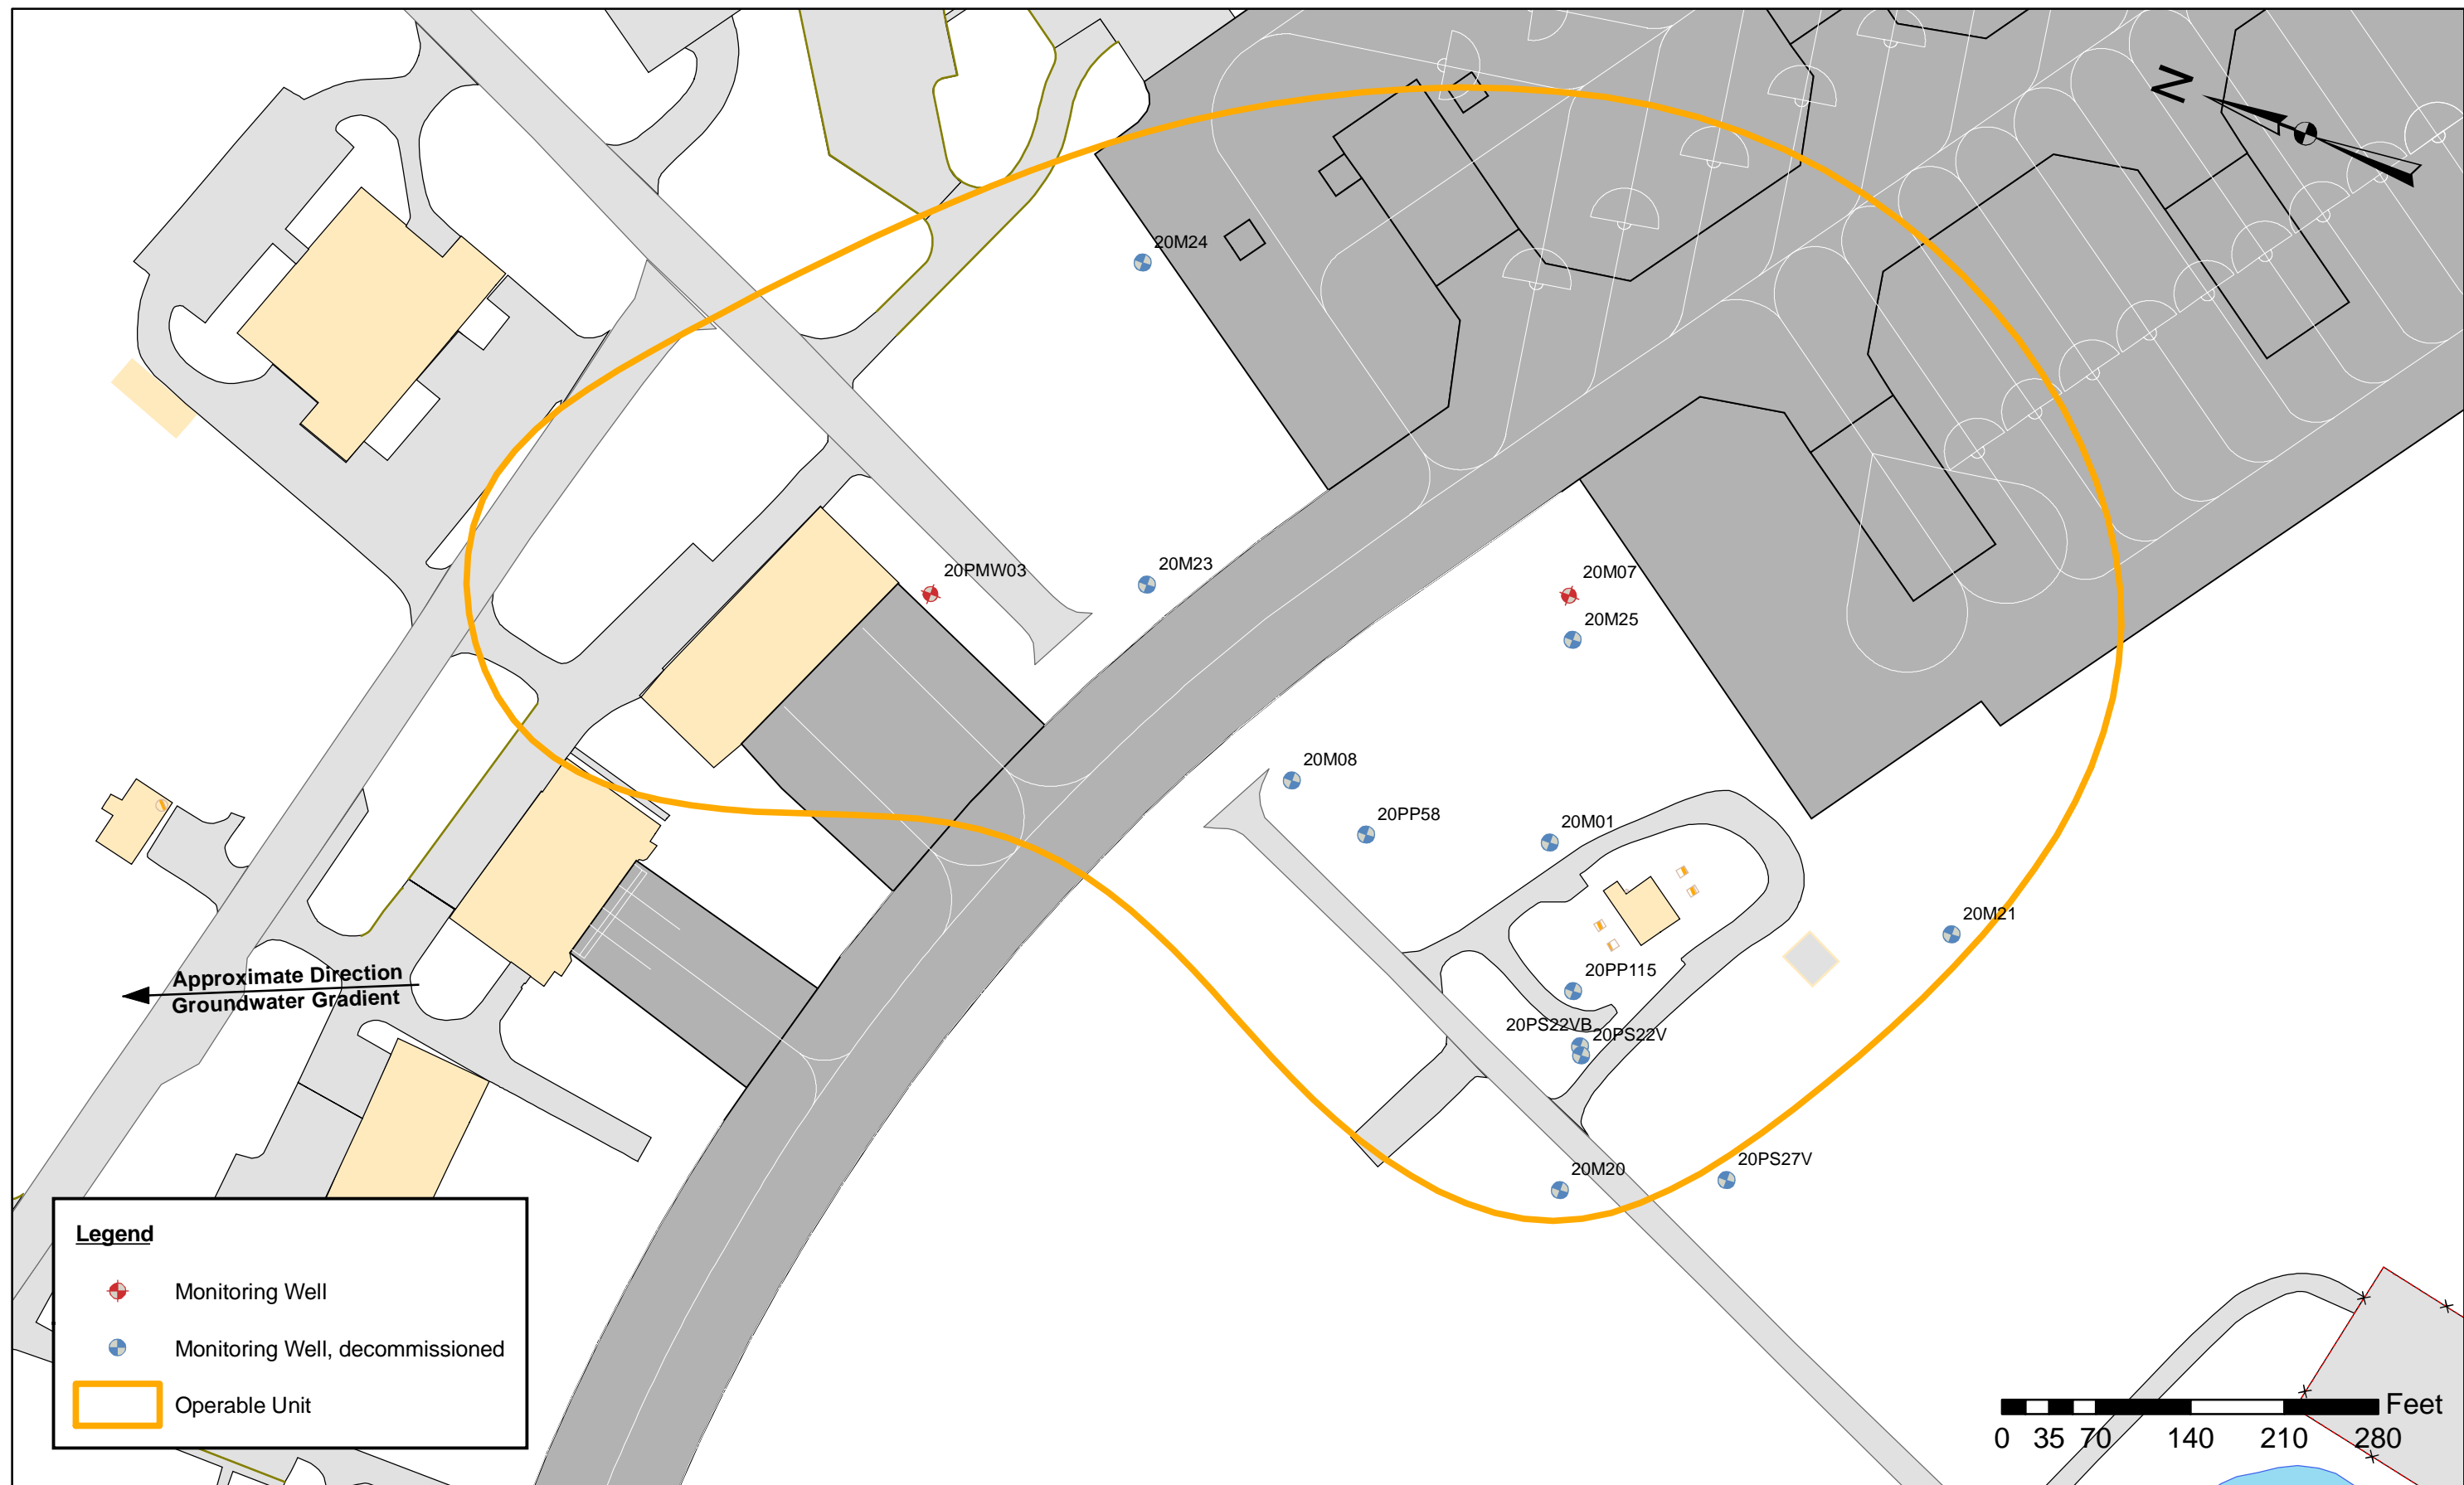
Figure ST20 (E-9)-1: E-9 Refueling Complex, Groundwater Monitoring Locations, Eielson AFB, Alaska

**E-9** In August 1988, a leak in fuel piping was discovered at E-9. The leak was repaired in June 1989. A second leak was observed during leak testing and repaired in June 1989. A passive skimmer was installed in 1989 removing less than 5 gallons of product. In June 1992, a third leak was discovered in the line to the defueling tank at E-9. The leak was repaired in July 1992.

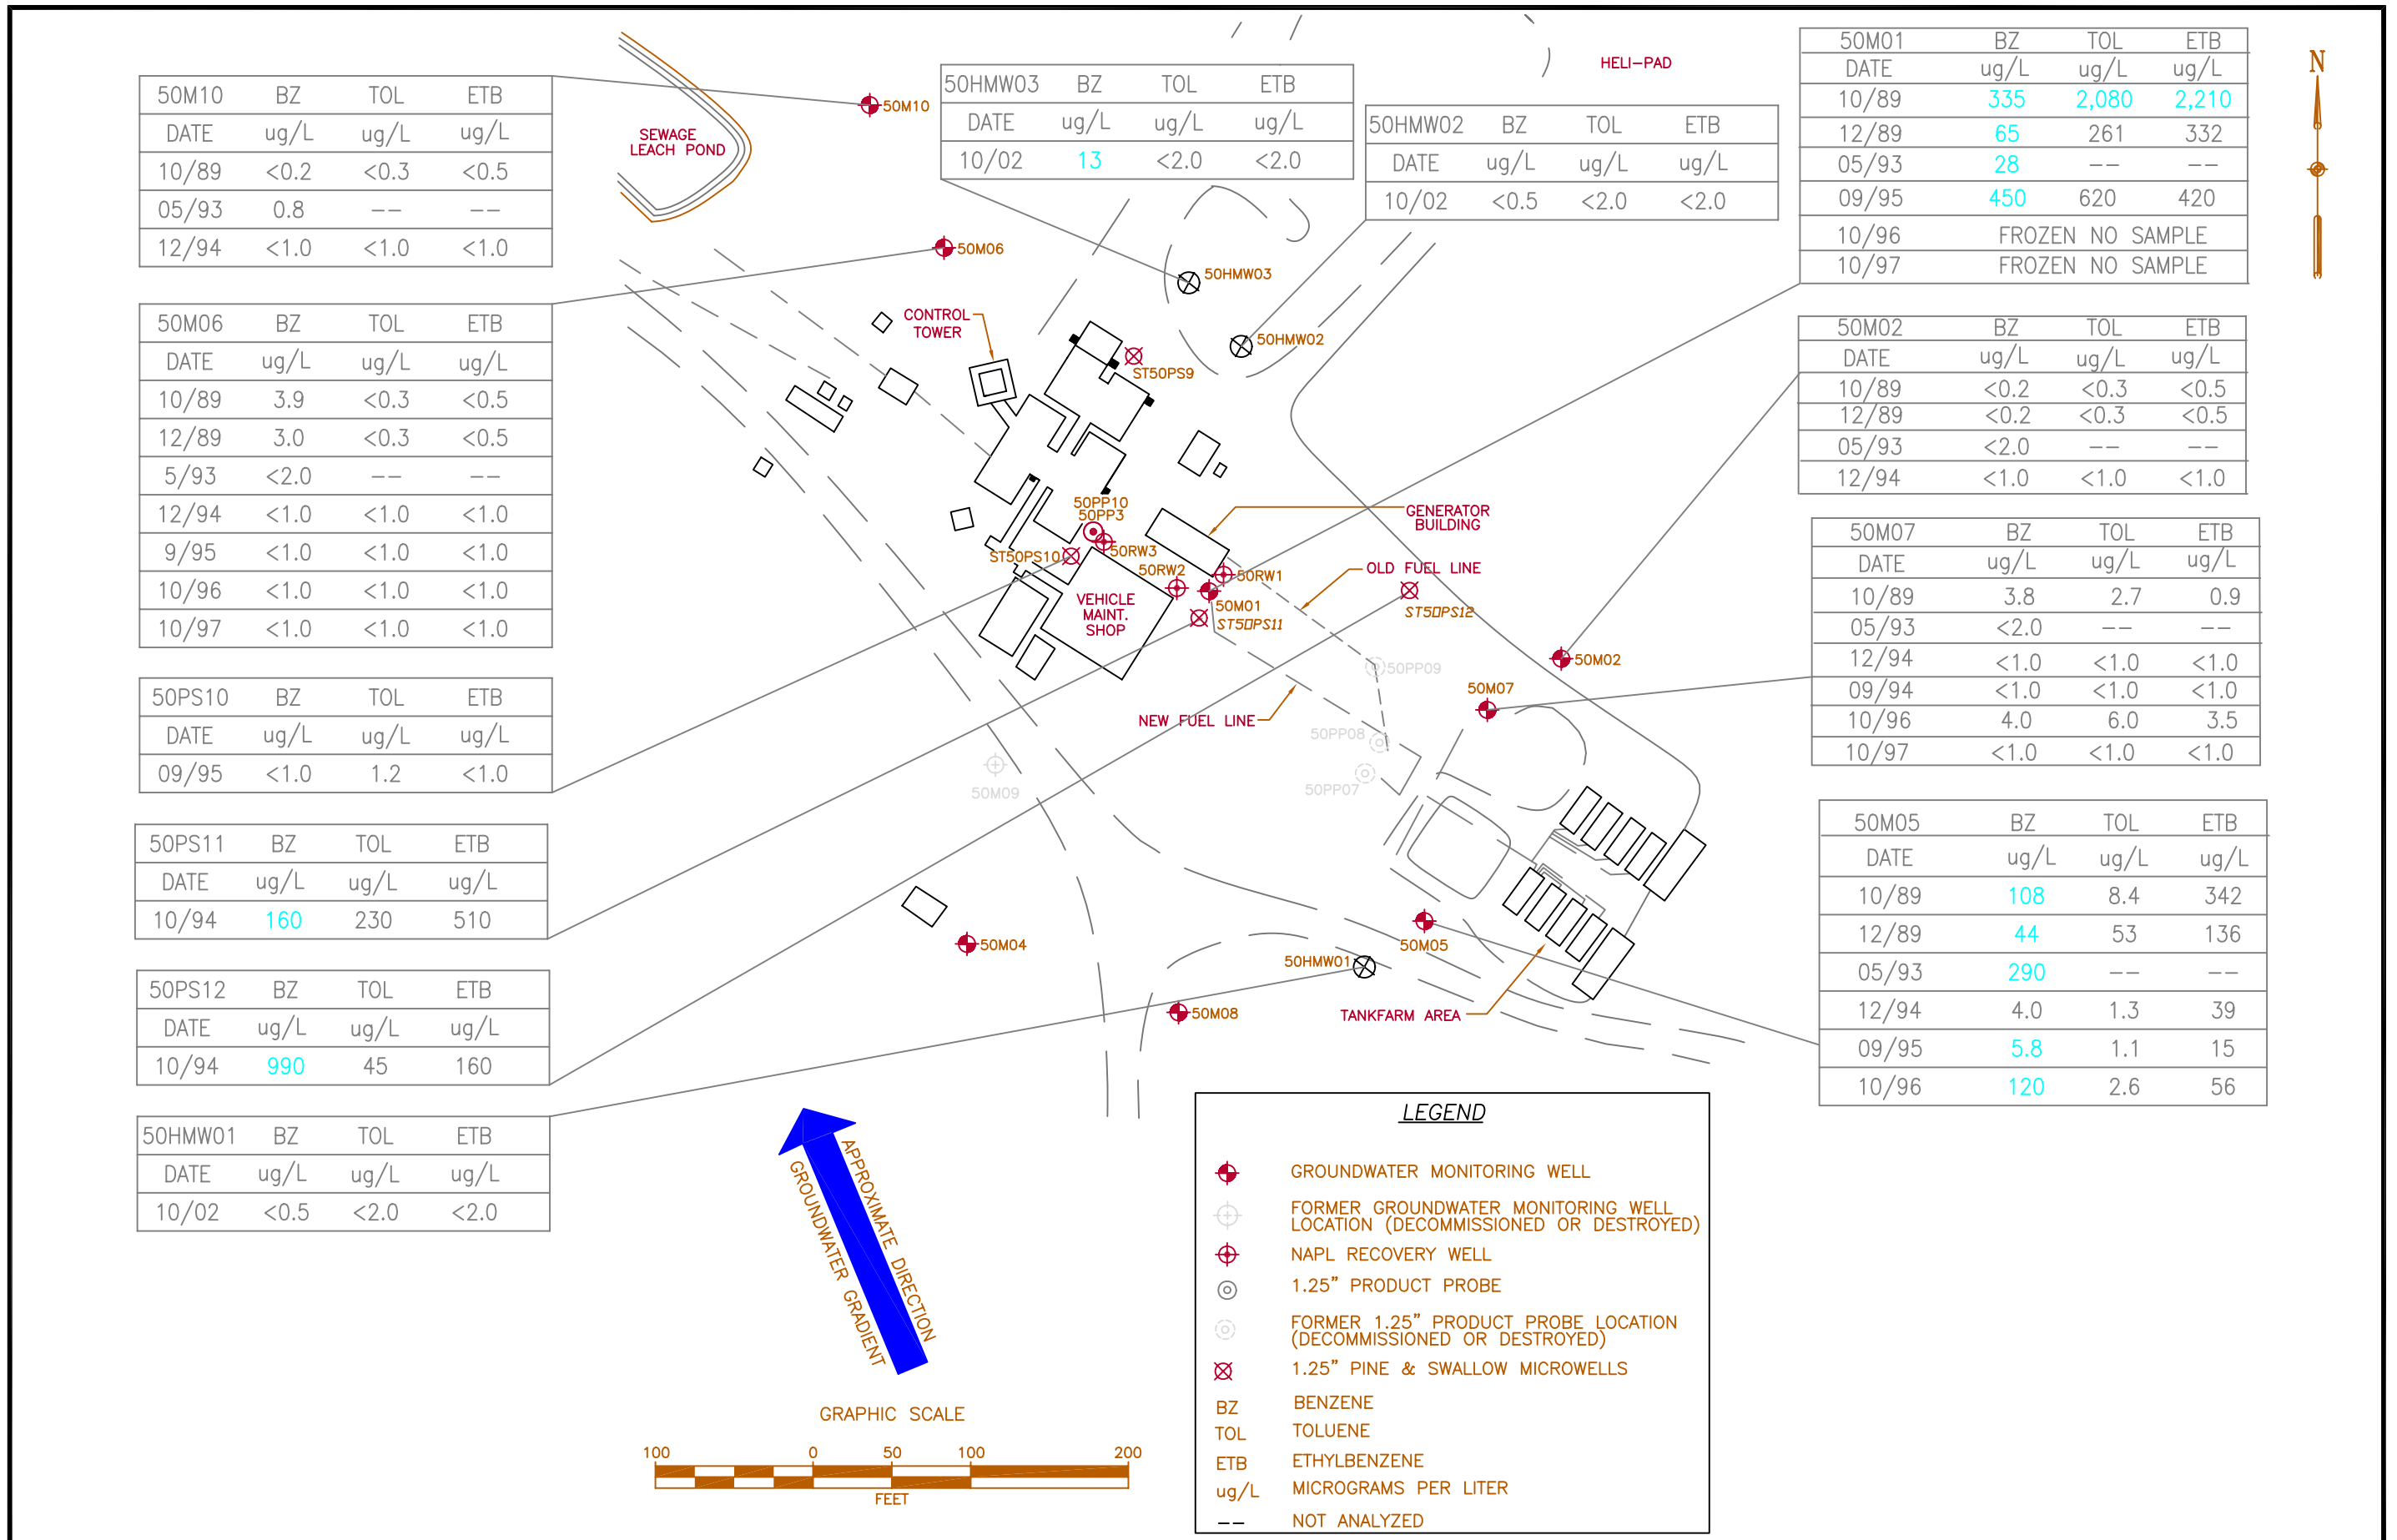
Figure SS50-52-1: SS50-52, Blair Lake Facility, Groundwater Monitoring Locations, Eielson AFB, Alaska

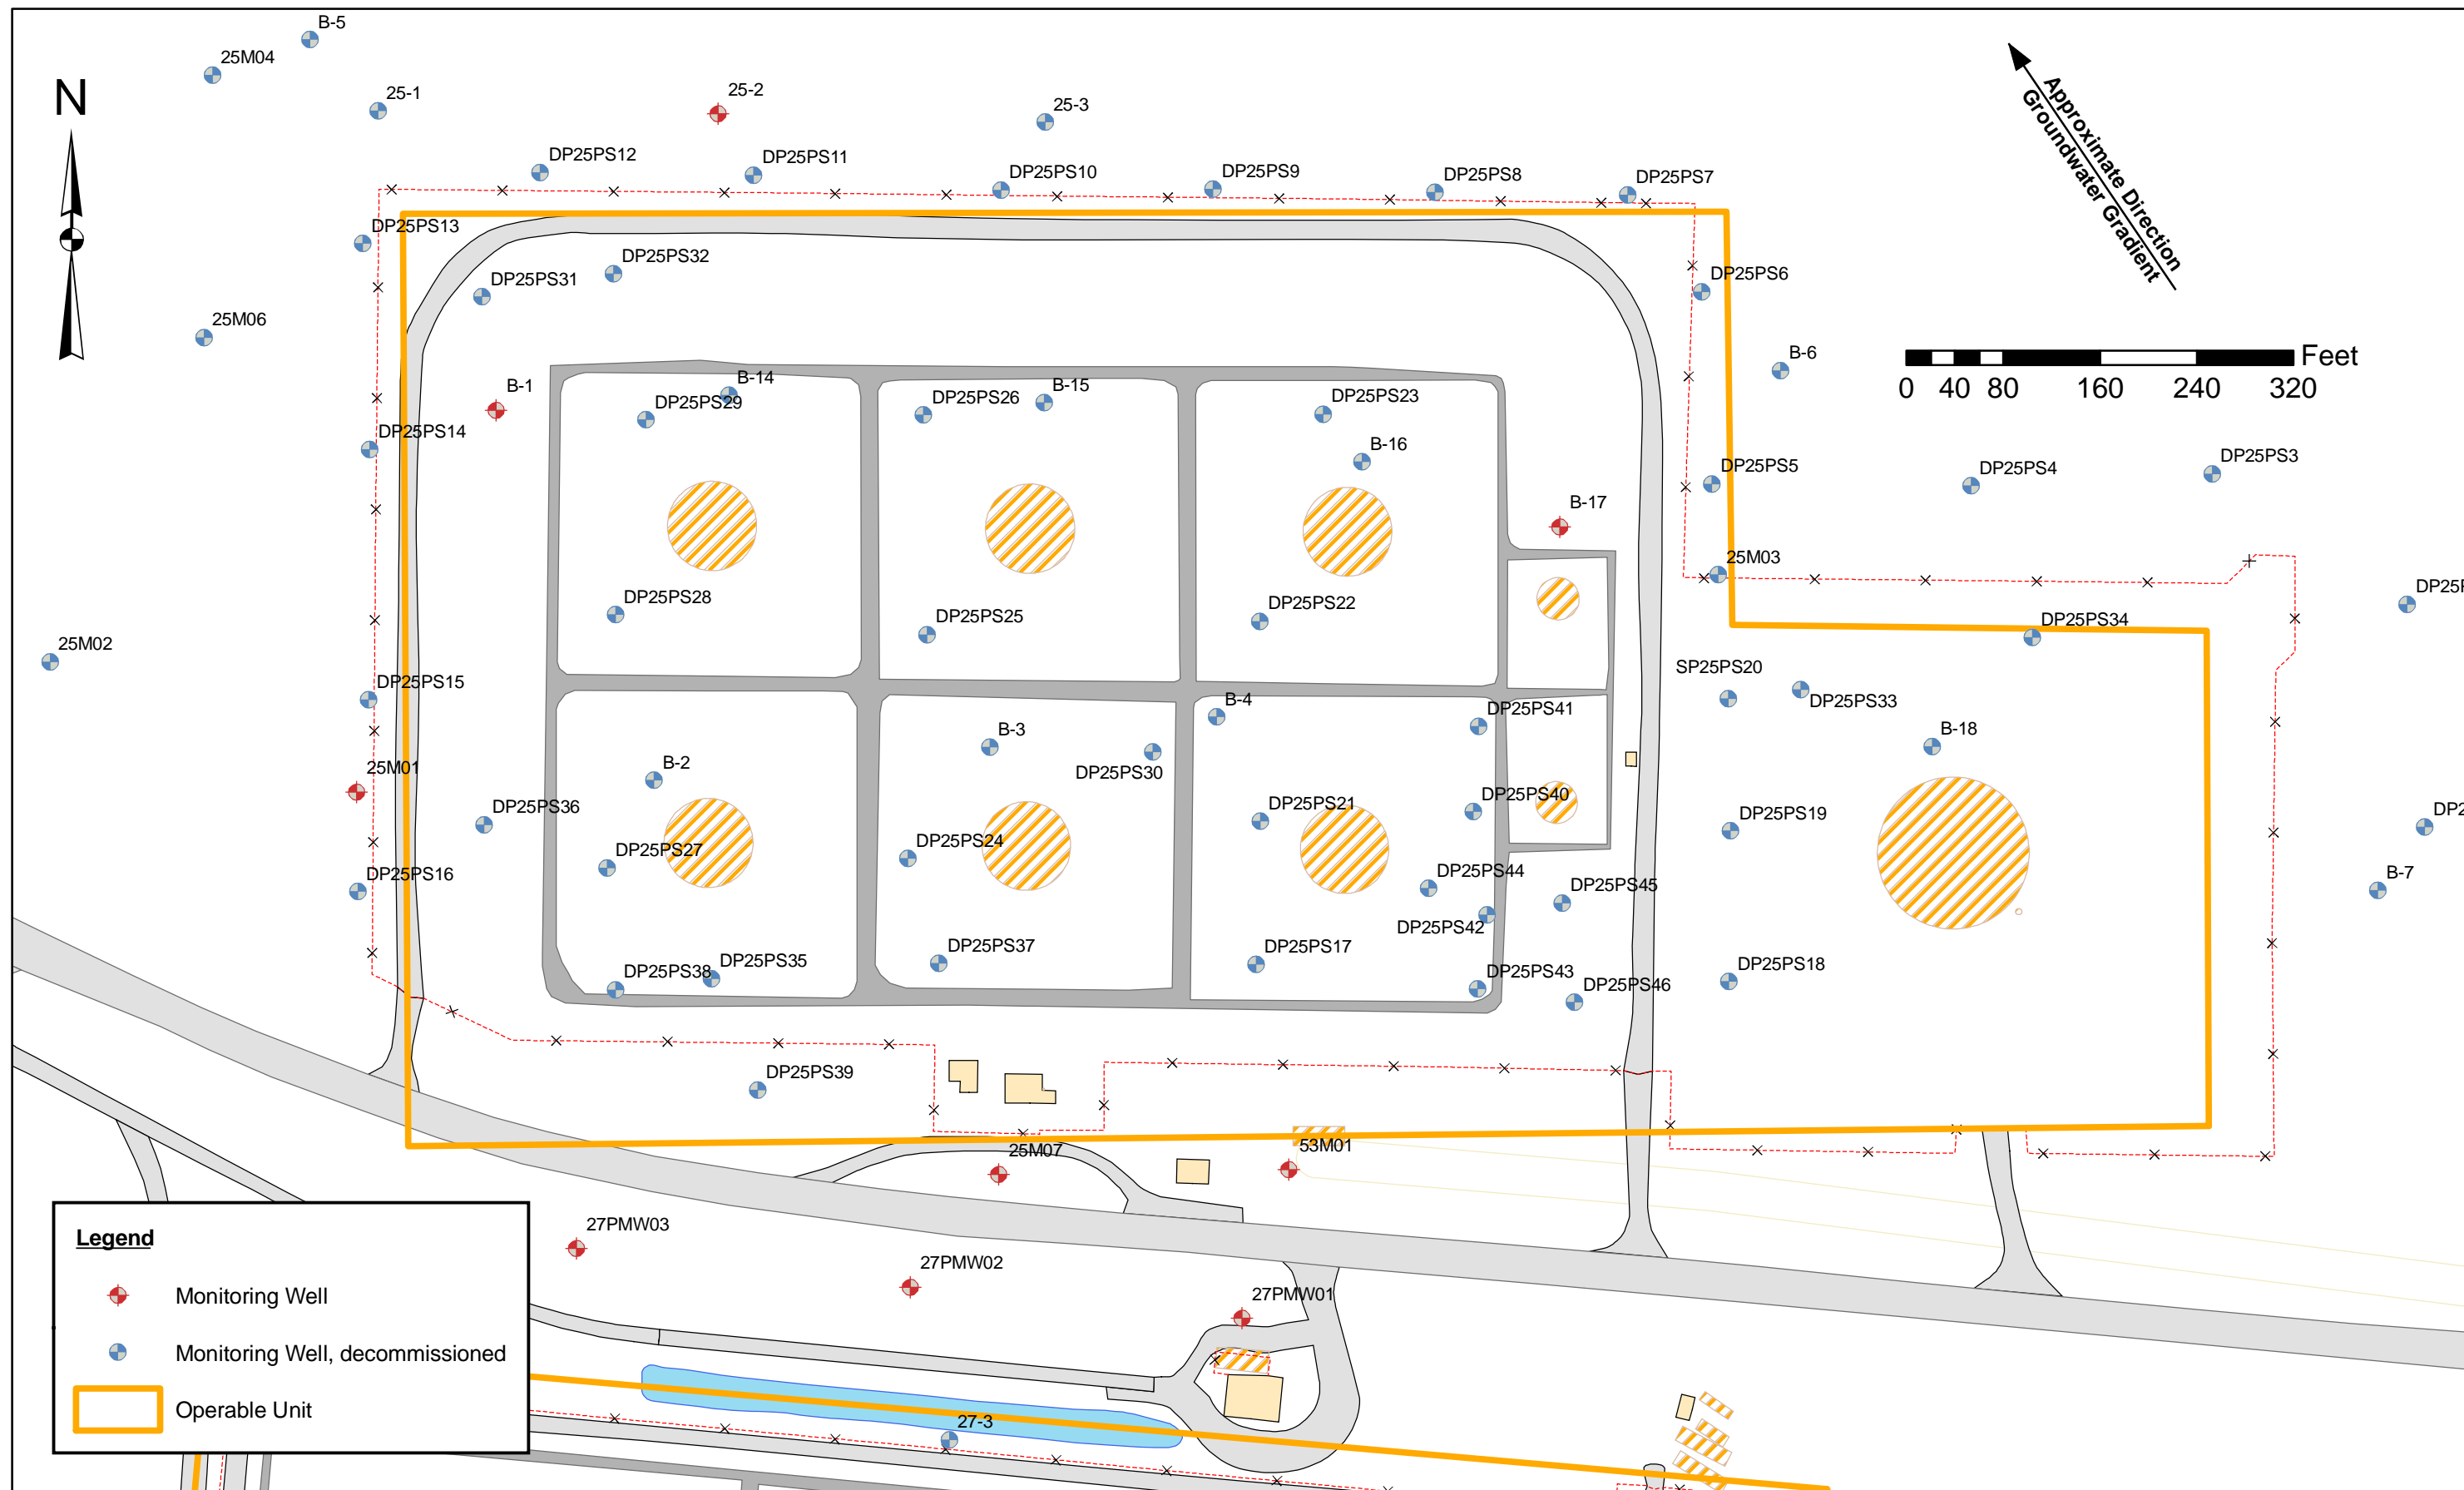
Figure DP25-1: DP25 E-6 Fuel Tank Sludge Burial Pit, Groundwater Monitoring Locations, Eielson AFB, Alaska
