**Department of Environmental
Conservation**

DIVISION OF SPILL PREVENTION AND RESPONSE
Contaminated Sites Program

Re: Decision Document: Eielson AFB Hangar (SO504) Bldg 1344 Area #2, Hazard ID 1651
Cleanup Complete Determination

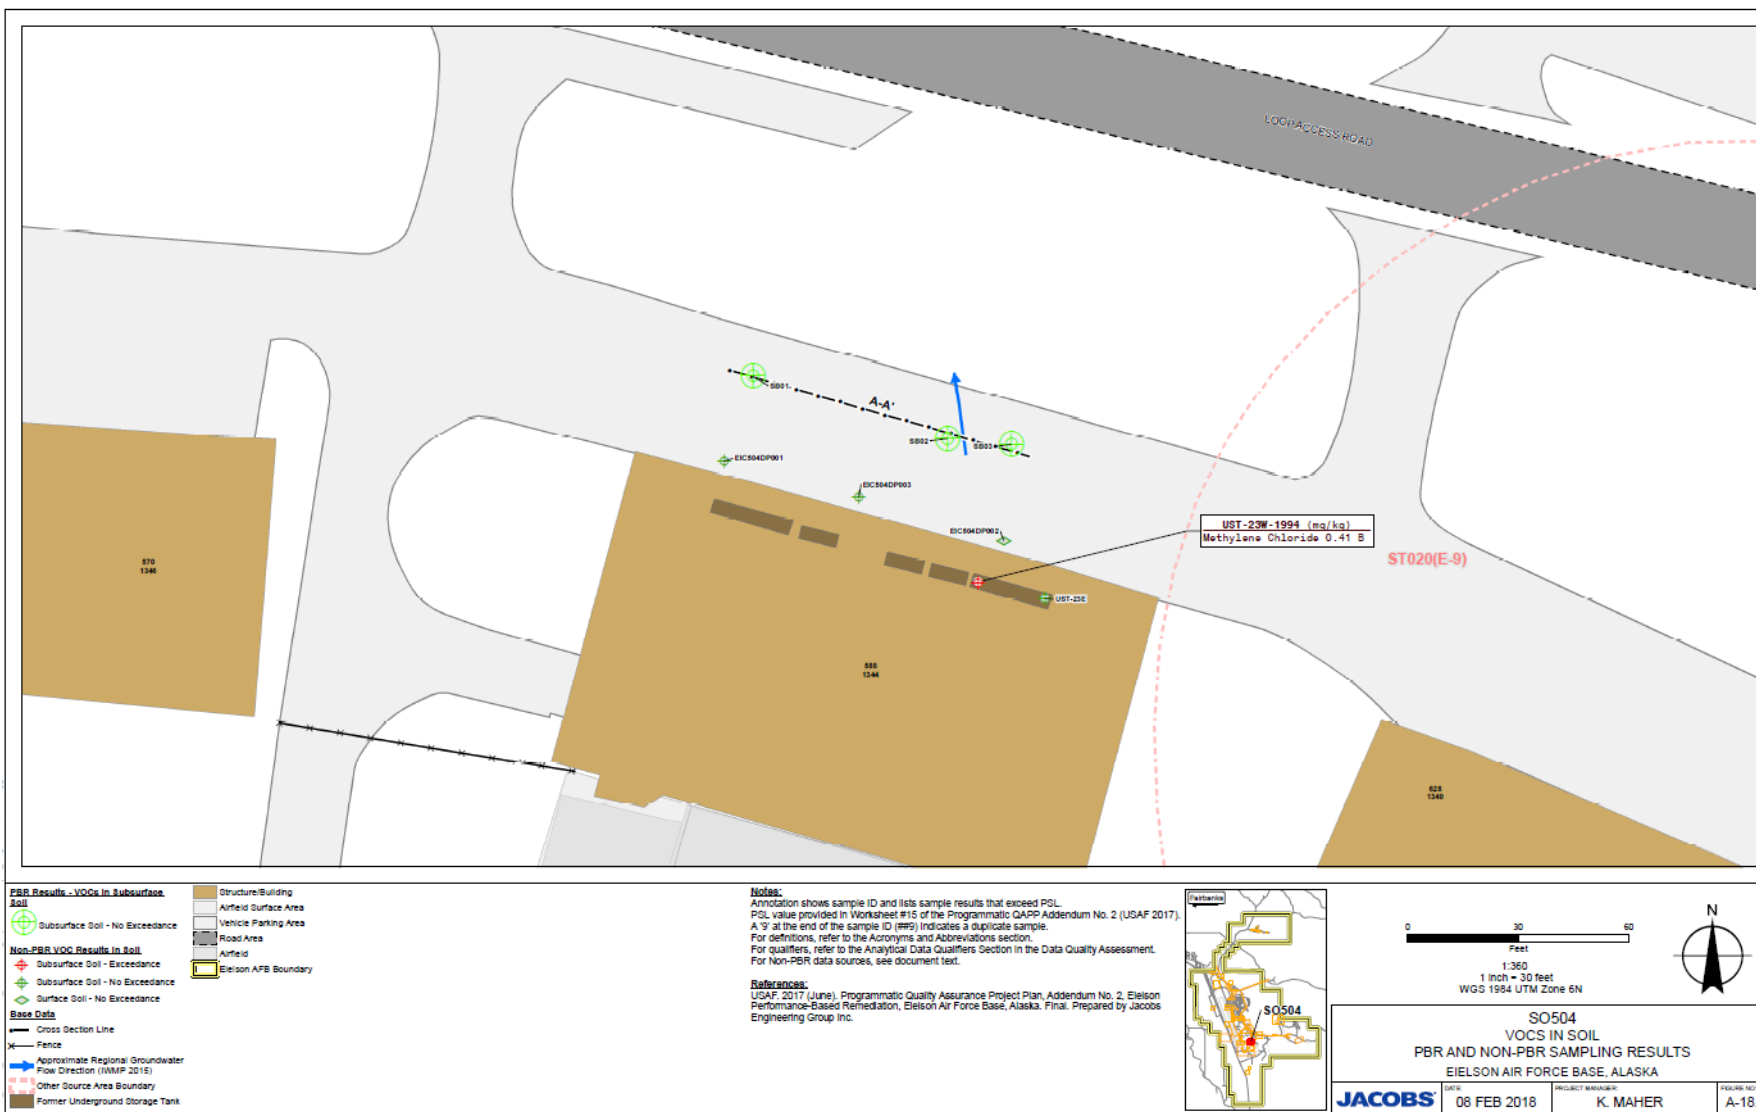
Figure A-18.3: SO504 VOCs in Soil PBR and non-PBR Sampling Results

After removal of Tank 23, methylene chloride was discovered in soil samples at concentrations above DEC cleanup levels. The volume and cause of the release was unknown. This letter discusses cleanup decision for Tank 23 under 18 AAC 75.
