**SITE RESTORATION PLAN**  
**WRANGELL JUNKYARD SITE**  
**WRANGELL, ALASKA**  
**ADEC File # 1529.38.006**  
**SEPTEMBER 7, 2018**

Per ADEC request, the NRC Alaska Project Team is providing this Site Restoration Plan. This plan describes the general layout and conditions that will remain at the Site upon completion of the stockpile soil removal effort, and the activities that will be conducted to attain and document the final Site restoration.

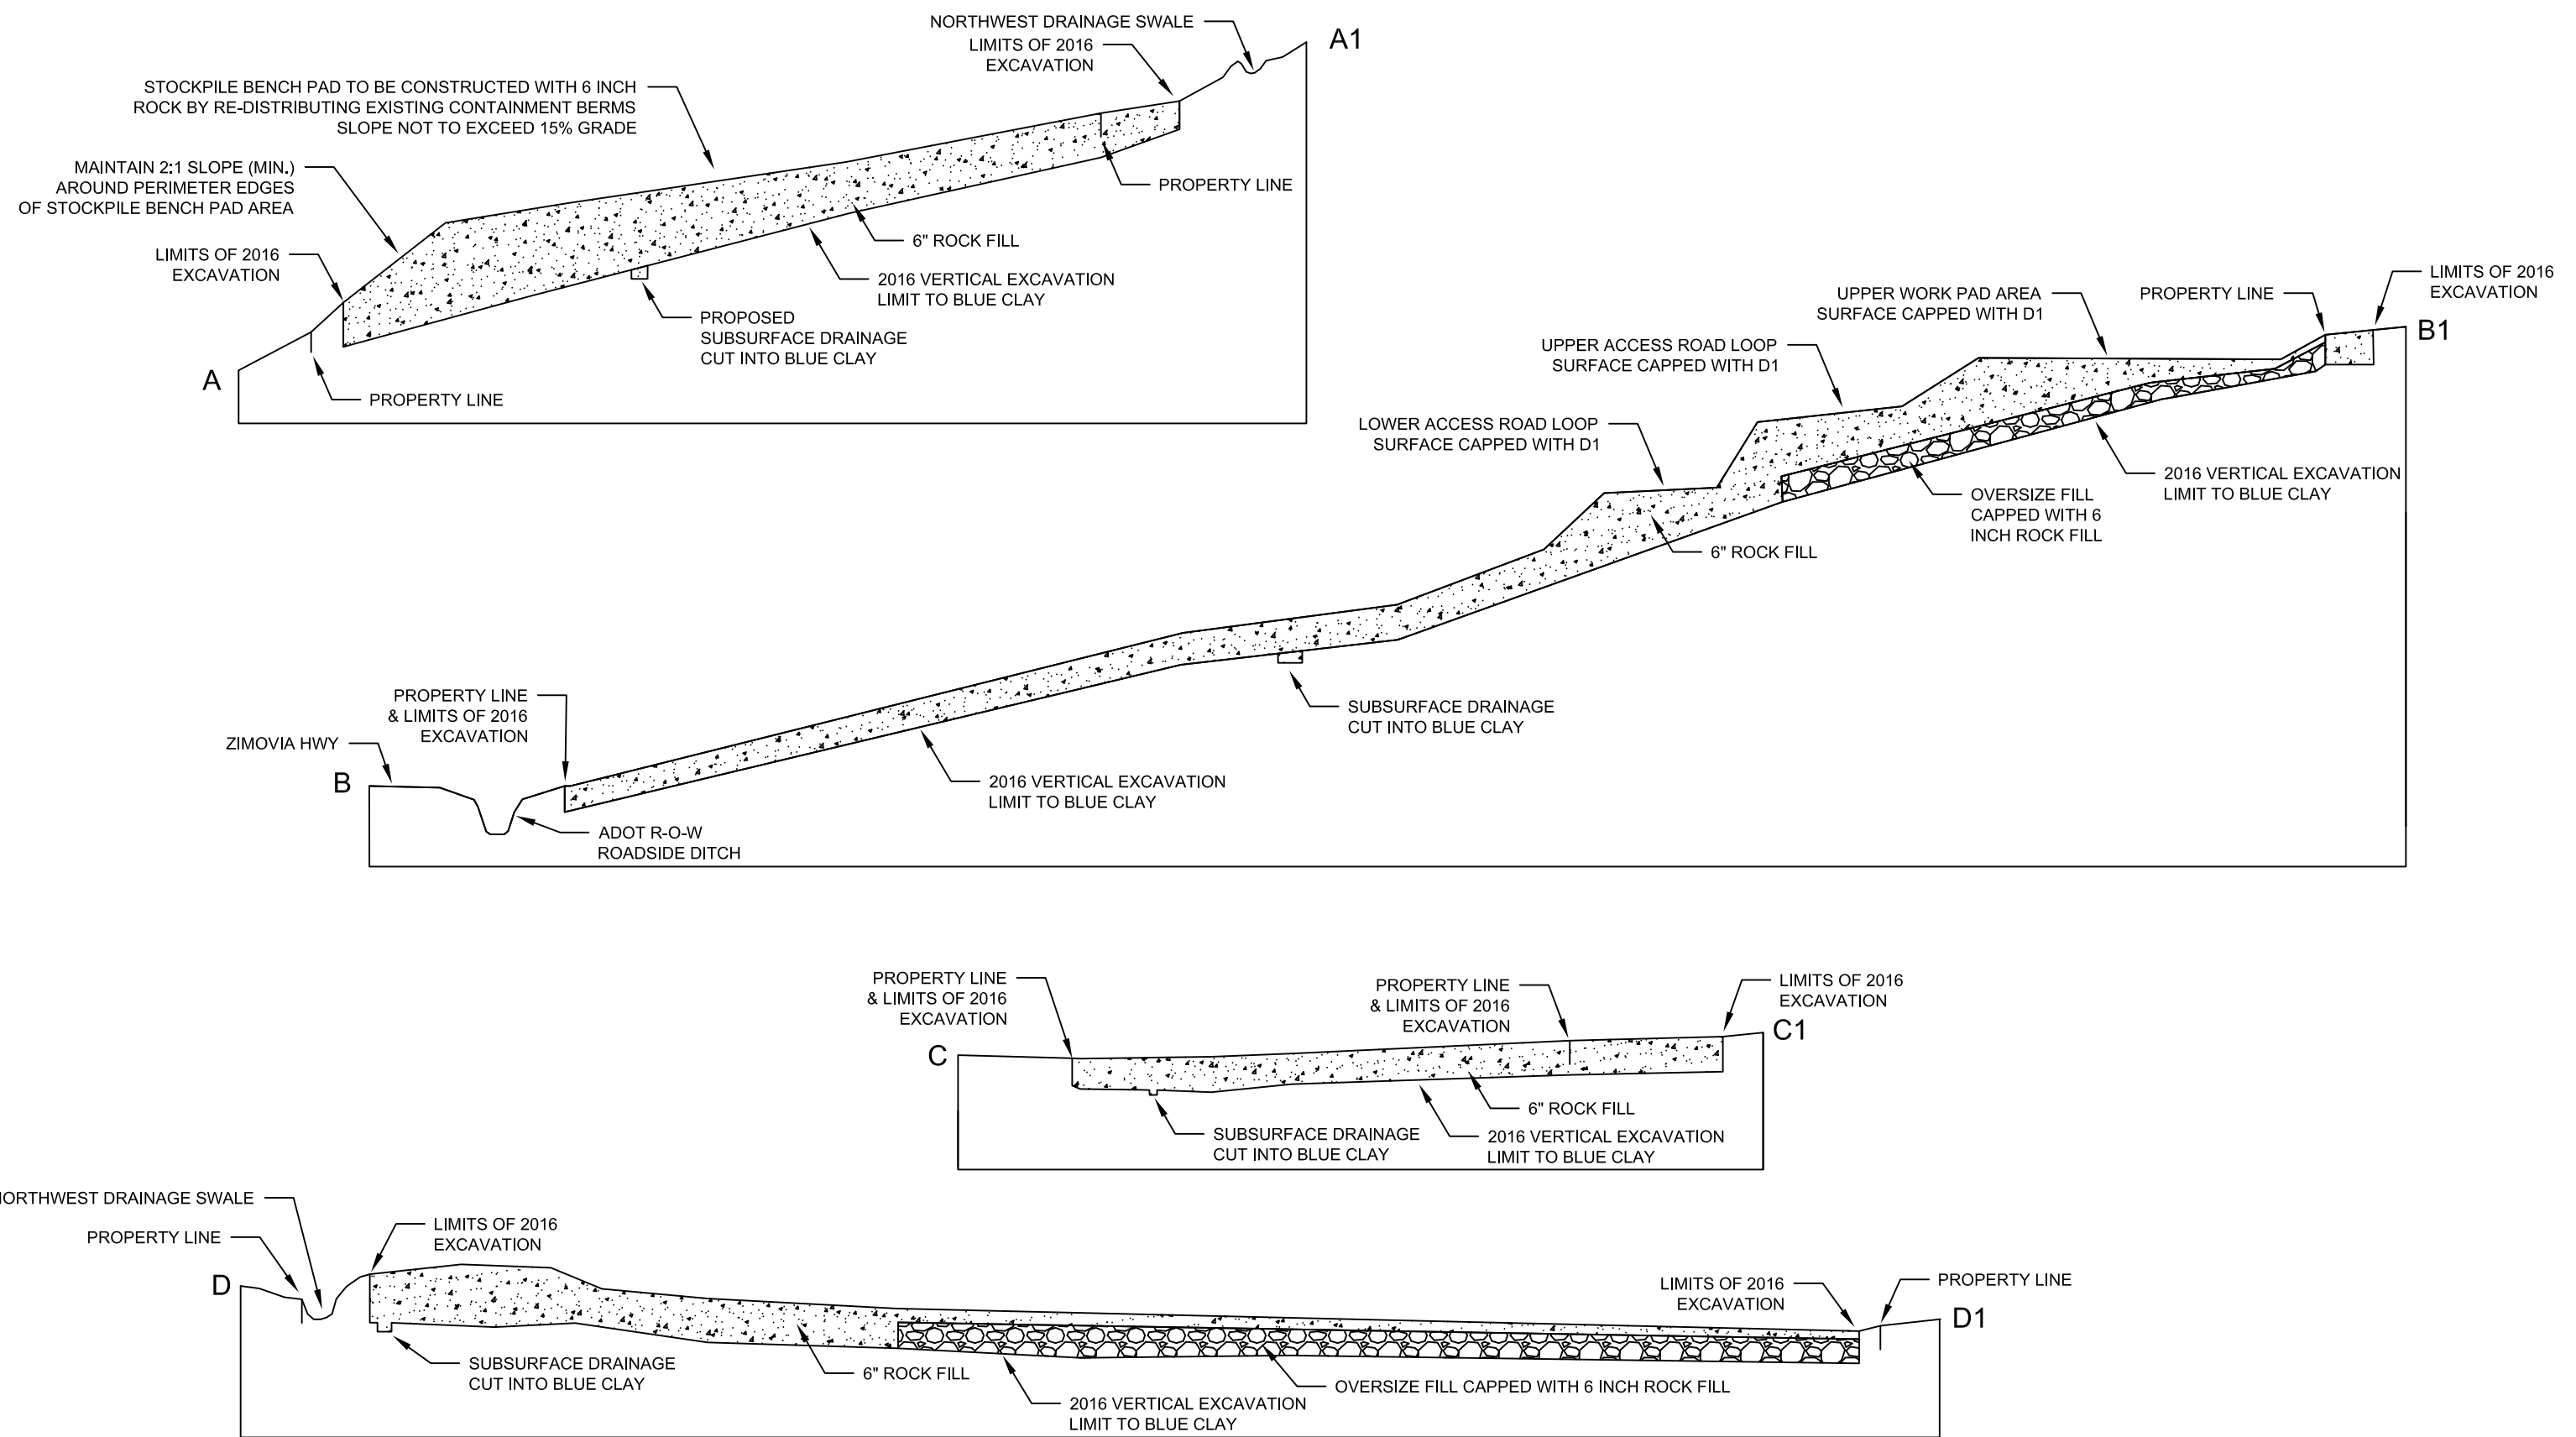
NOTE: 2x VERTICAL EXAGGERATION IN CROSS SECTIONS.

Final Site grading will be accomplished using heavy equipment which may include excavators, loaders, bulldozers and rolling compactors. Figure 2 shows the pre-existing Site prior to initiating the stockpile removal effort. Figure 4 provides a generalized graphic description of the Site as it will be left after completion of the removal effort and final Site grading. Figures 5 and 6 show the lines of section and generalized cross-sectional diagrams of the anticipated final grade of the Site at the completion of the restoration effort.
