# Heather Bay, PWS-NE-23

## Geographic Response Strategies for Prince William Sound Subarea

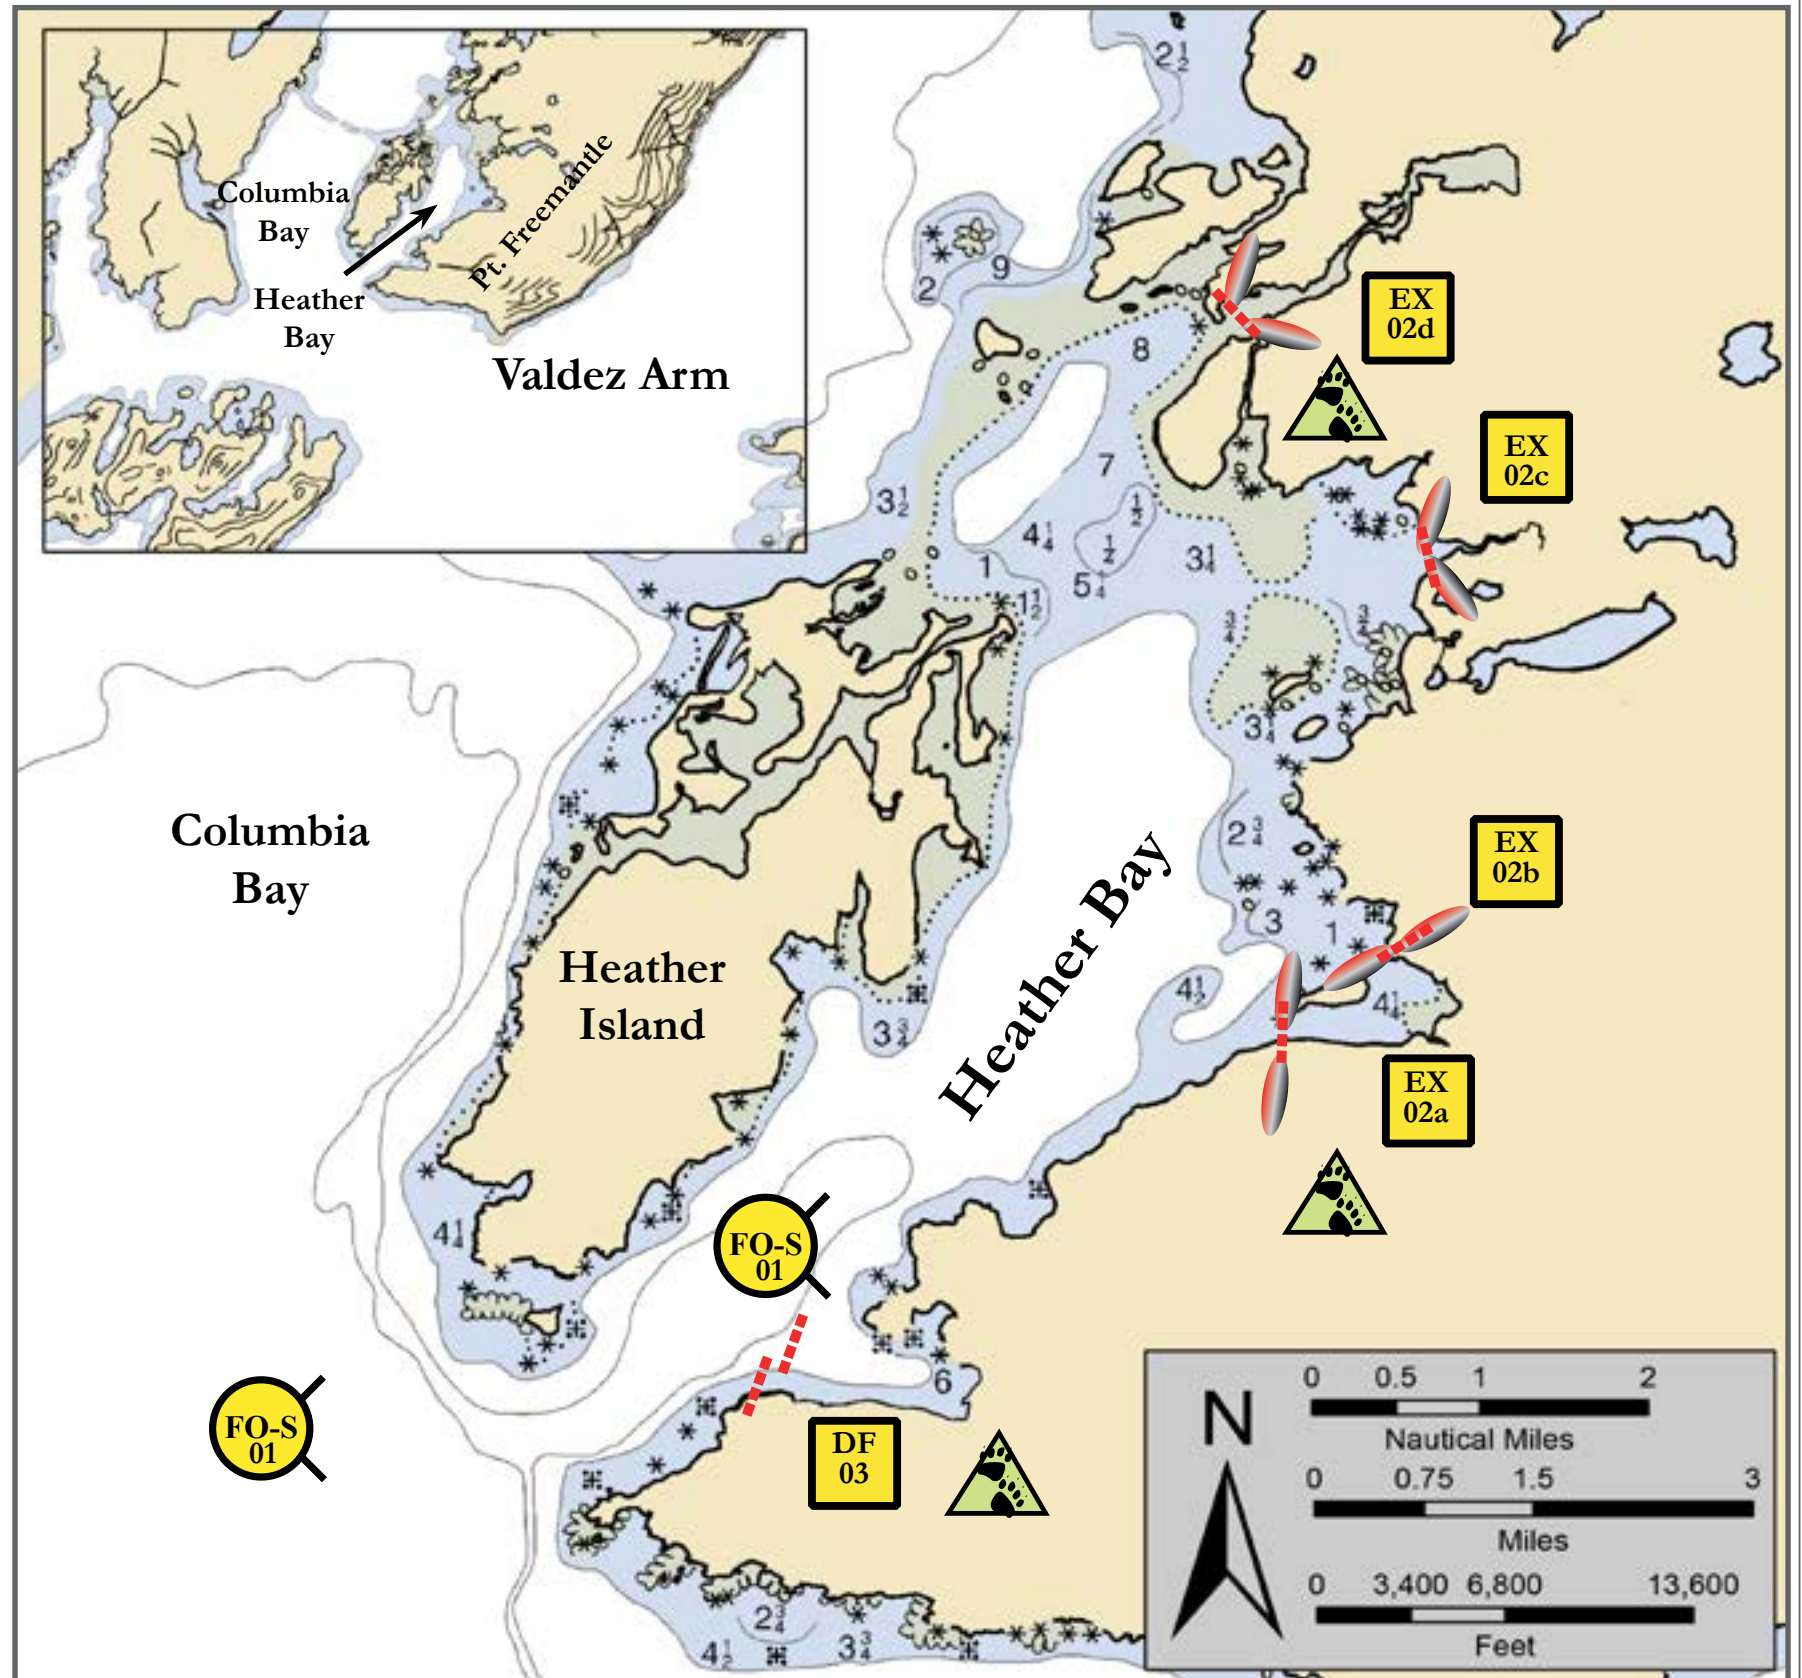
Map is not intended for navigational use.

Lat. 60° 58' 11.9" N  
Lon. 147° 0' 57.9" W

Depths in Fathoms

<b>Heather Bay</b> Nearshore waters in the general area of:  Lat. 60° 59.73' N Lon. 147° 00.18' W	<b>Free-oil Recovery</b>  Maximize free-oil recovery in the offshore & nearshore environment of Heather Bay depending on spill location and trajectory.	Deploy free-oil recovery strike teams upwind and up current of Heather Bay.  Use aerial surveillance to locate incoming slicks.	Deploy multiple free-oil recovery strike teams as required to maximize interception of oil before it impacts sensitive areas.	Valdez	Via marine waters See NOAA Charts 16713-1.	Same as NE-23-02	Vessel master should have local knowledge.  Use extreme caution, shoal waters with numerous reefs and rocks.
NE-23-02

<b>Heather Bay</b> a. Lat. 60° 58.18' N Lon. 146° 59.31' W  b. Lat. 60° 58.40' N Lon. 146° 59.01' W  c. Lat. 60° 59.61' N Lon. 146° 59.65' W  d. Lat. 61° 00.28' N Lon. 146° 59.65' W	<b>Exclusion</b>  Exclude oil from impacting the identified streams and intertidal areas in Heather Bay.	Deploy anchors and boom with skiffs (class 6) at high tide.  Place 60 ft. sections of tidal-seal boom on the ends of the exclusion booms and complete with protected-water boom.  Arrays (a) & (b) exclude the entrance to the small cove using the island as a shore anchor point.  Place arrays (c) & (d) in a chevron pattern in front of the identified streams.  Tend throughout the tide.  Boom Lengths: a. 750 ft. b. 1000 ft. c. 500 ft. d. 600 ft.	<b>Deployment Equipment</b> 2800 ft. protected-water boom 640 ft. tidal-seal boom 15 ea. Anchor systems 16 ea. Anchor stakes  <b>Vessels</b> 1 ea. class 3 2 ea. class 6  <b>Personnel/Shift</b> 7 ea. vessel crew/general techs  <b>Tending Vessels</b> 1 ea. class 3 1 ea. class 6  <b>Personnel/Shift</b> 3 ea. vessel crew/general techs	Vessel platform	Via marine waters  Chart 16713-1	<b>Fish</b> -intertidal spawning-salmon (May-Sept.)  <b>Birds</b> -waterfowl concentrations, eagle nesting, seabird nesting  <b>Marine mammals</b> -otters, seal, sea lions  <b>Habitat</b> -marsh, sheltered rocky shoreline  <b>Human use</b> -high-use recreational area, commercial fishing, wildlife viewing	Vessel master should have local knowledge.  Title 16 Fish Habitat Permit required from ADF&G.  A population of bears is present during salmon runs. A bear guard is required.  Site surveyed: 6/17/09 PWS GRS Tactics Committee.  Tested: (02a) and (02d) tested 09/07/17 SERVS Deployment

<b>Heather Bay-Emerald Cove</b> Lat. 60° 57.04 N Lon. 147° 02.54 W	<b>Deflection</b>  Deflect oil coming from the southwest away from Emerald Cove and back into the channel for free-oil recovery.  If natural deflection is sufficient for Free-oil Recovery, deployment is not necessary.	Deploy boom and anchor system with skiffs (class 6).  Anchor one boom ashore and position the 2x 300 ft. booms in a cascaded fashion at a proper angle to deflect oil from Emerald Cove.  Tend throughout the tide.  Water depth 300 ft. from shore is 75ft. dropping quickly to 150 ft. Based on plotted depths at site, a vessel would be required to tend the water end of the boom set.	<b>Deployment Equipment</b> 600 ft. protected-water boom 5 ea. medium anchor systems 2 ea. Anchor stakes  <b>Vessels/Personnel/Shift</b> Same as NE23-03  <b>Tending Vessels/Personnel/Shift</b> Same as NE23-03	Vessel platform	Via marine waters  Chart 16713-1	Same as NE-23-02	Vessel master should have local knowledge.  Shore access is challenging due to steep, rocky cliffs.  Tested: 09/07/17 SERVS Deployment
