# Cook Inlet Risk Assessment FINAL REPORT

*Prepared by:* Nuka Research and Planning Group, LLC  
and Pearson Consulting, LLC

The Cook Inlet Risk Assessment (CIRA) was initiated and led by the Alaska Department of Environmental Conservation, U.S. Coast Guard, and Cook Inlet Regional Citizens Advisory Council (Cook Inlet RCAC) from 2011-2014. These parties comprised the Management Team for the project. A multi-stakeholder Advisory Panel provided input throughout the process.

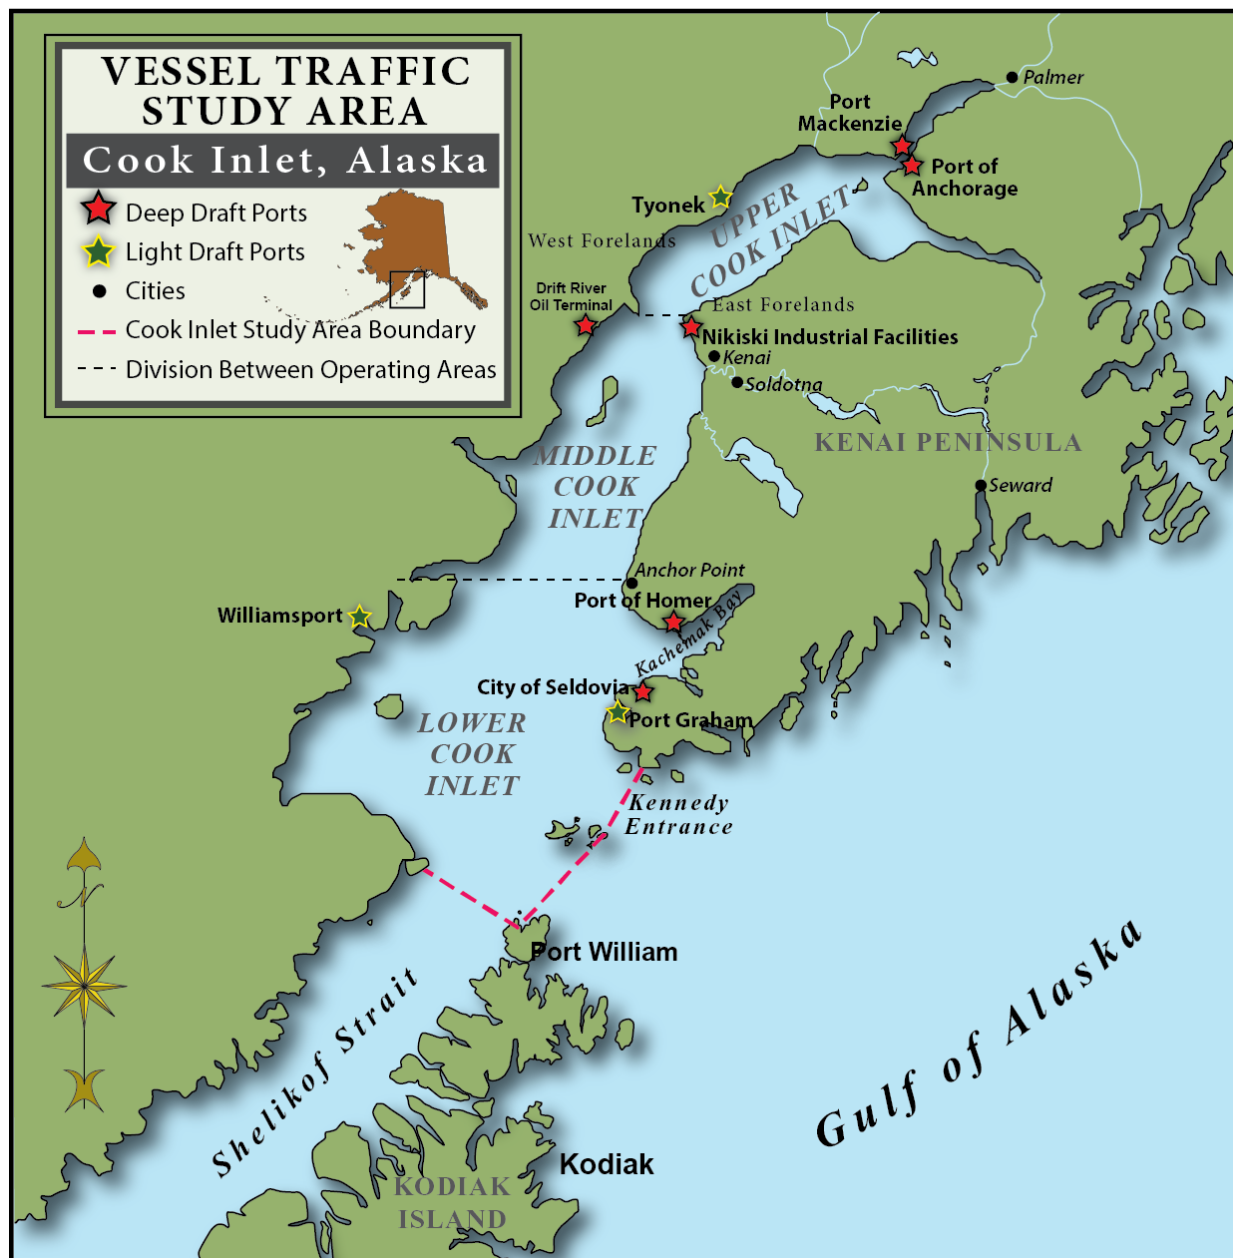
Figure 1. Map of Cook Inlet, including study area boundaries and operating areas

The CIRA focused on the marine waters and coastal areas of Cook Inlet as defined in regulation<sup>2</sup> and shown in Figure 1. Cook Inlet has some of the most extreme tides in the world and is home to commercial and recreational fisheries; petroleum exploration, extraction, and transport; tourism; subsistence use; and both endemic and migratory birds and wildlife. More than 40% of Alaska's population lives in the Cook Inlet region and the vast majority of the state's commodities and goods are shipped through its ports. Conditions and activities vary across the Inlet's operating areas, which are defined as: Lower, Middle, and Upper. These are shown in Figure 1.

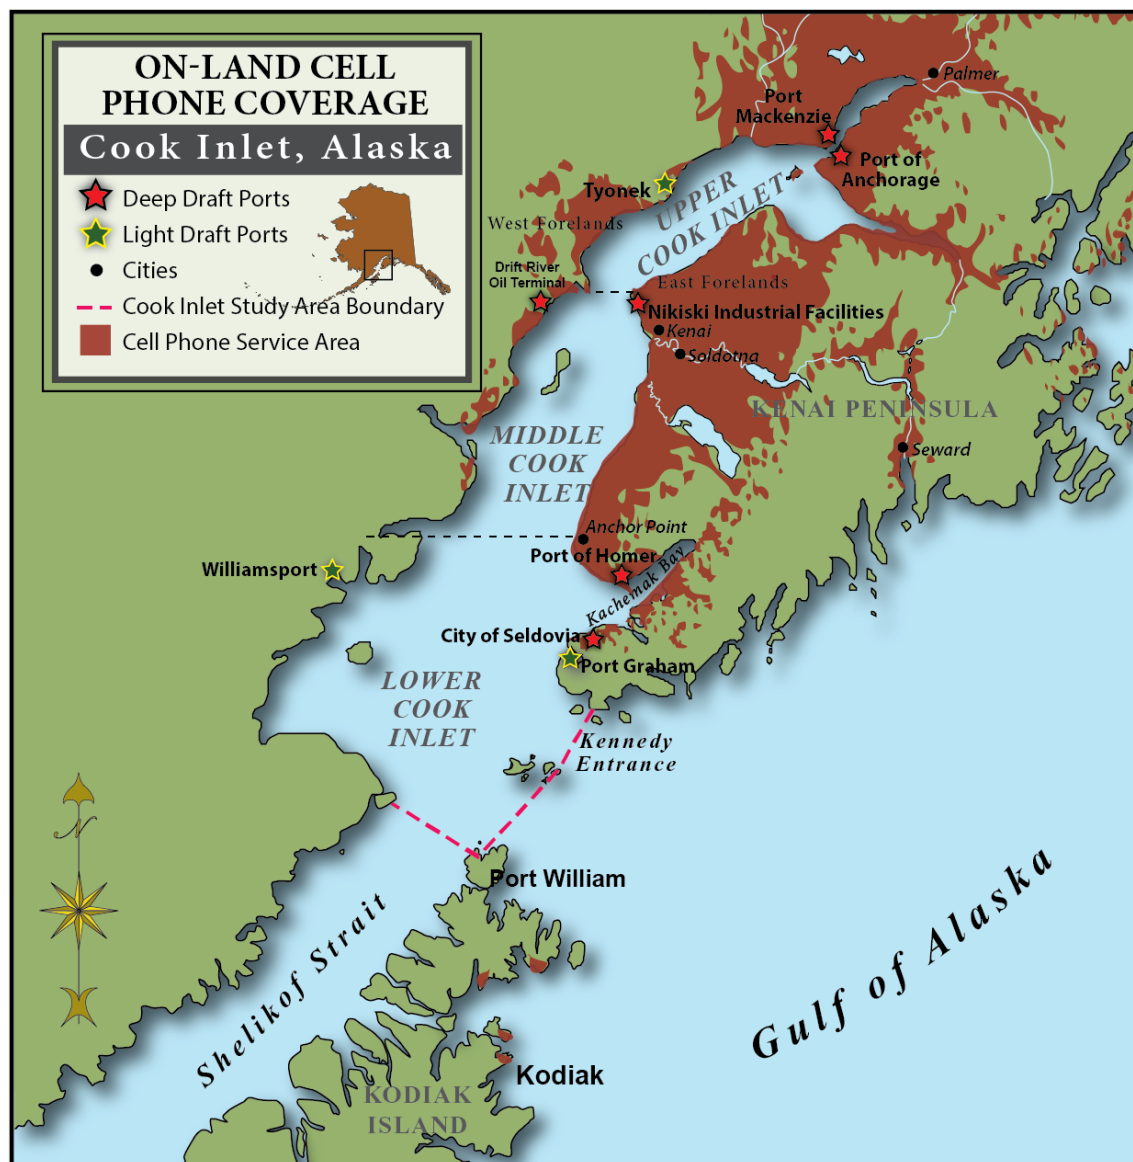
**Figure 6. Generalized on-land cell coverage area, based on Verizon Wireless (Verizon, 2013)**

The cellular providers decide to put in new towers or enhance existing towers if they believe it will expand their customer base. One option for expanding coverage is to use a repeater either on a vessel or (if coverage reaches far enough) a platform near the shipping route. Currently, vessels do not use repeaters as use of cellular phones is discouraged in safety management systems.

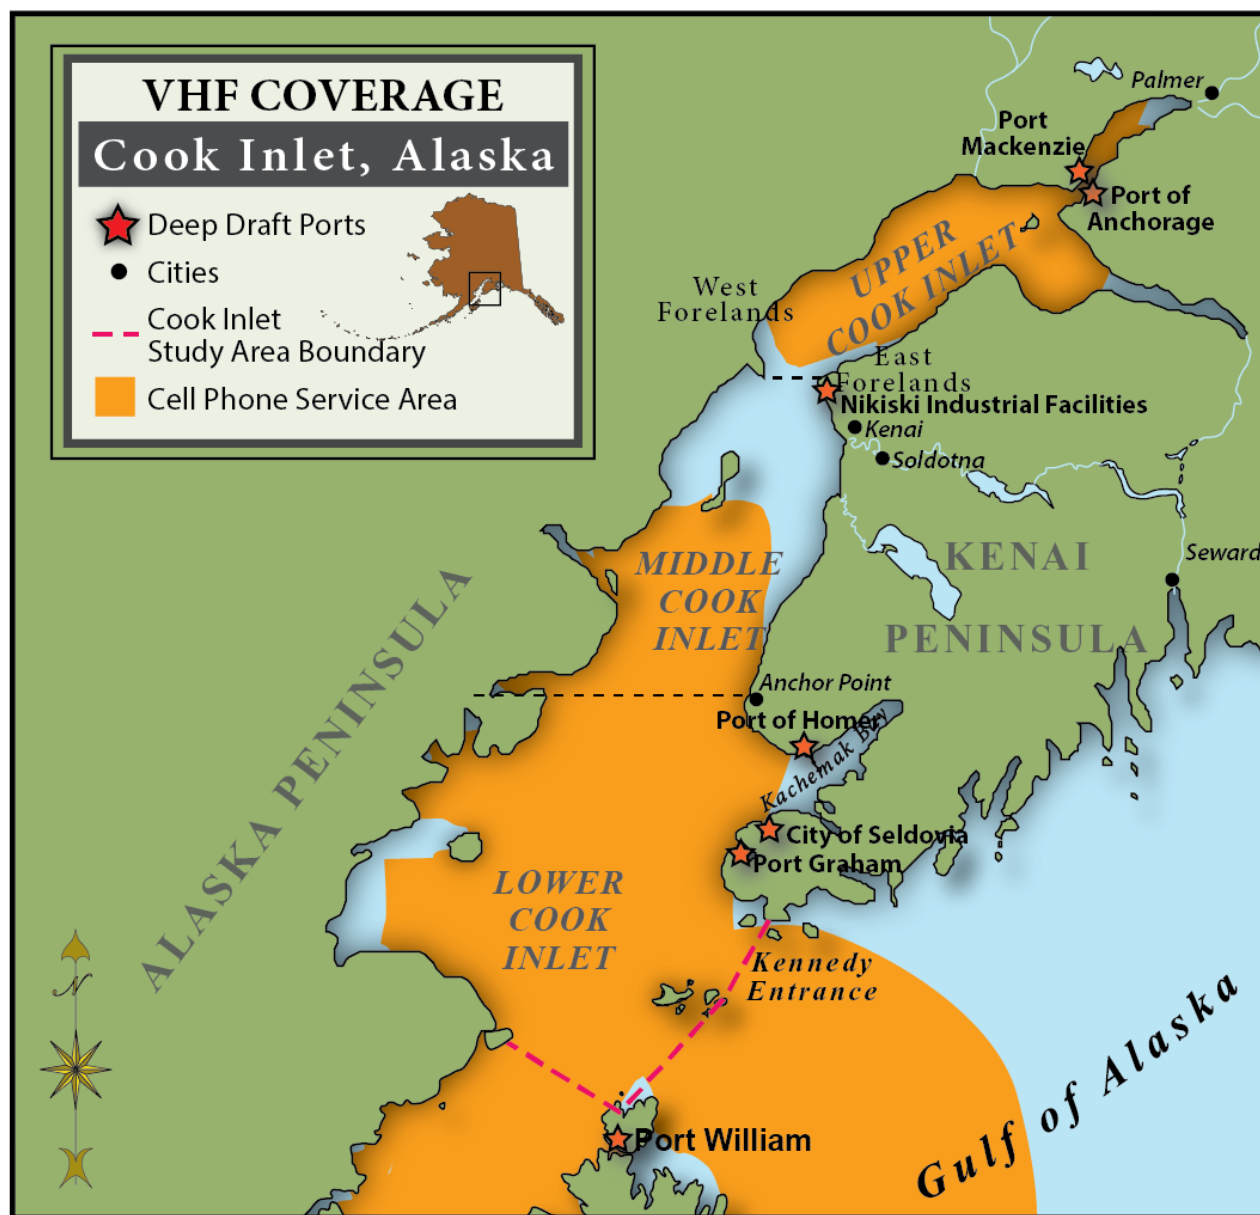
Figure 7. U.S. Coast Guard VHF coverage in Cook Inlet based on a vessel with one watt (based on information provided by USCG Sector Anchorage)

The U.S. Coast Guard maintains VHF stations on shore to facilitate communications between vessels and shore-based resources. Stations serving the Inlet provide coverage for much of the Upper and Lower Cook Inlet areas. However, there is a gap in coverage for vessels operating in the northern part of the Middle Cook Inlet area, up to and just past the Forelands. The gap, portrayed in Figure 7, will vary depending on the size and the power of the vessel's VHF radio.

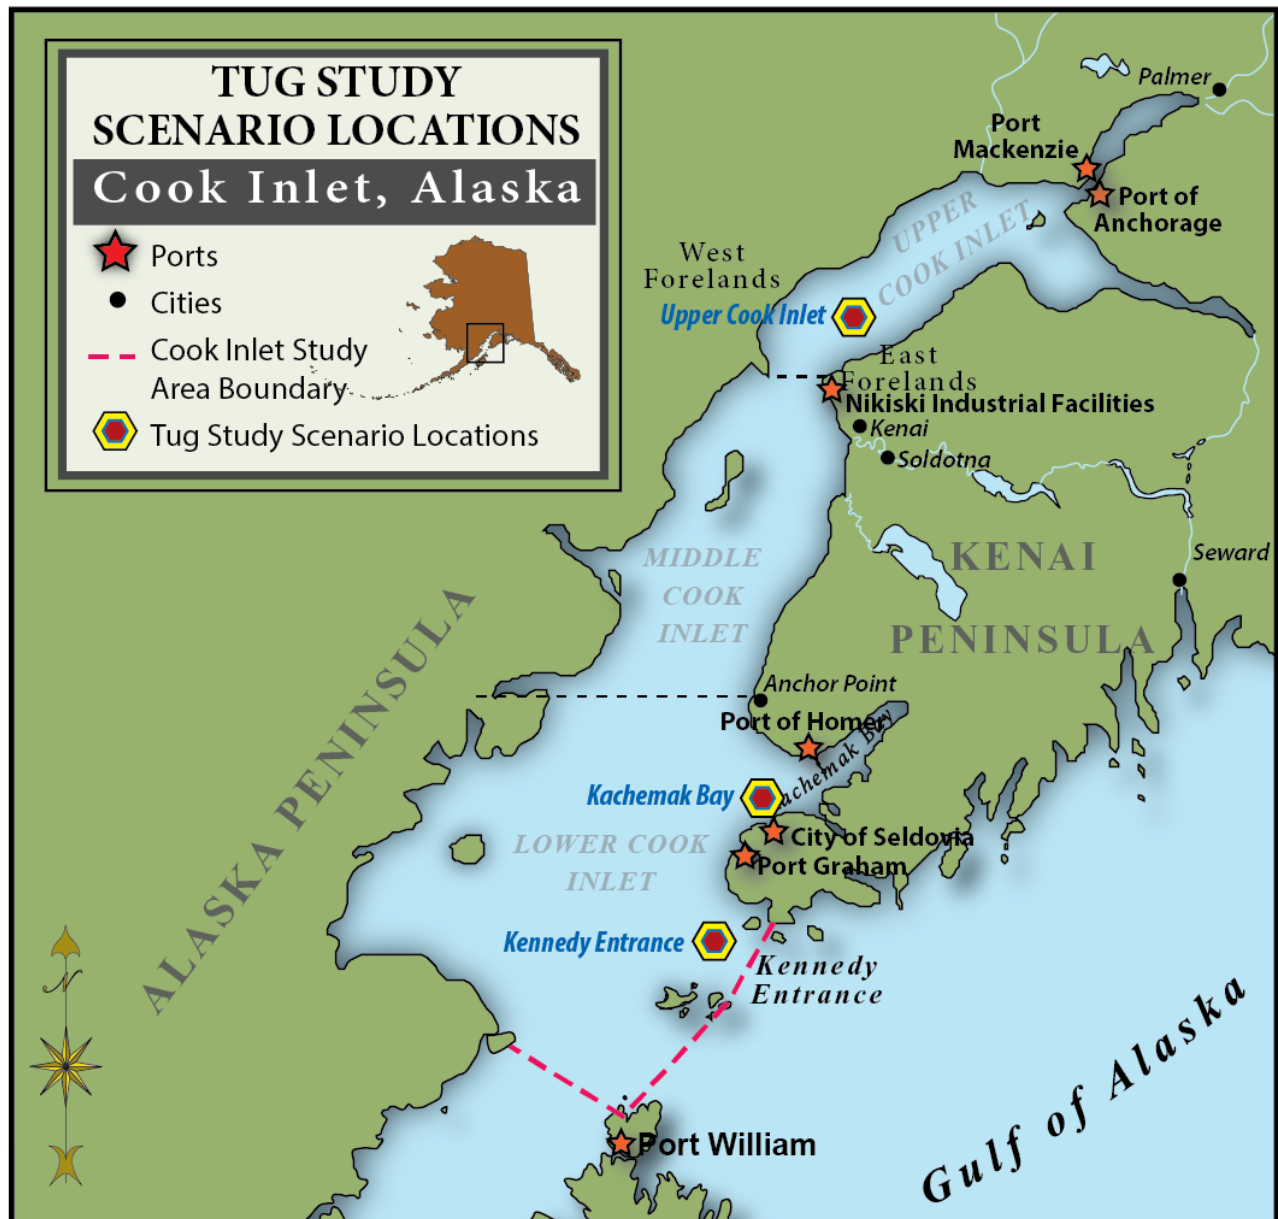
Figure 9. Three scenario locations for Cook Inlet towing analysis

The *Evaluation of 2012 Tugboat Response Times* (The Glosten Associates, 2013b) estimated the minimum bollard pull required to control a disabled vessel, assuming the rescue vessel arrests the drift of the disabled vessel and turns it into the direction of the prevailing drift (gain control and arrest its drift). The estimated minimum bollard pull is derived from the scenario conditions summarized in Table 6 and depicted in Figure 9.

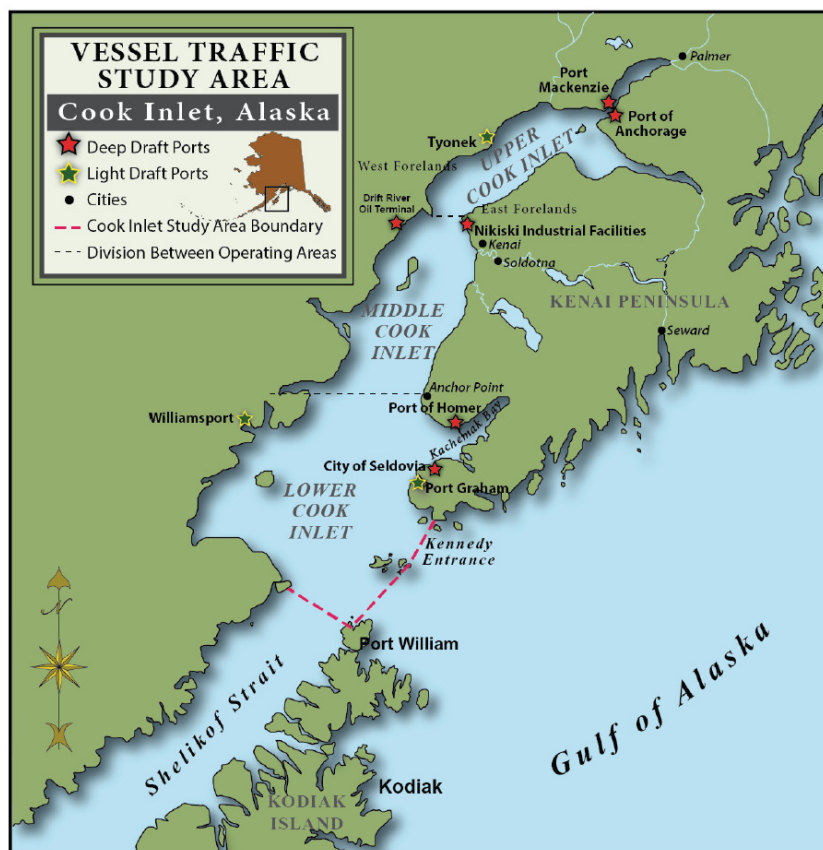
**Figure 1.2: Map of Cook Inlet Areas**

Figure 1.2 includes a map showing the Cook Inlet Areas.

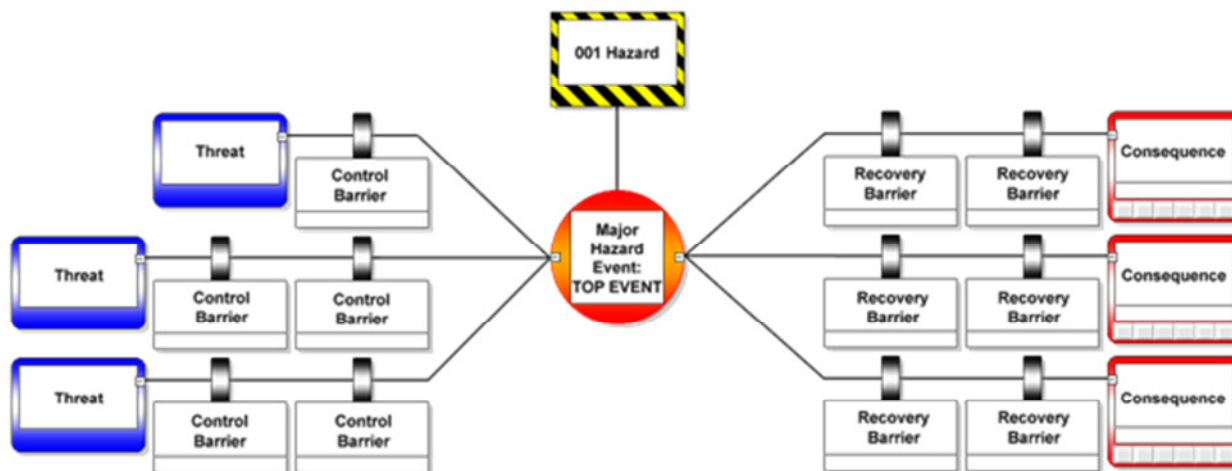
Figure 3.1: Example Bowtie Diagram

A stylized BTM is illustrated in Figure 3.1

BTM are now widely accepted as being a highly effective means of illustrating the causes, outcomes and preventative/mitigative controls associated with major accident events. The CIRA report would have benefited from presenting the characteristics of the oil spill events in this manner.
