Final Groundwater Sampling of AP-6573B Report

Fairbanks Environmental Services

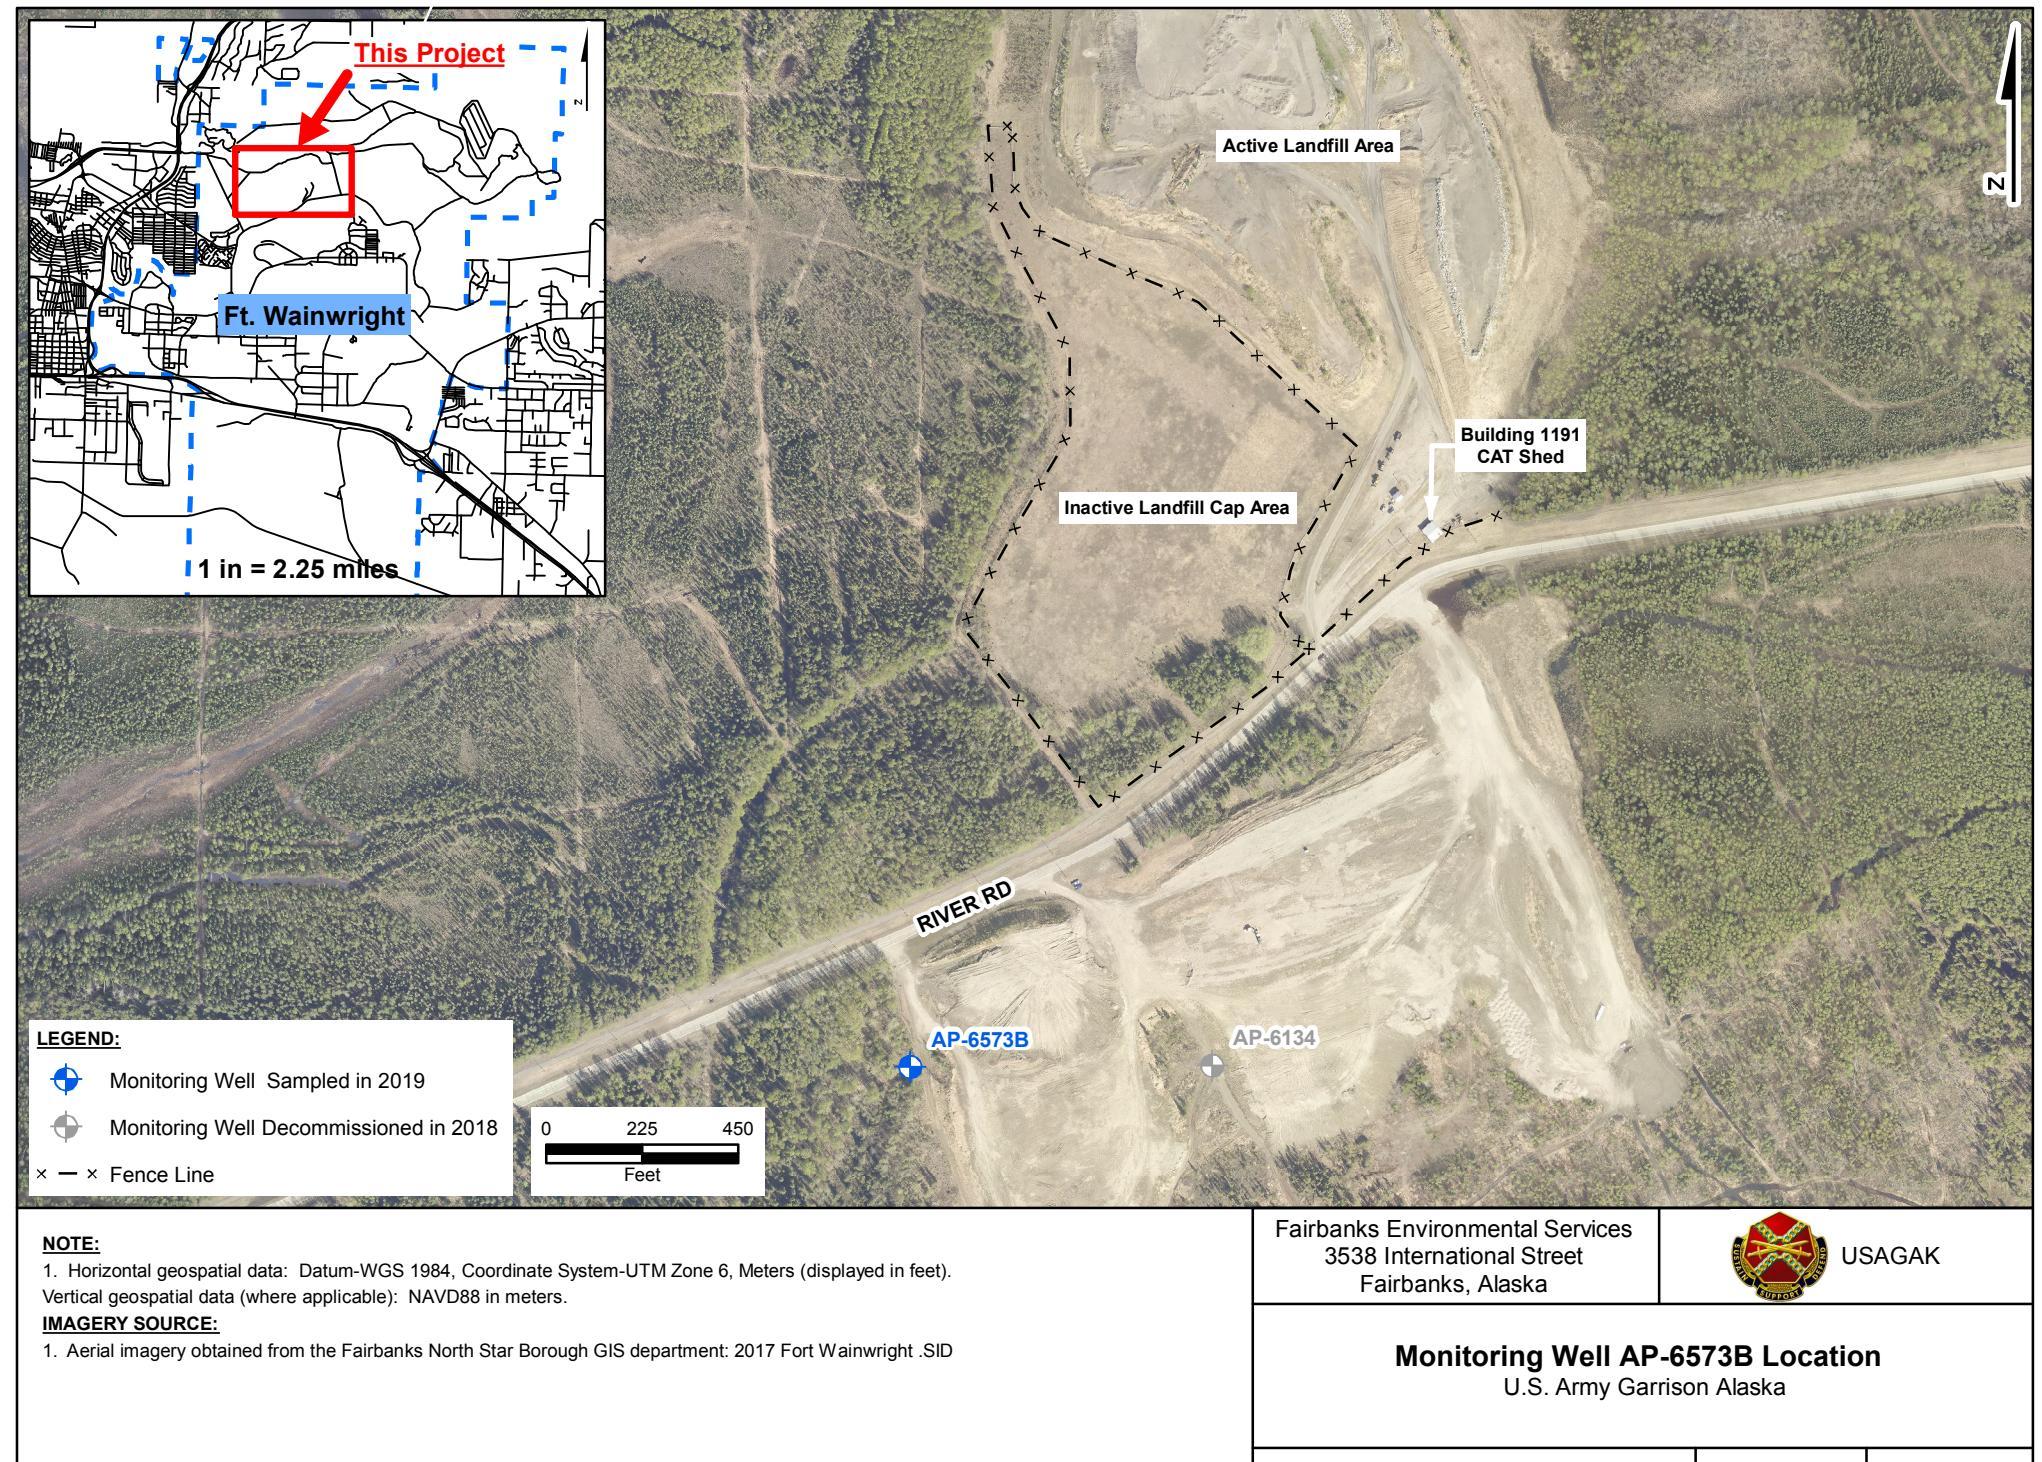
Figure 1 Monitoring Well AP-6573B Location

This report documents groundwater sampling of monitoring well AP-6573B located south of the landfill on Fort Wainwright, Alaska. The well location is shown in Figure 1.

A nearby former well, AP-6134 (also shown on Figure 1) was sampled in 2018 and subsequently decommissioned. Results of AP-6134 were documented in a memorandum (U.S. Army Corps of Engineers [USACE], 2019). Due to some data quality concerns relating to AP-6134, the Alaska Department of Environmental Conservation (ADEC) requested that another nearby well be sampled.

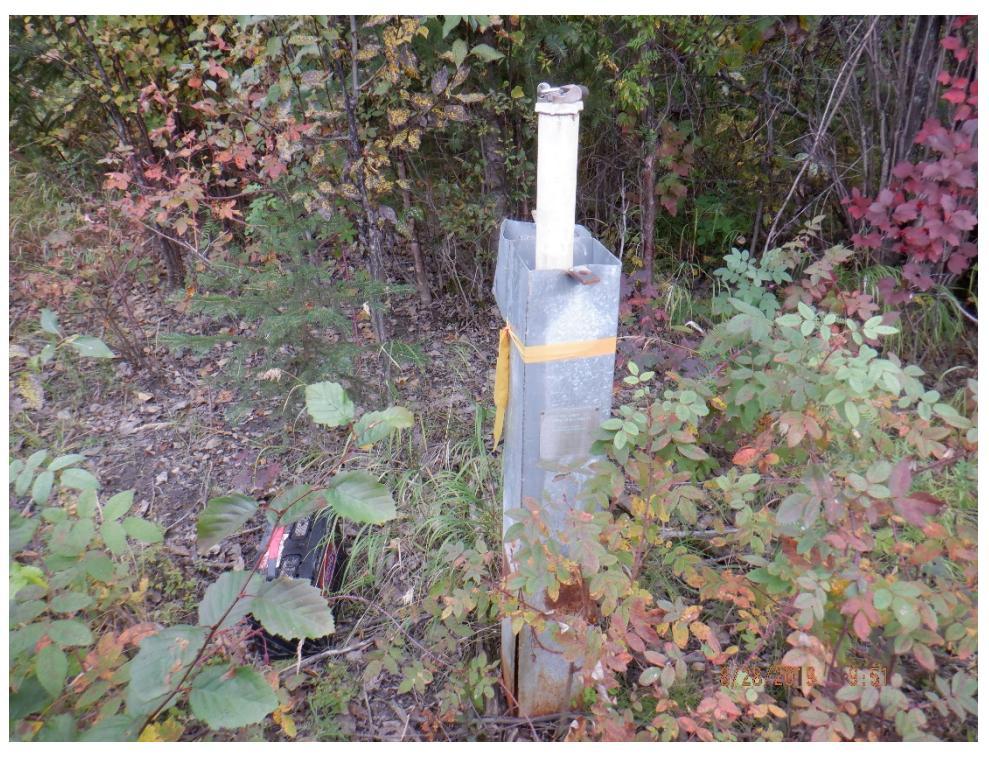
Photo 1 – AP-6573B Shown Frost Jack out of Casing

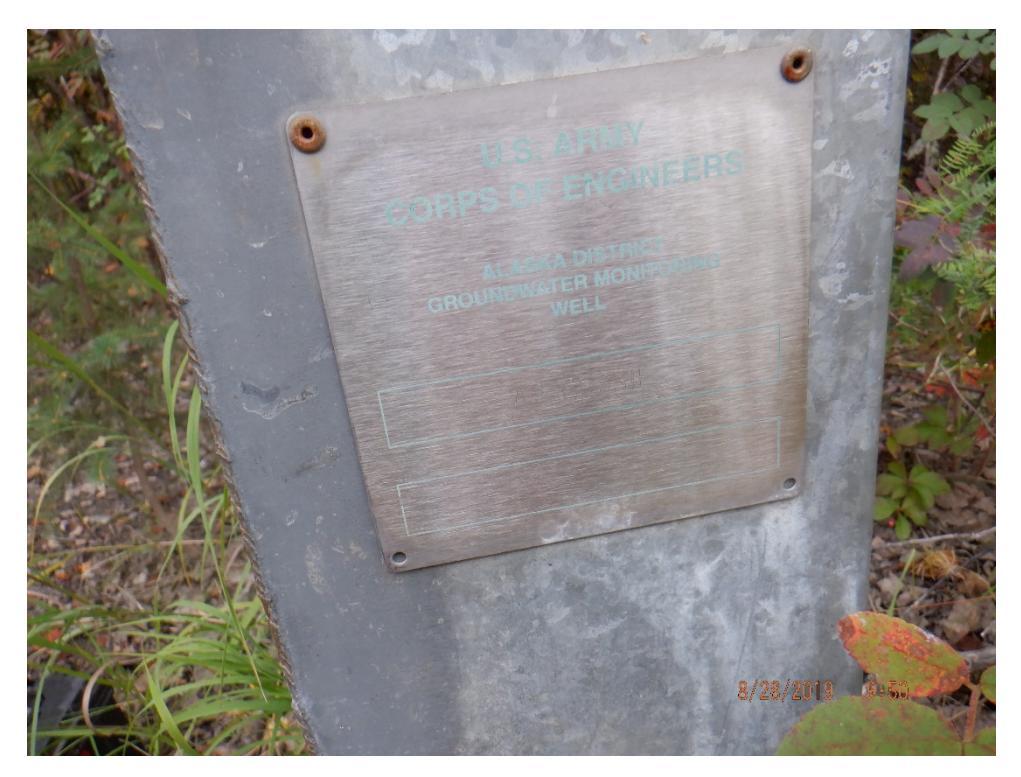
Photo 2 – Closeup of AP-6573B Name Plate

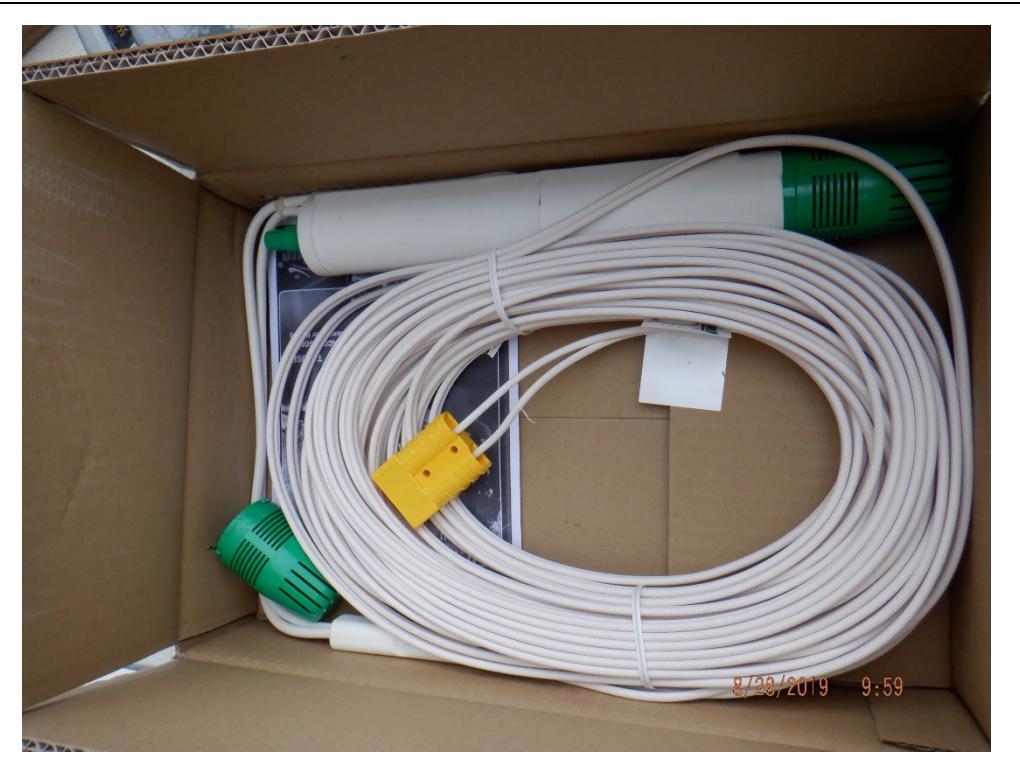
Photo 3 – Submersible pump used to sample AP-6573B

A groundwater sample was collected from AP-6573B on August 28, 2019. The groundwater sample was collected using a submersible pump; low-flow procedures were used to purge and sample the well at a rate between 0.03 and 0.15 gallons per minute. The samples were collected upon achieving the stabilization criteria identified in the ADEC Field Sampling Guidance (ADEC, 2019). The groundwater sample was collected by Chris Boese, an ADEC-qualified sampler.

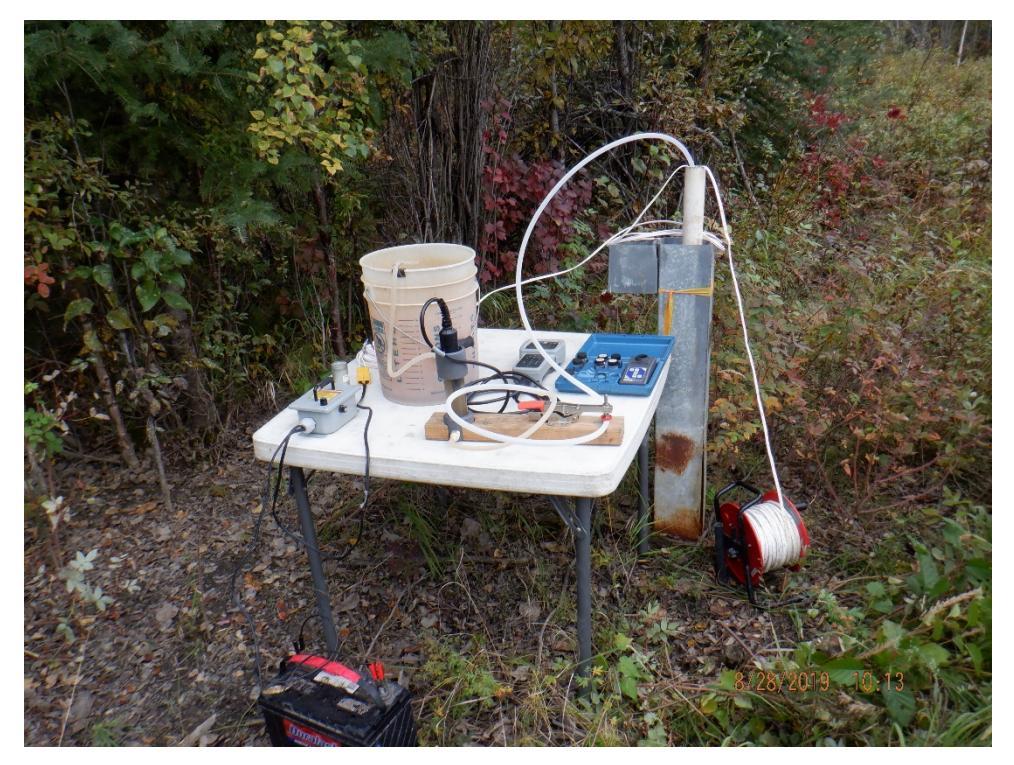
Photo 4 – Groundwater sampling AP-6573B

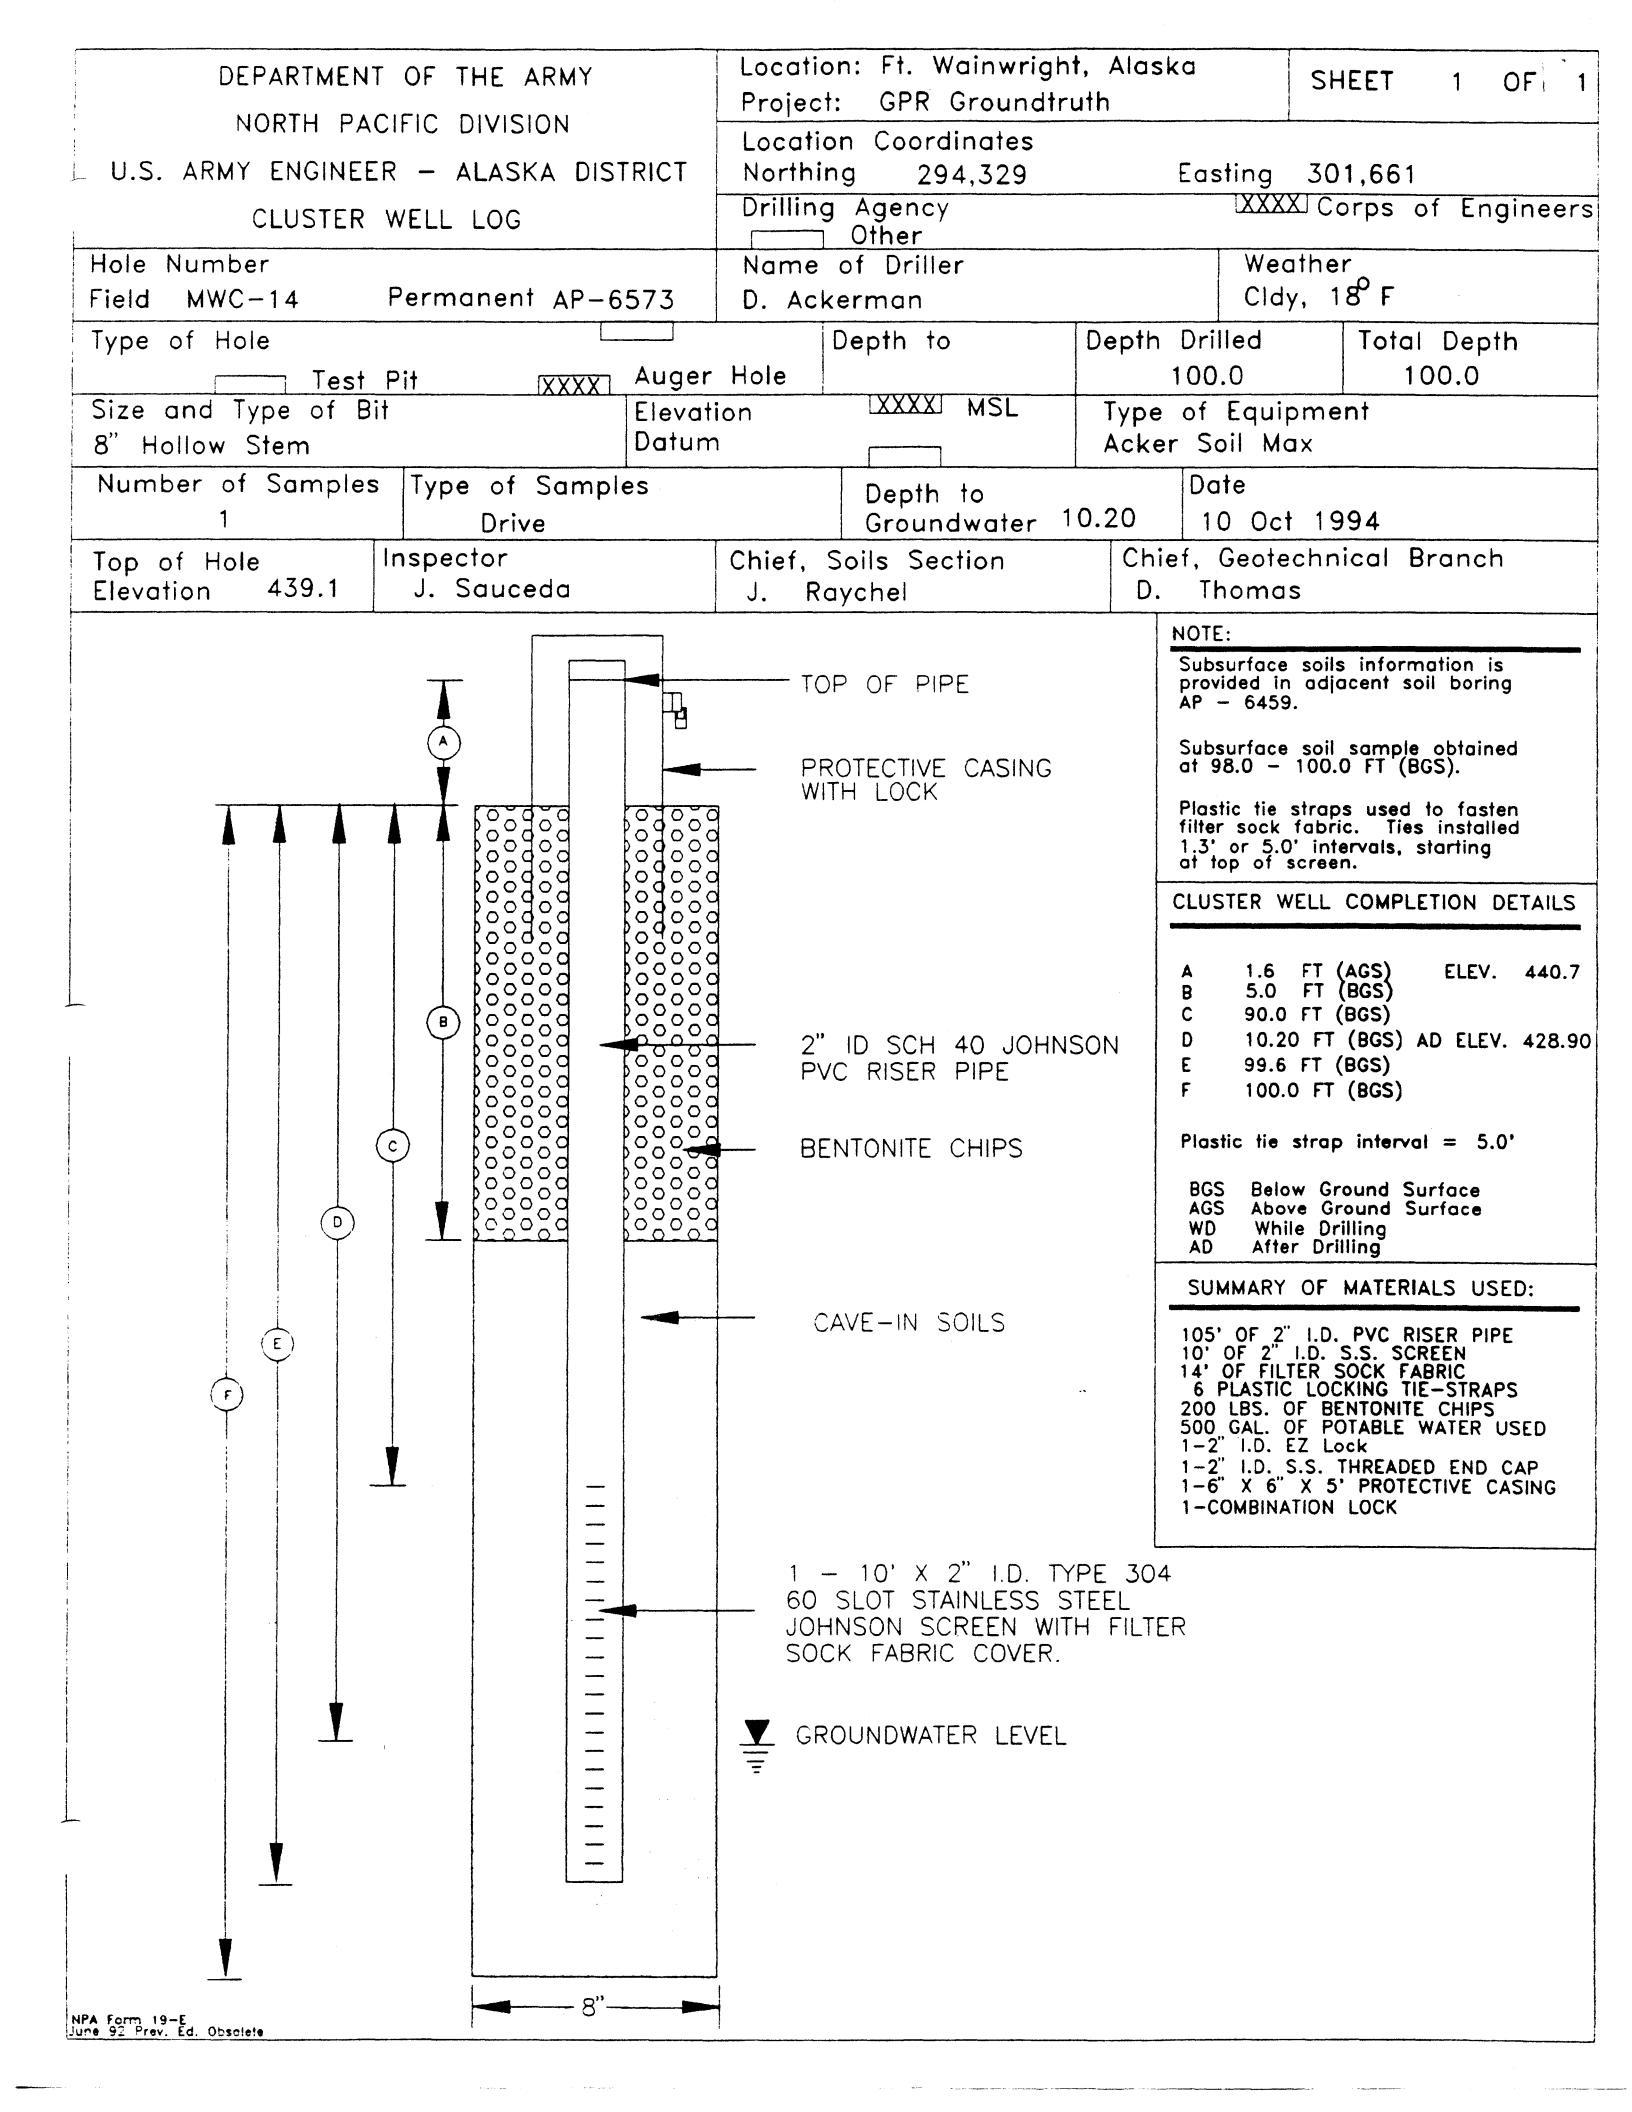
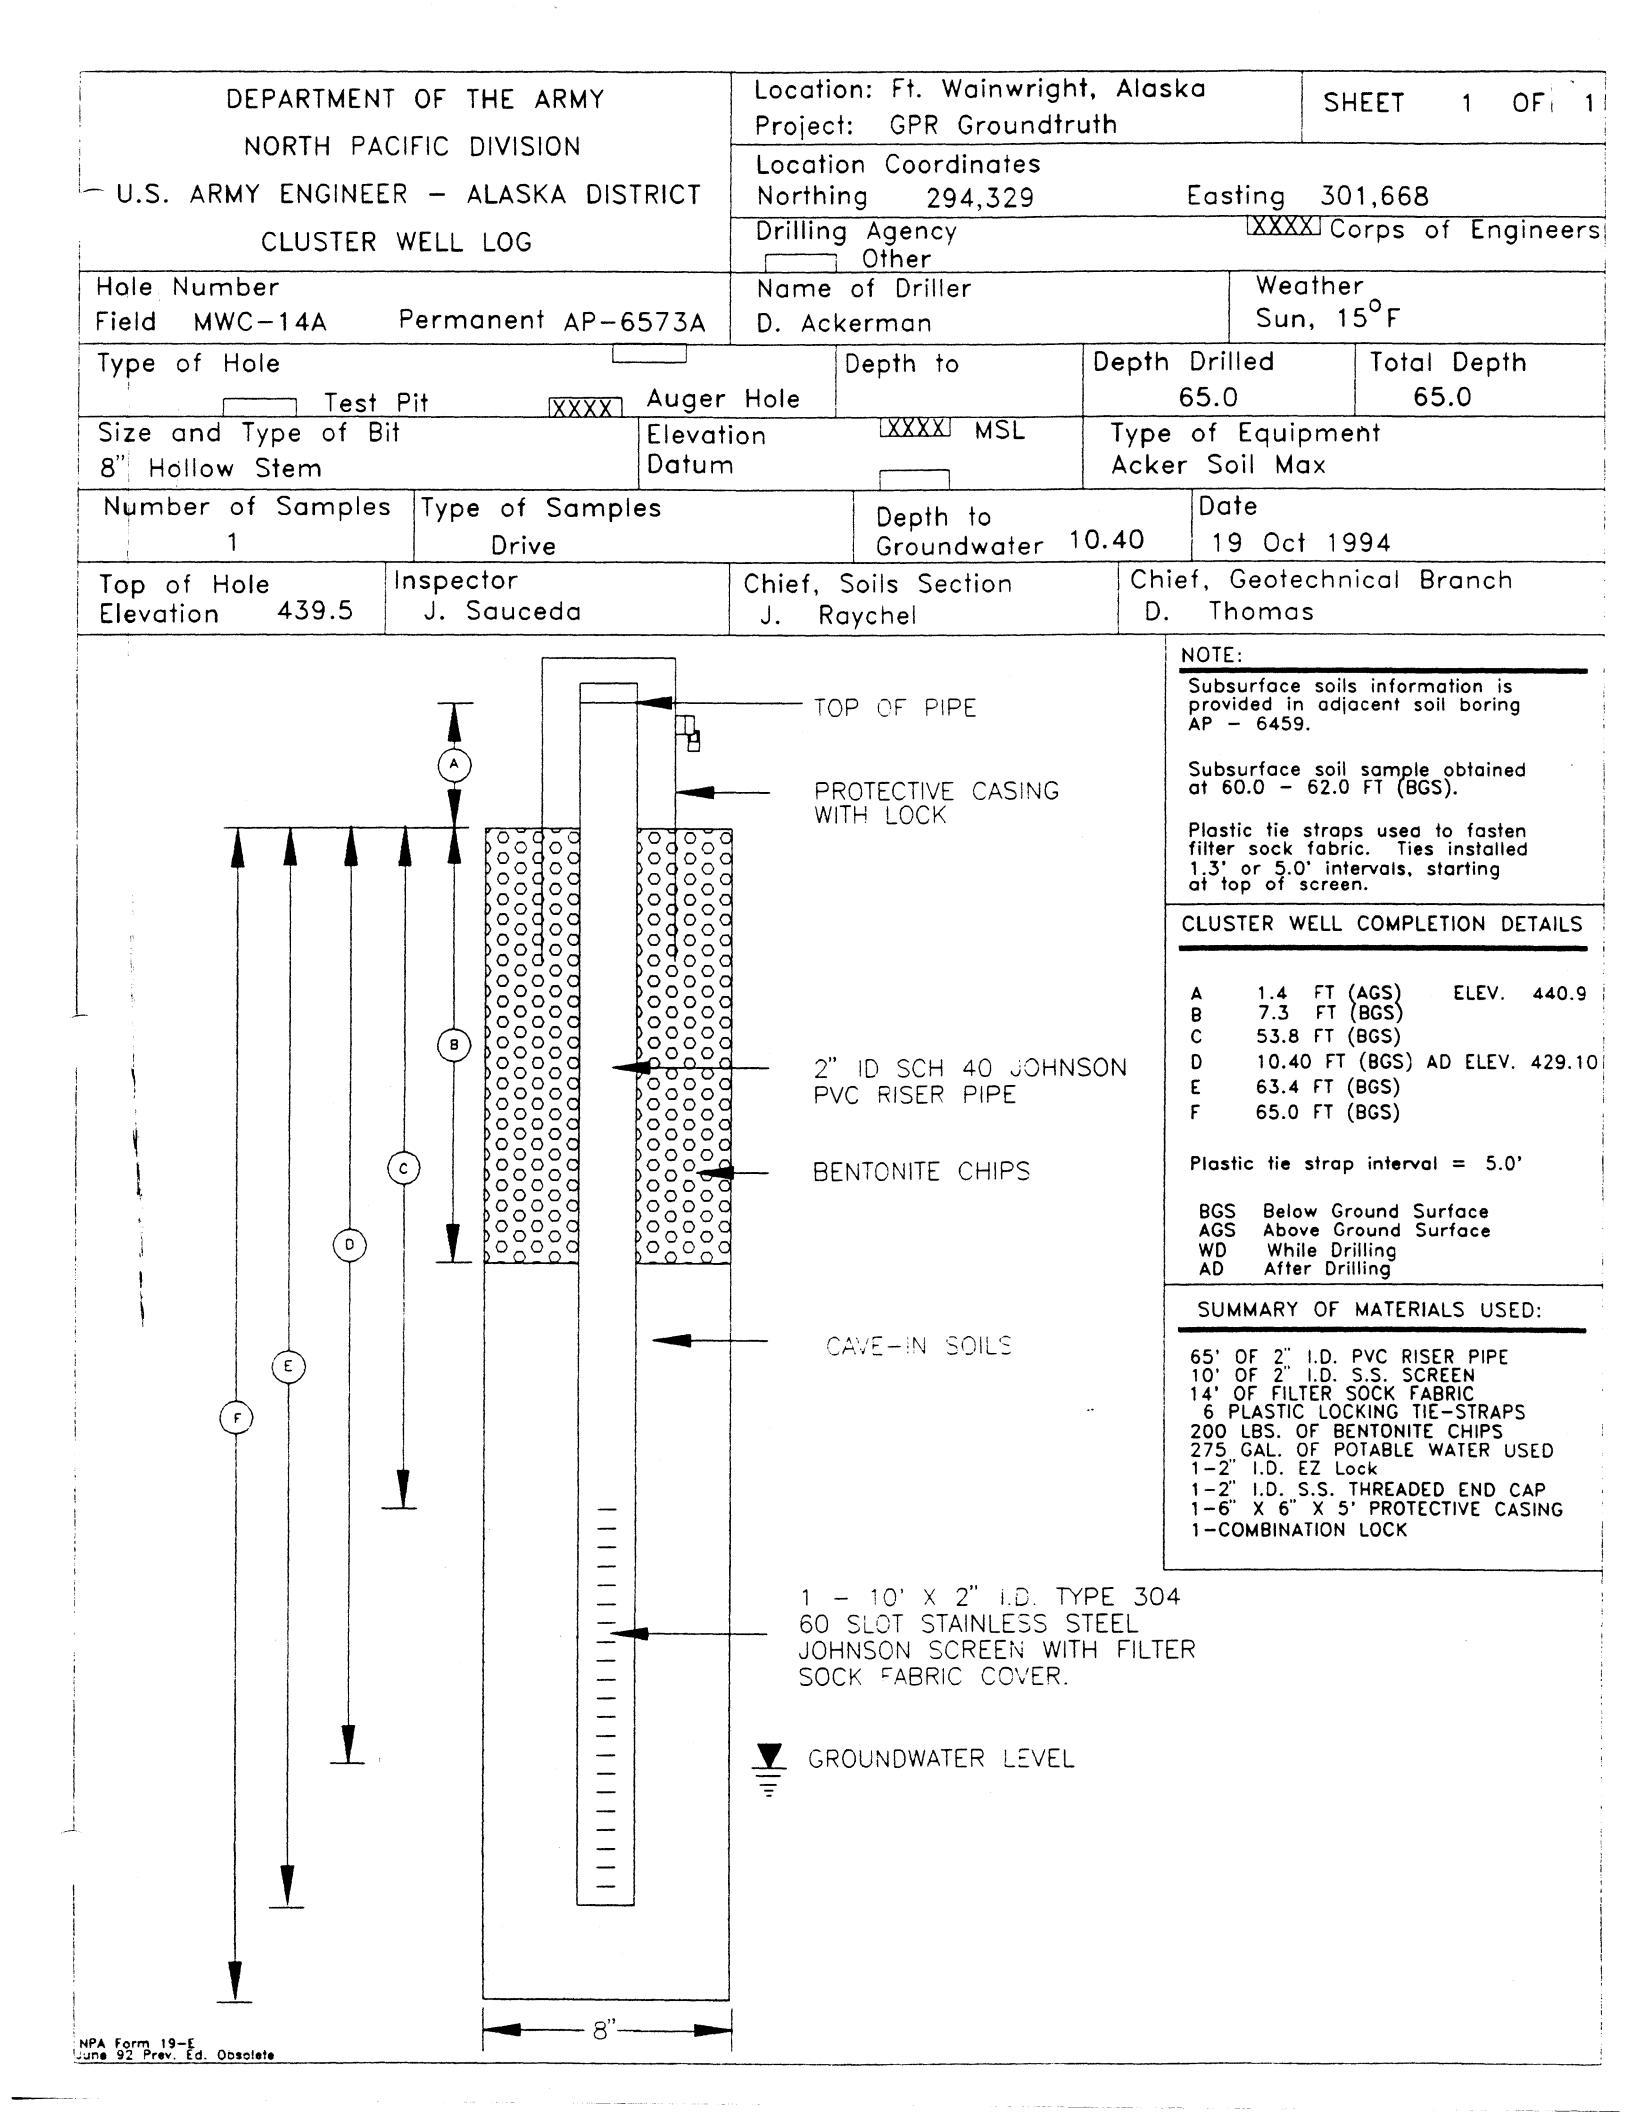
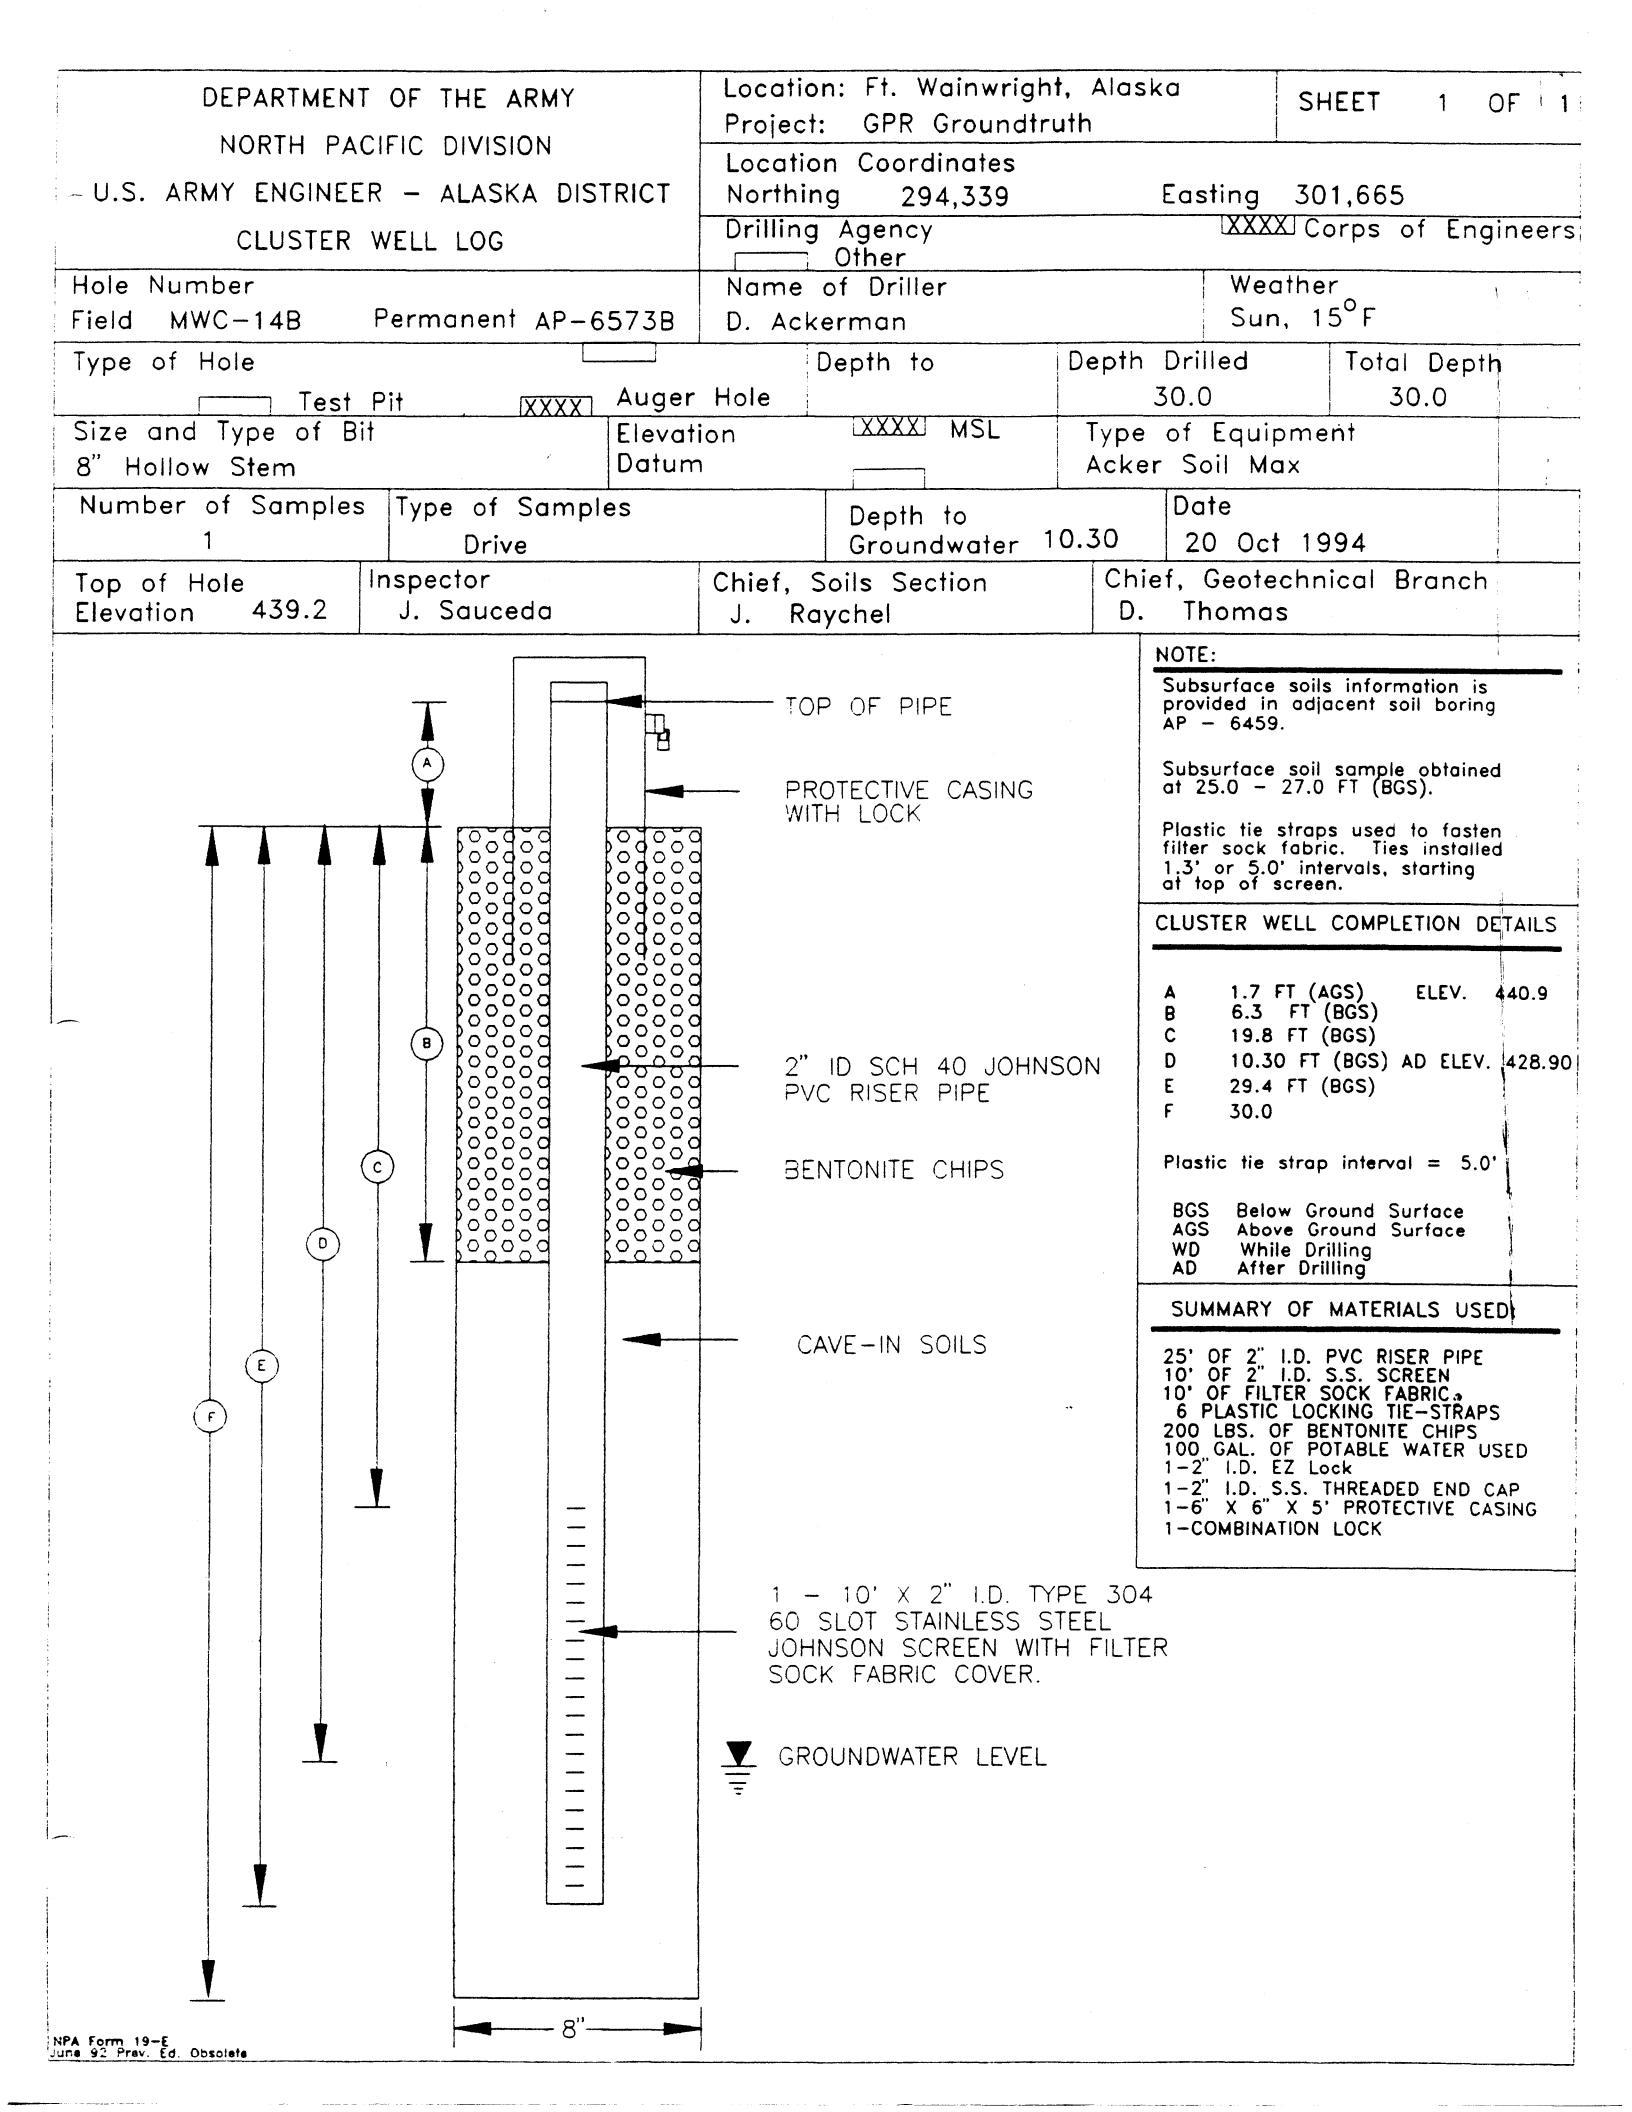
APPENDIX C WELLS LOG

Monitoring well AP-6573B was installed in 1994 and was the shallowest of three cluster wells. AP-6573 and AP-6573A were decommissioned in 2017. AP-6573B is screened below the water table at a depth of approximately 20 feet below ground surface (bgs) to 30 feet bgs. AP-6573A was an intermediate well screened from approximately 54 to 64 feet bgs. The deepest well was AP-6573 that was screened from approximately 90 to 100 feet bgs. The wells were installed as part of a permafrost and groundwater flow study in the vicinity of the landfill. It is unknown if the wells were ever sampled. The AP-6573, AP-6573A, and AP-6573B well logs are included in Appendix C.
