ALASKA DEPARTMENT OF ENVIRONMENTAL CONSERVATION

SITUATION REPORT

BPXA L-1 Test-Header Pipeline Leak

SITREP #: 3 and Final

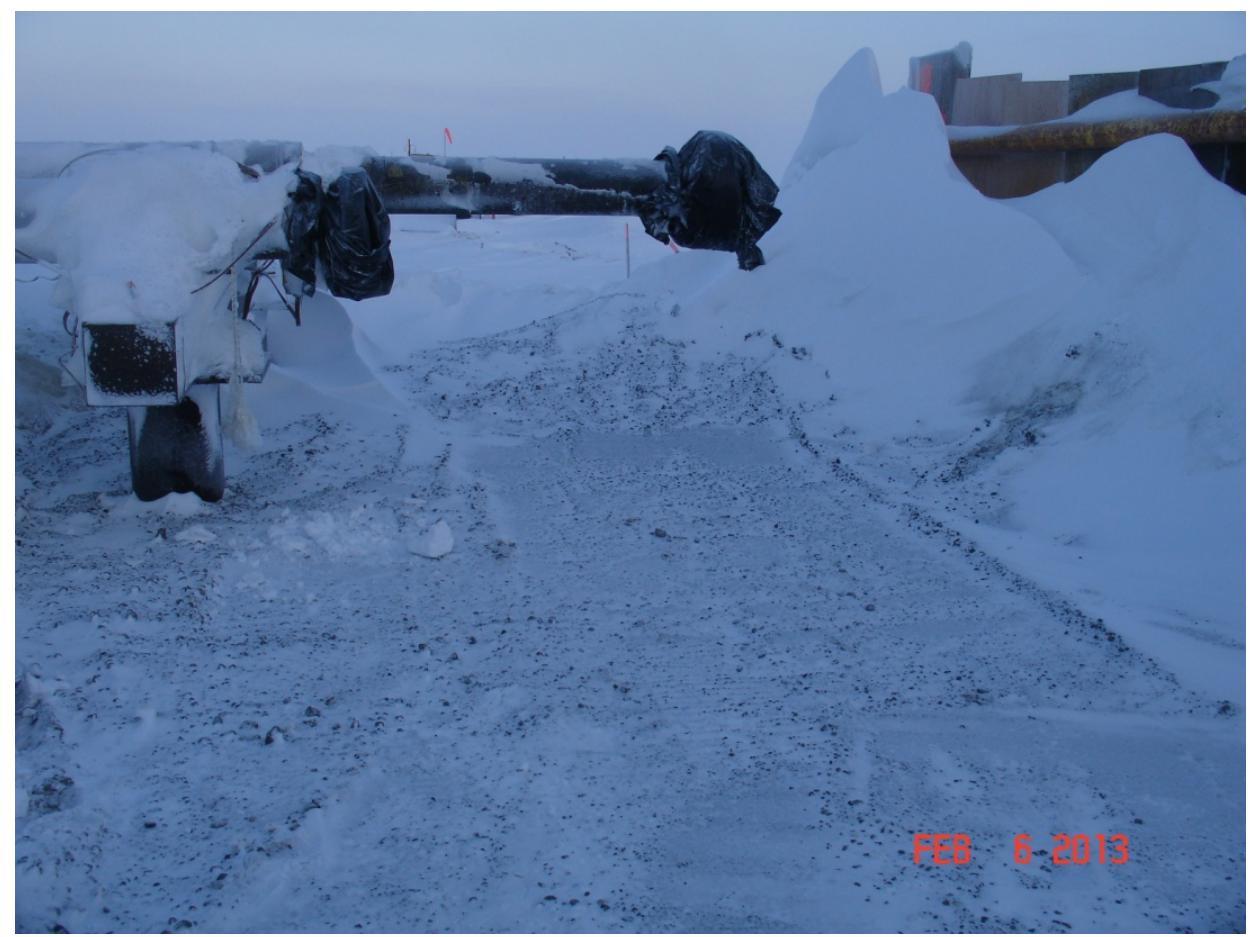
Lisburne Production Center L-1, eight inch test header pipeline – above ground crossing. (ADEC Photo)

BPXA redesigned the pipeline at the road crossing, eliminating some of the 90-degree elbows and changing the pipe profile to elevate the pipeline above water level. Installation of the newly fabricated pipeline segment should be completed in spring, 2013. The test header pipeline has remained out of service.
