REHABILITATION PLAN FOR KUPARUK RIVER STATE, PRUDHOE BAY OILFIELD, ALASKA

FINAL

Prepared by **BP Exploration (Alaska), Inc.** and **ABR, Inc.—Environmental Research and Services** 4 February, 2002

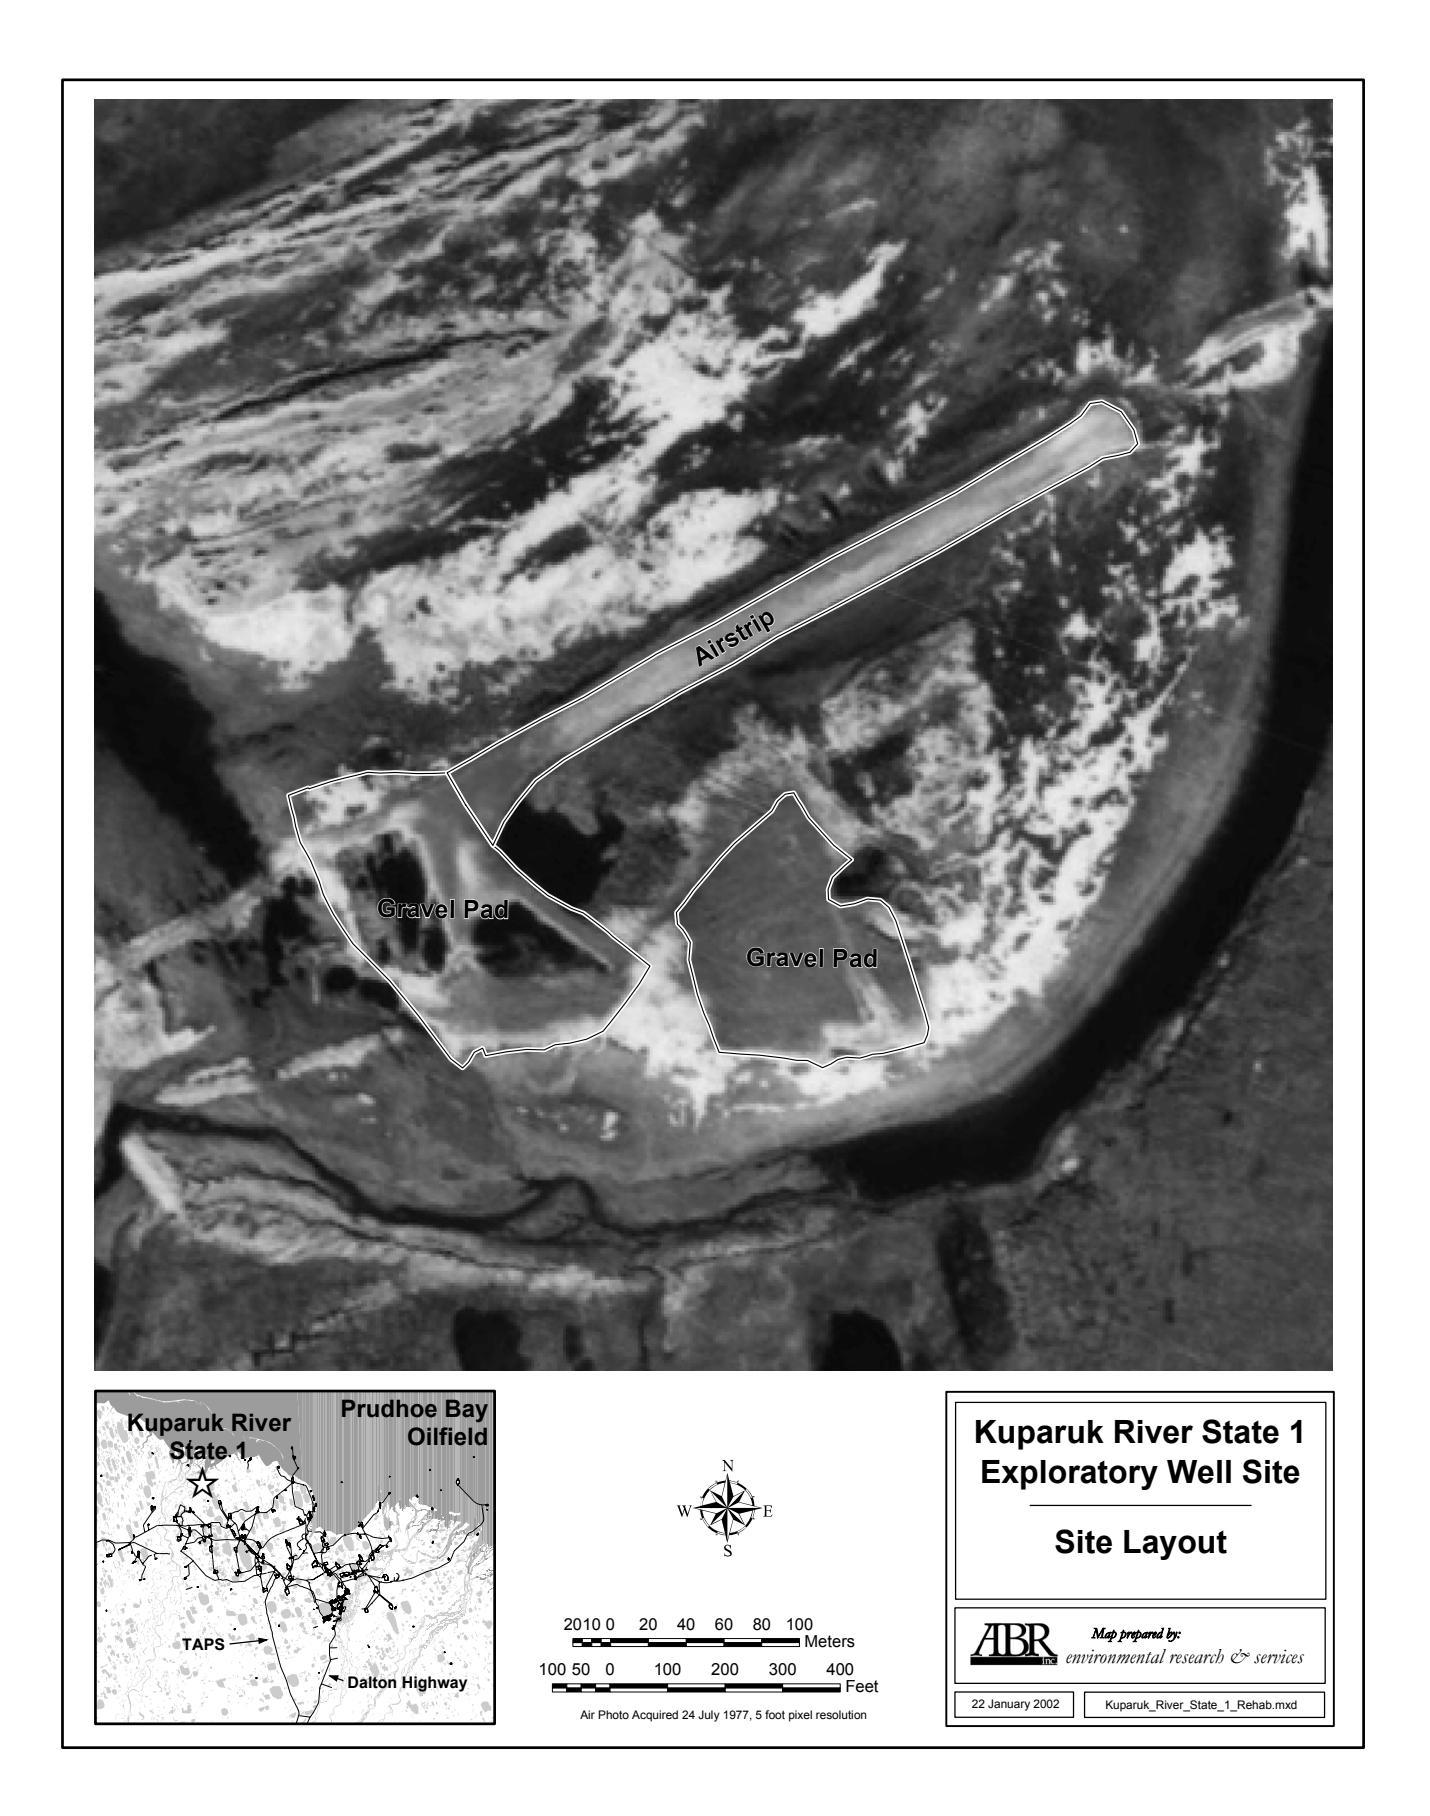
<u>LOCATION</u>: The Kuparuk River State exploratory well site is located within the active floodplain of the Kuparuk River (Figure 1).
