# **Tesoro Alaska Company LLC**

### RE: KLNG Gravity Rock Retaining Wall – Completion Report Tesoro Alaska Company LLC Kenai Refinery EPA ID# AKD 048679682

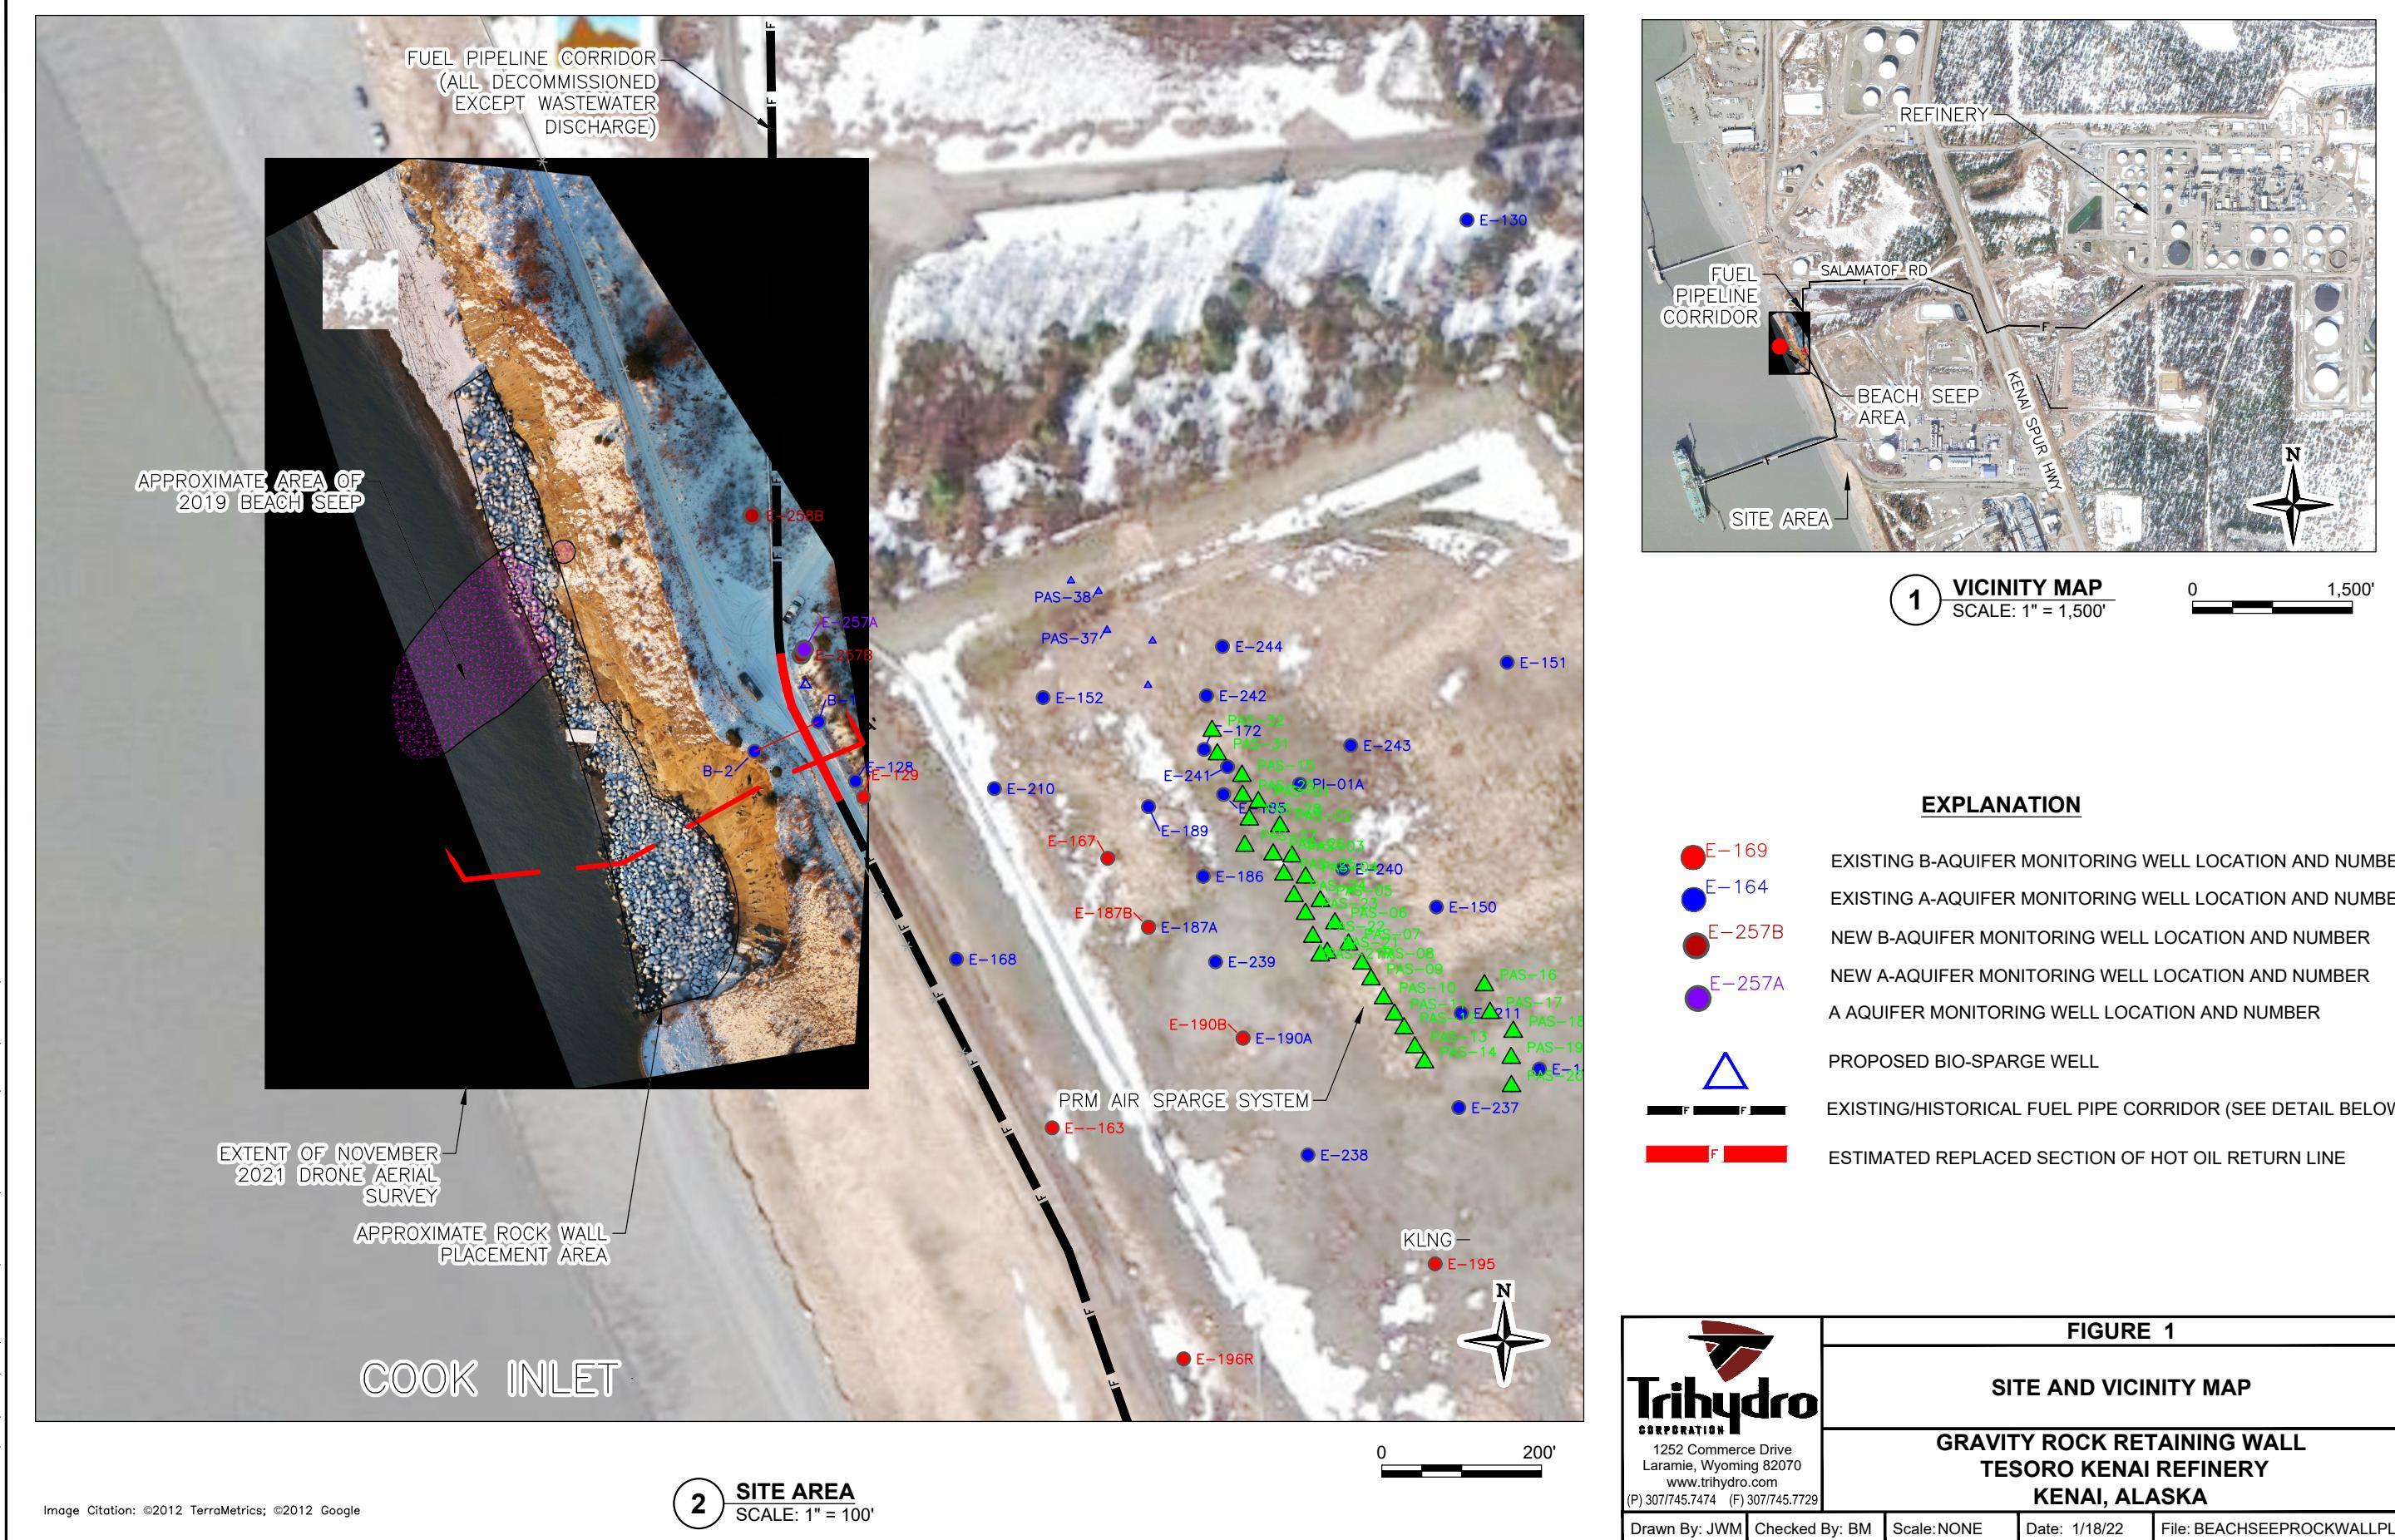
FIGURE 1											
D		SIT	FE AND VICIN									
	GRAVITY ROCK RETAINING WALL											
)		TES	ORO KENAI	REFINERY								
729			KENAI, ALA	ASKA								
ed I	By: BM	Scale:NONE	Date: 1/18/22	File: BEACHSEEPROCKWALLPLAN2021

Tesoro Alaska, LLC (Tesoro) is submitting this Rock Wall Completion Report to update the status of Cook Inlet bluff erosion and sluffing mitigation. The gravity stack boulder rock wall (wall) was constructed at the Kenai Liquified Natural Gas facility (KLNG) bluff from October 28 to November 5, 2021 (Figure 1). An unmanned aerial vehicle (UAV), or drone, survey was conducted on November 16, 2021 to update topographic information from the bluff erosion and compare to a similar survey conducted on October 1 and 2, 2020. A comparison of UAV surveys from 2020 and 2021 is included on Figure 2 along with bluff material loss estimates from topography comparisons.

EXISTING/HISTORICAL FUEL PIPE CORRIDOR (SEE DETAIL BELOW)

Large rocks (2-foot diameter minimum) were placed in a stack to approximately 10- to 15-feet above the beach level. Rocks were placed to 'lock' with each other, as practical, to mimic the effect of a monolithic gravity retaining wall.

Slope of rocks were placed at a maximum slope of approximately 2:1.

Rocks were placed using an excavator with a thumb attachment. Once ice is free from the beach in the spring of 2022, we anticipate rock wall maintenance to reposition rocks that have moved and fill in gaps opened up from winter beach dynamics.

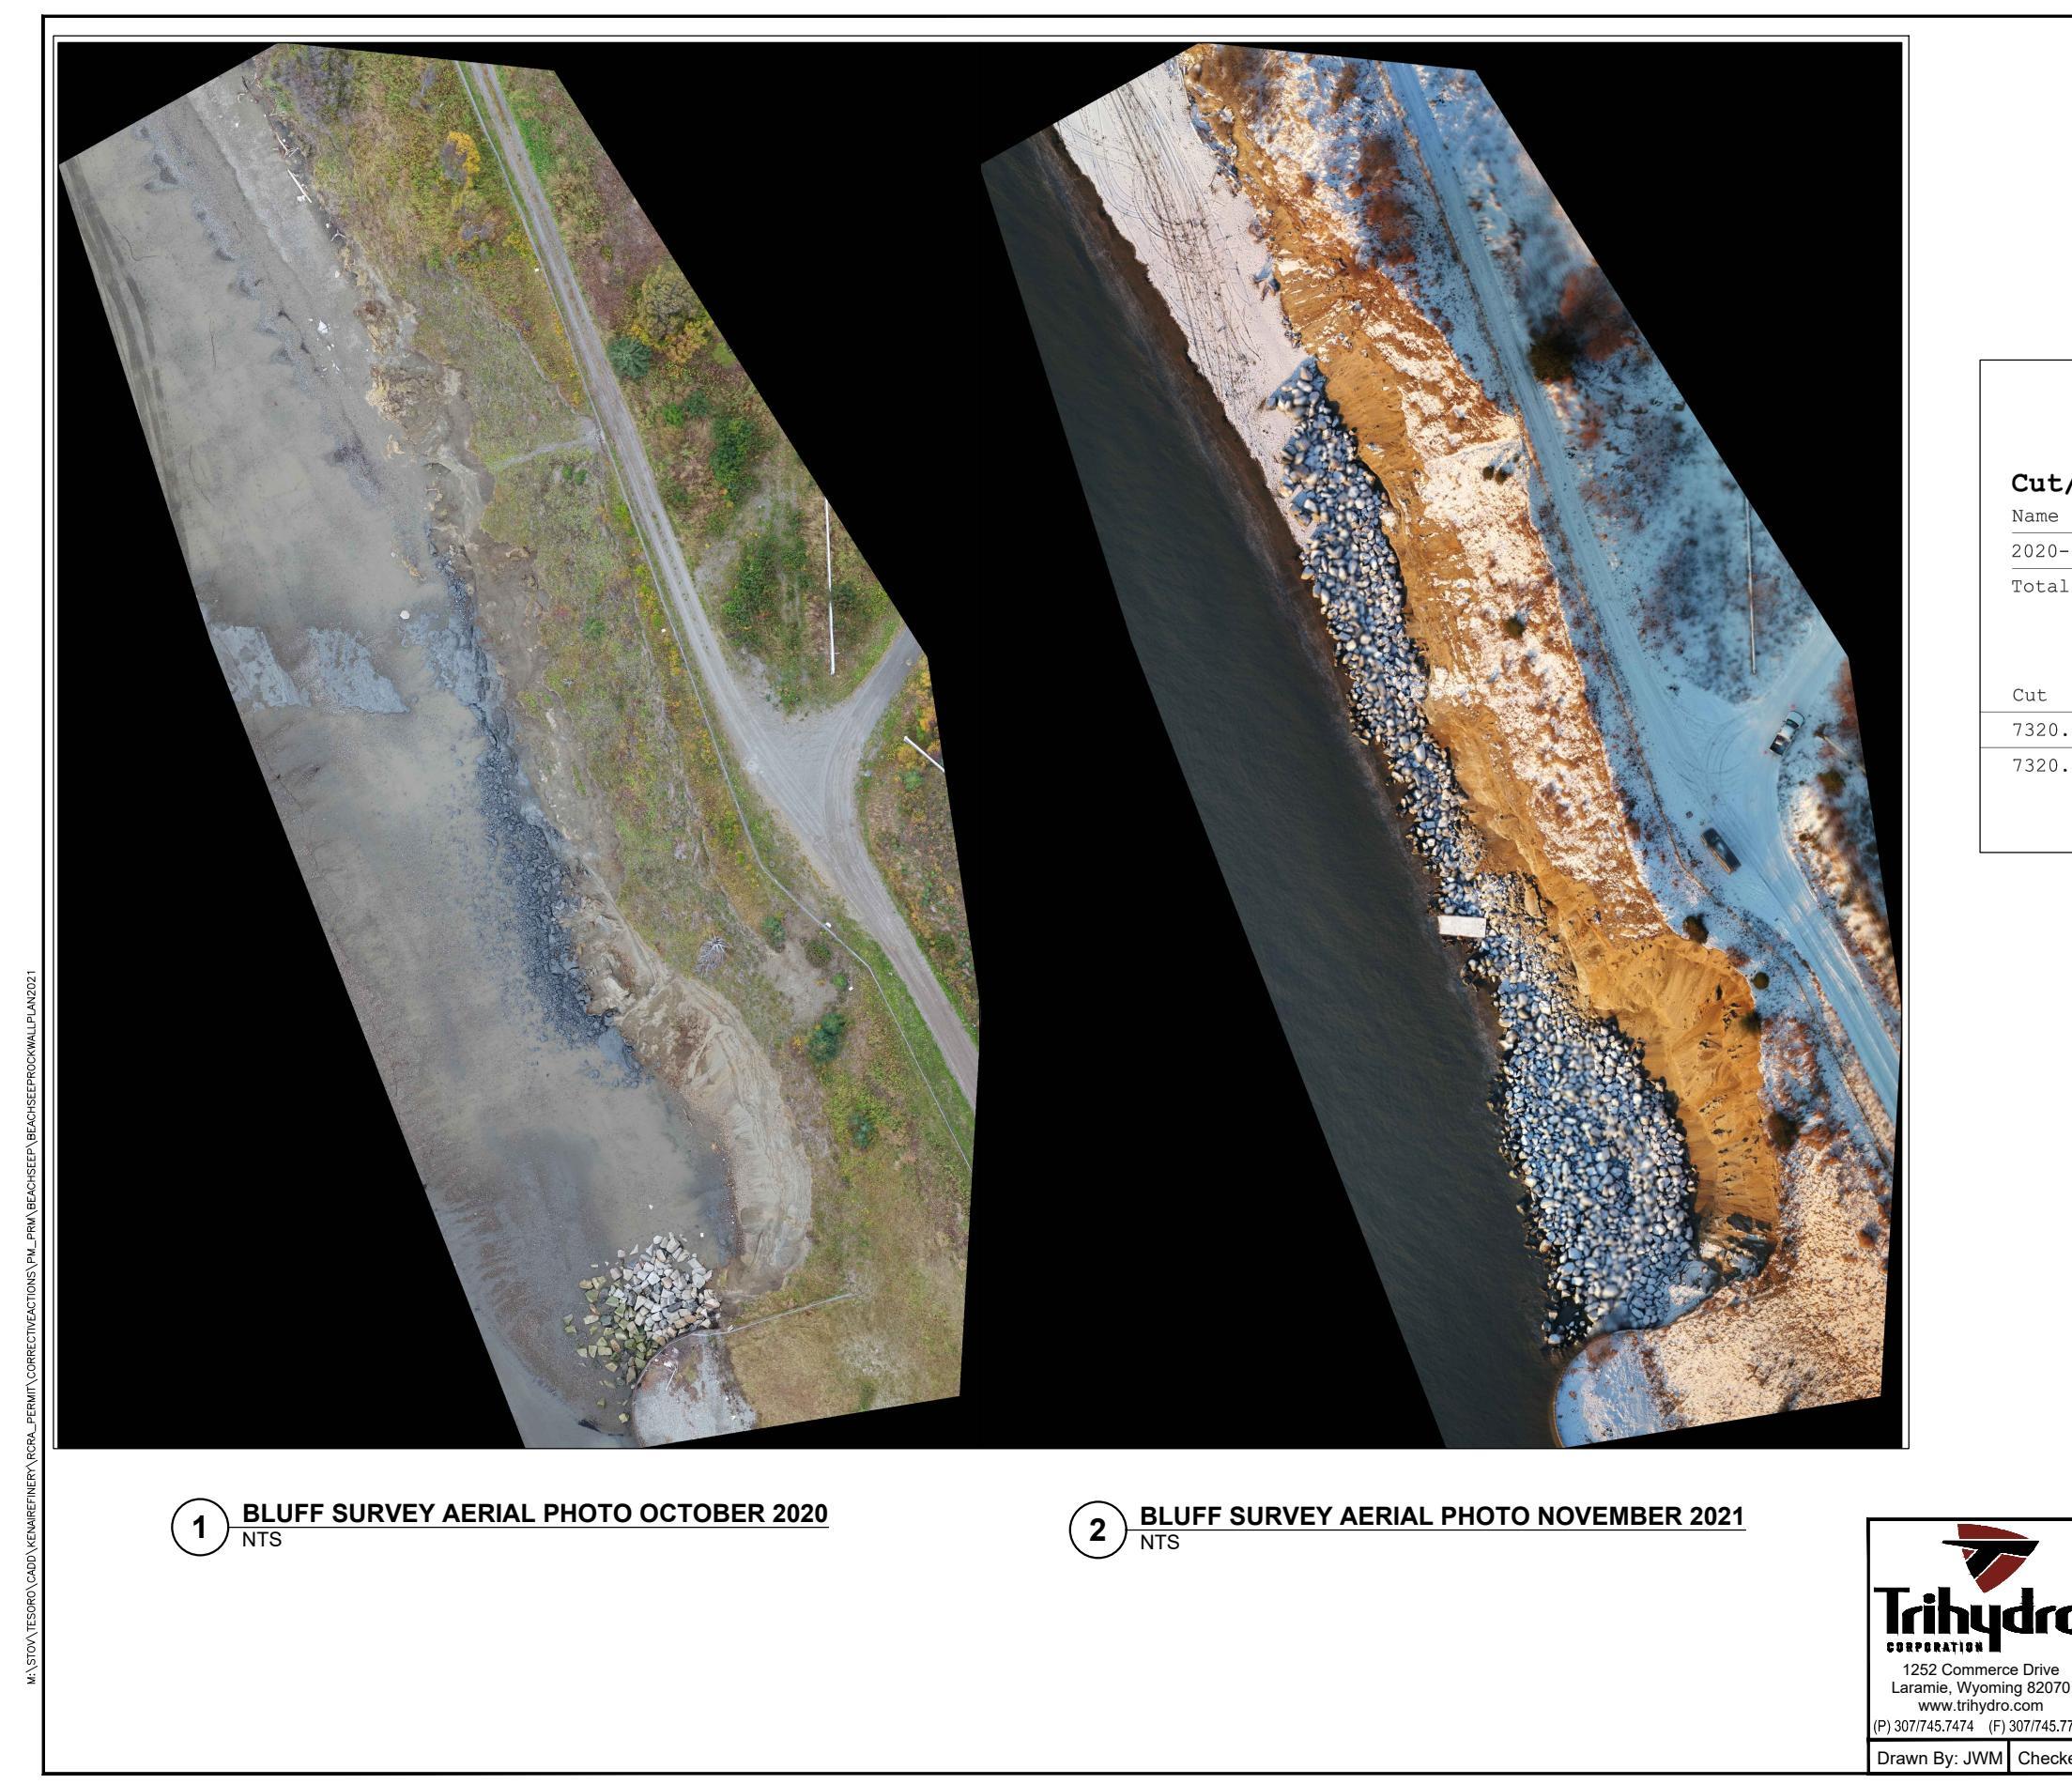
The rock wall stabilization project was completed to help slow bluff erosion, protect existing infrastructure, and better control beach sheen release events. Aerial imagery presented on Figure 2 shows extent of rock placement after project completion in November 2021. Rock placement extended beyond planned footprint detailed in the project work plan to better cover extent of erosion. The wall will be reassessed in the spring of 2022 for any needed repairs.

The rock wall is not intended to stop bluff erosion but is an attempt to slow recent sluffing, provide additional bluff stability for planned pilot test installation activities, and slow migration of 1987 hot oil return pipeline release. The UAV surveys from 2020 and 2021 suggest approximately 7,200 cubic yards of bluff material sloughed from the bluff between October 2020 and November 2021 in the approximate 550-foot stretch of surveyed beach length (Figure 2).

Cut Name 2020-Total

Cut 7320. 7320.

Cut	Fact	or	Fill Fa	actor	2d Area		
2021 E	ros	ion	1.00			1.00		50602.83	Sq.	Ft.
S								50602.83	Sq.	Ft.
		न	'ill			Net				
14 Cu.	Yd	. 1	26.08	Cu.	Yd.	7194	.07 Cu	1. Yd. <cut< td=""><td>.&gt;</td><td>_</td></cut<>	.>	_
14 Cu.	Yd	. 1	26.08	Cu.	Yd.	7194	.07 Cı	1. Yd. <cut< td=""><td>.&gt;</td><td>_</td></cut<>	.>	_
					1	FIGURE	2			
						FIGURE	- 2			
			BI 11	EE 9	I	- 2021	<u> </u>			
			BLU		1	<del>- 2021</del>	<u>2</u>	PARISON		
			BLU	FF 2	<u> </u>	FIGURE - 2021	<u>2</u>	PARISON		
			BLU	FF 2	I 020 7 RO	- 2021 CK RE	E 2 COM	PARISON		
			BLU	FF 2 VITY ESC	1 020 7 RO 0 RO	FIGURE - 2021 CK RE KENAI	E 2 COM REFI	PARISON NG WALI NERY		
29			BLU GRAV	FF 2 VITY ESC		FIGURE - 2021 CK RE KENAI IAI, AL	E 2 COM REFI ASKA	PARISON NG WALI NERY		
By: Rf		Scale	BLU GRAV T	FF 2 VITY ESC	I 0020 RO DRO KEN Date:	FIGURE - 2021 CK RE KENAI IAI, AL	E 2 COMI REFI ASKA	PARISON NG WALI NERY	- -
