### DESCRIPTION

Port Heiden is located on the north side of the Alaska Peninsula, approximately 400 air miles southwest of Anchorage. The town has two former military installations:

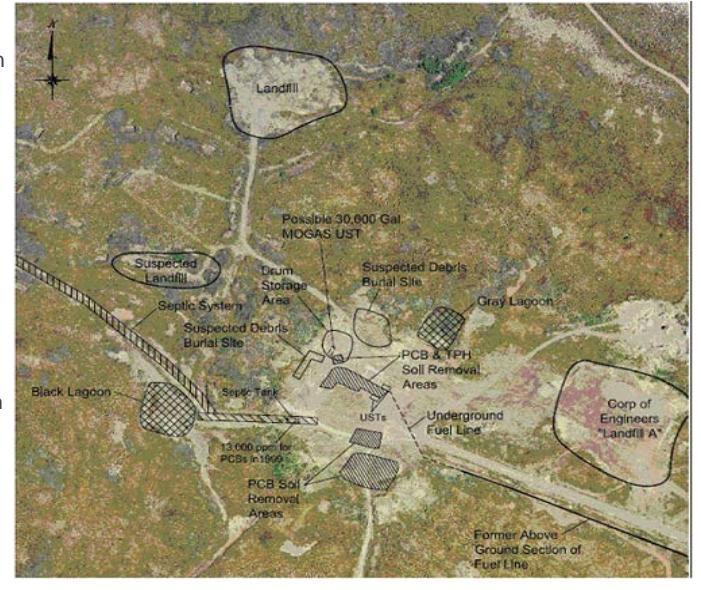
View of former site of the Port Heiden Radio Relay Station, with drawing indication locations of key features.

The site had consisted of the Former Facility Area, the Marine Terminal Area (a former location of a petroleum, oil, and lubricant [POL] tank farm and pump house), and a Former Pipeline Corridor connecting the Marine Terminal Area to the Former Facility Area. There are approximately 18 source areas at this site. No buildings or structures left at the site.
