Re: Decision Document; SAFE Women's Shelter  
Cleanup Complete Determination – Institutional Controls

SAFE Women's Shelter  
21 G Street West  
Dillingham, Alaska 99576-0094

**Attachment B: Site Figure****SAFE WOMEN'S SHELTER**

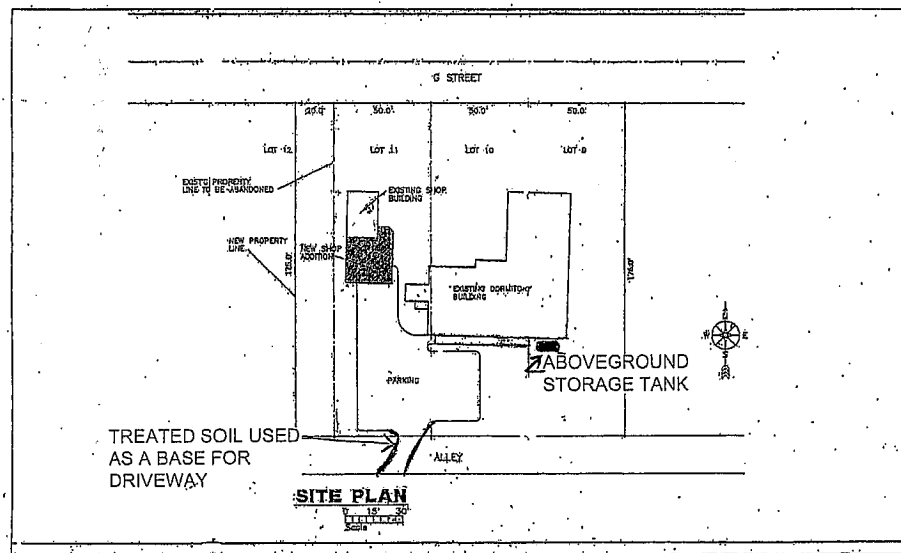
21 G Street West  
Dillingham, Alaska

2. Any proposal to transport soil or groundwater off site requires ADEC approval in accordance with 18 AAC 75.325 (i). A “site” [as defined by 18 AAC 75.990 (115)] means an area that is contaminated, including areas contaminated by the migration of hazardous substances from a source area, regardless of property ownership. (See attachment B Site Figure)
