-REMOVED OR DECOMMISSIONED-

DECOMMISSIONING WELL
 DETAIL

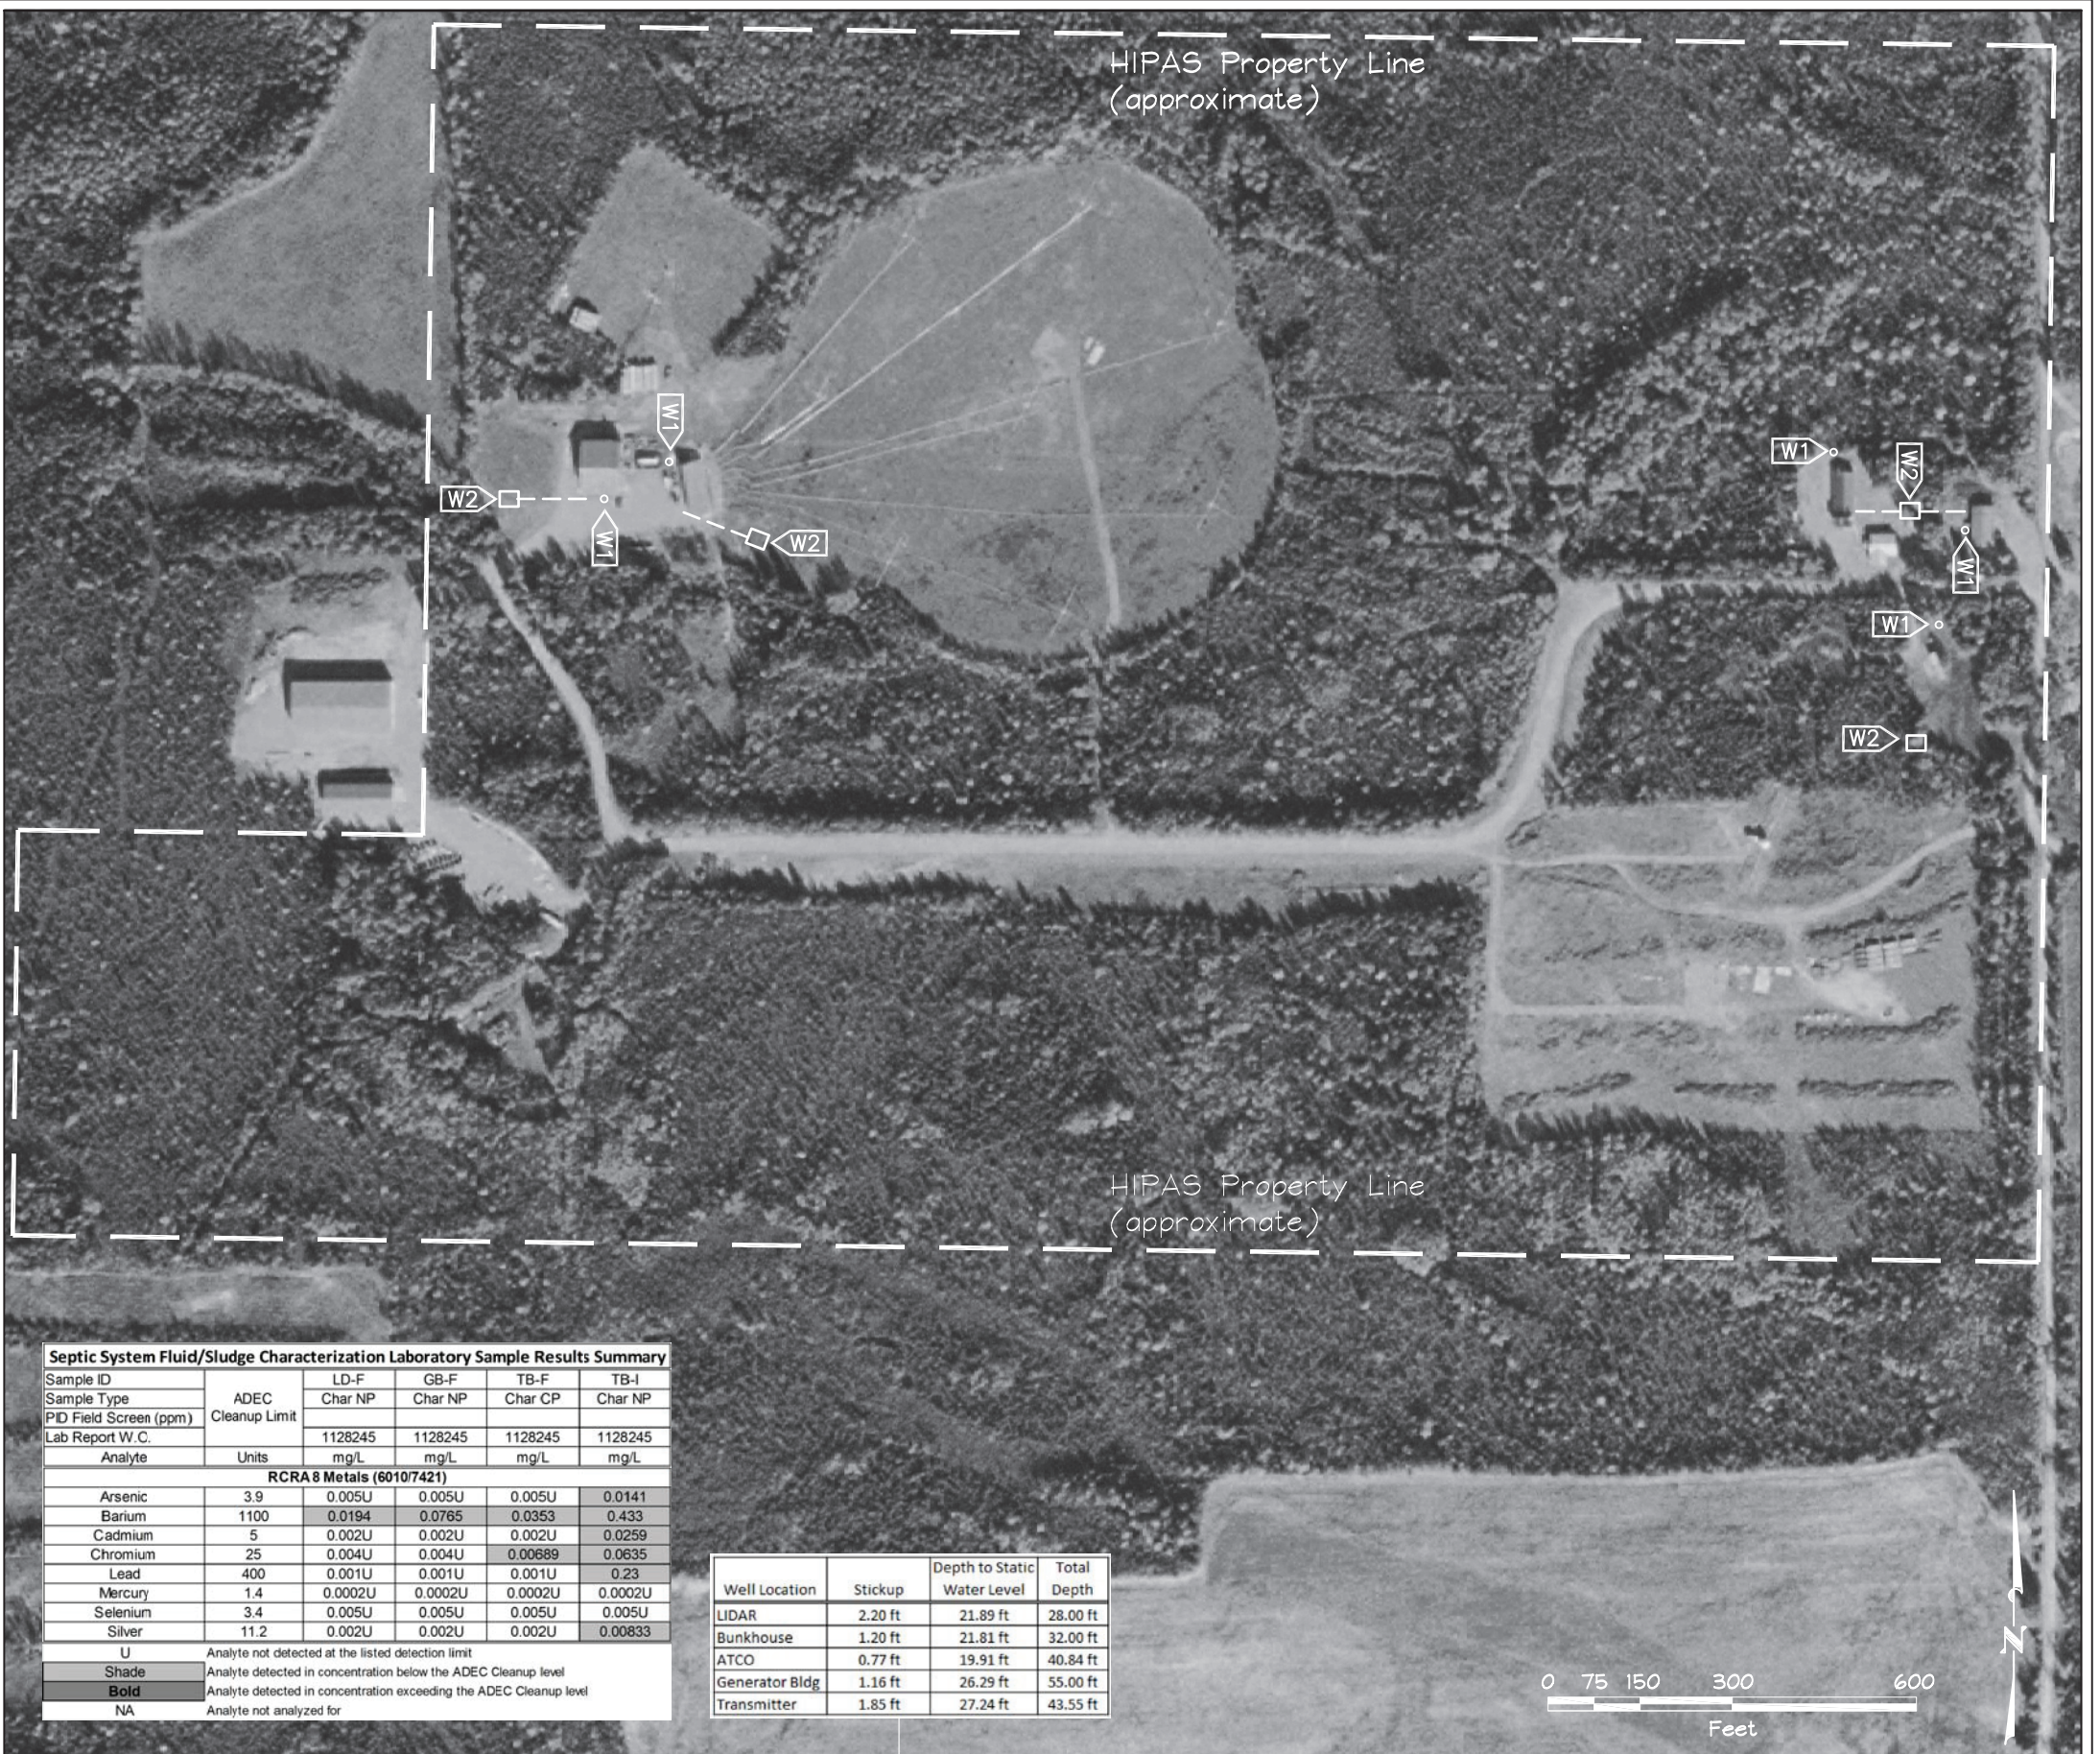
W1 Water Well
 -Decommissioned in accordance with applicable guidance.

W2 Septic tank and associated components
 -Based on clean sampling results, the septic tanks were removed, the soil absorption systems and piping were abandoned in place.
 -Soil absorption systems were approximately 10-15 feet past septic tanks. Inspection pipes were removed.
