Re: Selawik Old AVEC Tank Farm and Barge Landing Cleanup  
ADEC File #500.38.007, 500.57.001

ALASKA VILLAGE ELECTRIC COOPERATIVE, INC.  
FIELD TRIP REPORT

**Selawik Old AVEC Tank Farm Cleanup: Photo Log – April-June, 2012**

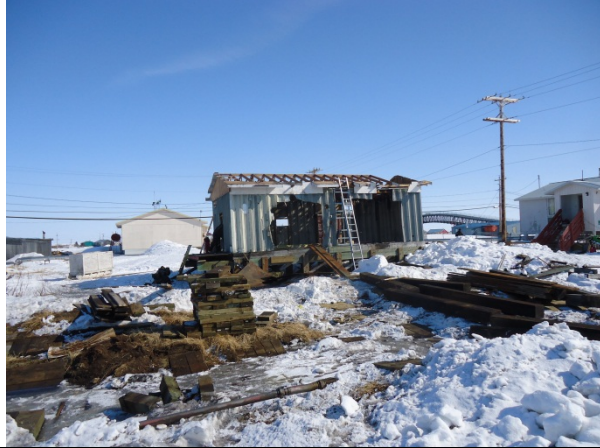
Continued demolition of the old generator building.

Following the removal of the generators, the generator building was demolished. All debris from the demolition including wood framing materials, metal siding and roofing materials, and the wood support structure were disposed in the Selawik landfill. The removal included the creosote-soaked timbers that were mentioned in the 2011 Brownfield Assessment report. No remnants of the generator building remained on site.

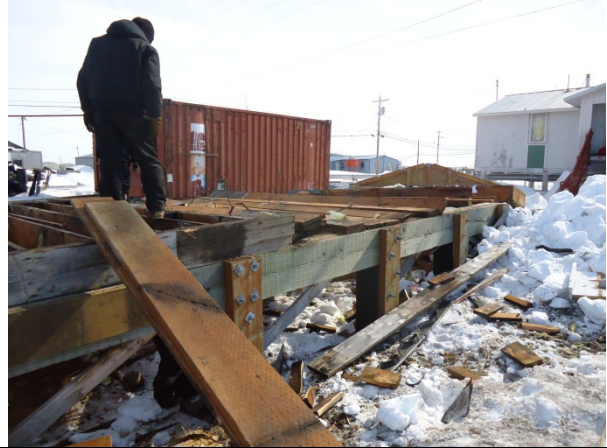
Structural demolition of foundation.

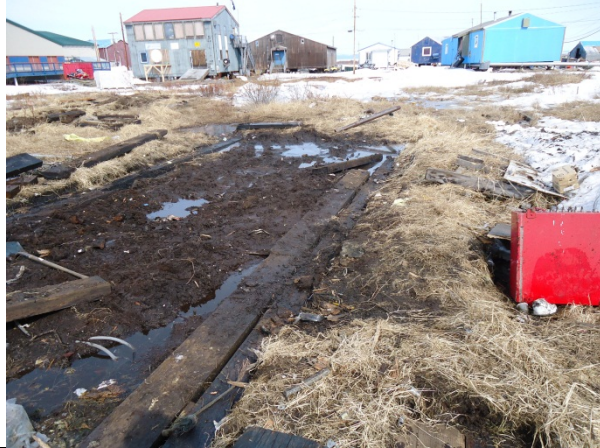
Clearing of the site and timbers.

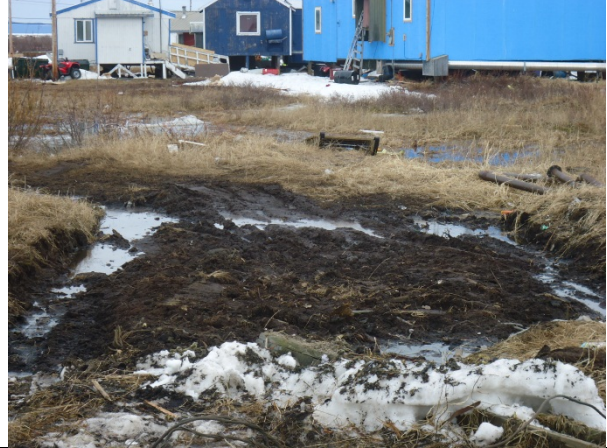
Mostly cleared generator building site.

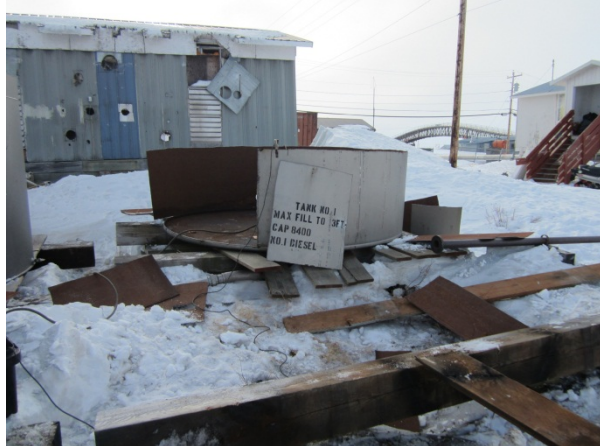
Cutting of fuel tanks on AVEC tank farm site.

Eight vertical above-ground storage tanks (AST) were located at the old tank farm. Each storage tank sat on a creosote timber foundation. None of the eight tanks contained any fuel products and had previously been decommissioned. The demolition and disposal of the fuel tanks was conducted by Rural Alaska Fuel Services. Each of the tanks were cut apart into manageable pieces using a plasma torch. The scrap metal was disposed in the landfill. The timber support frames were disassembled and where necessary excavated from the ground. All timbers were disposed in the landfill. No remnants of the tanks or their support structures remained on site.

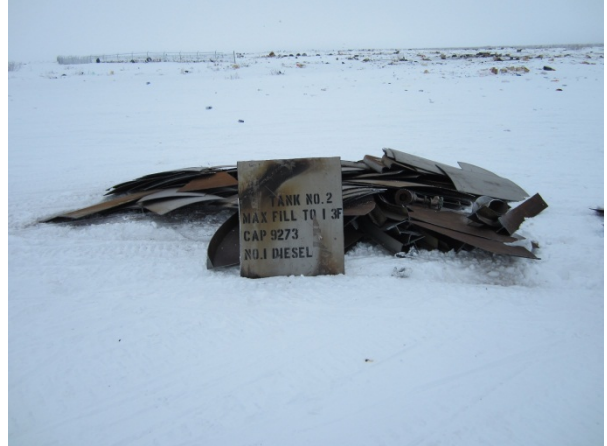
Fully cut and removed fuel tank.

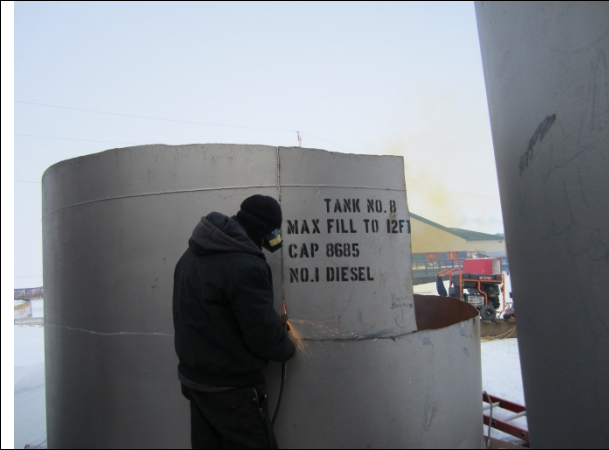
Cutting of fuel tanks at the AVEC tank farm site.

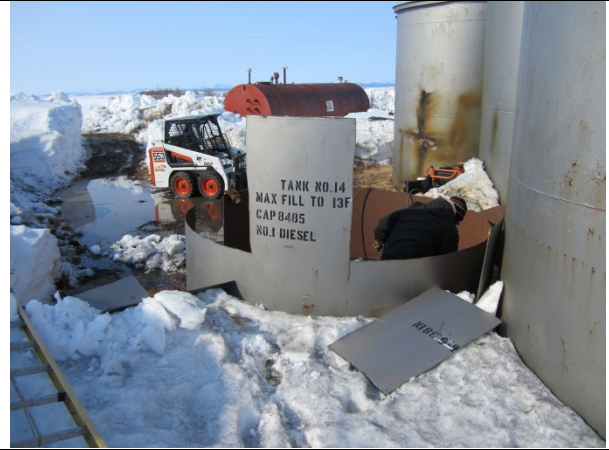
Cutting of fuel tanks at the barge landing site.

Around the year 2000, AVEC decommissioned several tanks and relocated them to the barge landing. These tanks were also mentioned in the 2011 Brownfield Assessment report under the Barge Landing section. During the cleanup process, AVEC also cut and disassembled the tanks and then disposed them in the landfill. AVEC no longer has any tanks at the barge landing site.

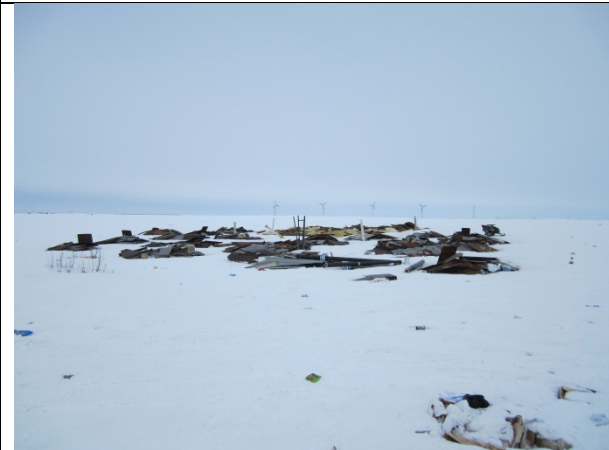
All fuel tank scrap at the landfill.

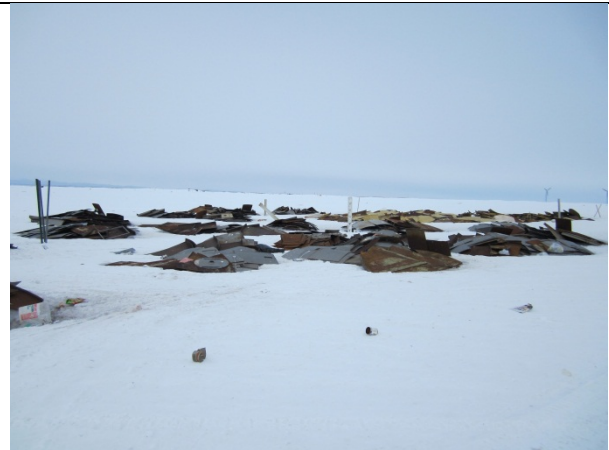
All fuel tank scraps at the landfill.
