7-Eleven Store #46745
(Former Speedway Store 5314 -
TNS #76) ADEC File #2265.26.037

2Q - June 2022 GWM Event Report

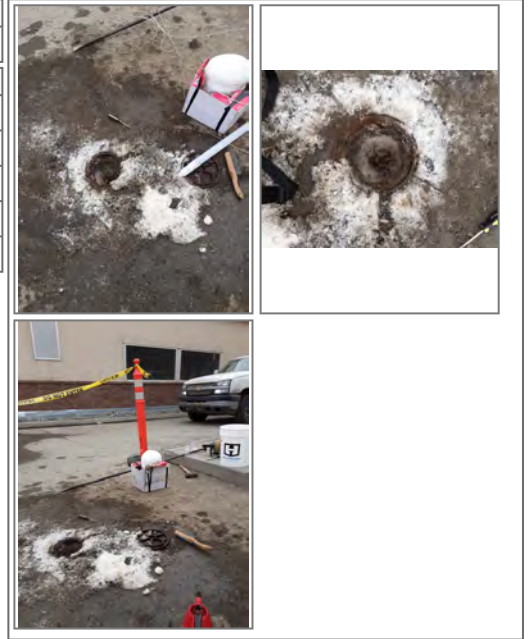
Speedway 5314 TNS
Date: 06/22/2022, 12:02 PM
Name(s): Remi Malenfant
Site Name: 76

Location ID	GPS Latitude (decimal)	GPS Longitude (decimal)
MW-2	61.5843106137	-149.358489851
Field Data		
Sampler Names:	Sheen/Odor?: None	
pH: 6.28	Specific Conductance: 1088	
DO: 1.35	Temperature (C): 7.6	
ORP: 267.9	Purge Volume (gal): 3.5	
Notes: Dark brown with spring tails
