Alaska Department of Environmental Conservation (ADEC) Solid Waste Program (Trisha Bower and Rebecca Colvin) conducted a Coastal Impact Assistance Program (CIAP), Waste Erosion Assessment and Review (WEAR) site visit for Elim on September 25<sup>th</sup>, 2013. Marlin Paul, Landfill Operator, and Judith Daniels, IGAP Coordinator participated in the site visit. The following narrative is a brief description of our findings during the September inspection.

### WEAR Sites

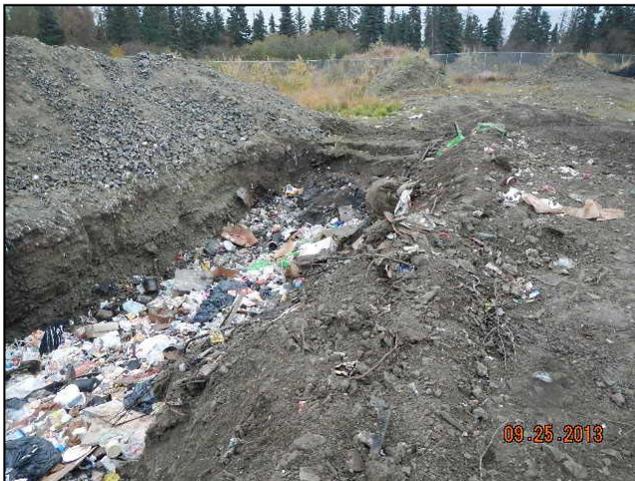
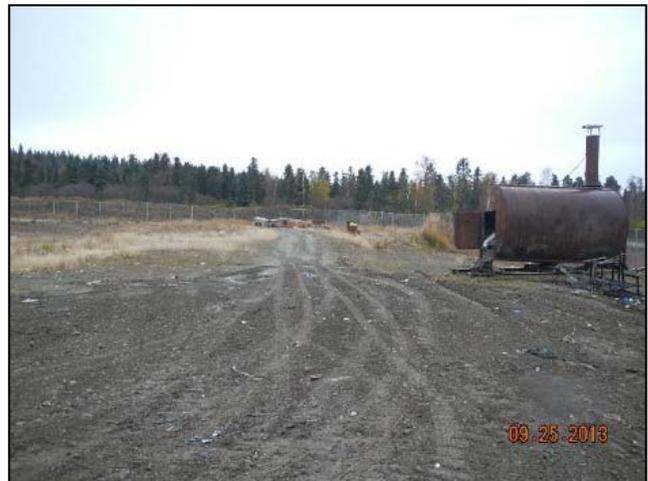
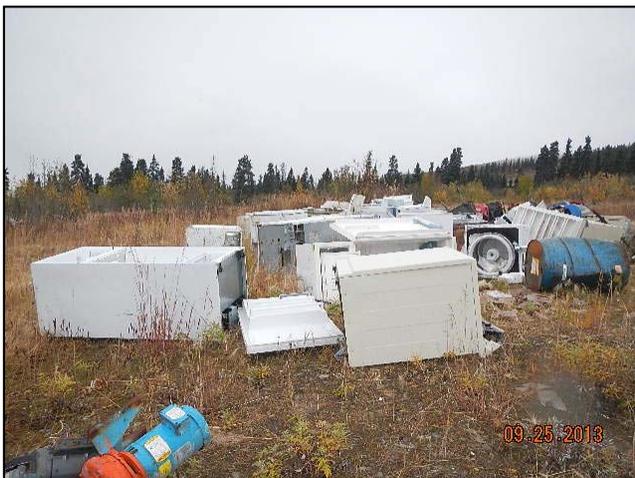
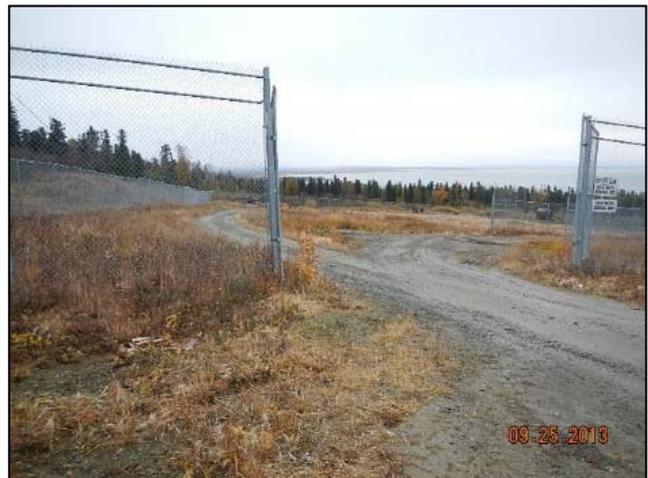
- **Landfill, 64.64609/-162.22386 (Active)** – This permitted, Class III landfill is located 2 miles northeast of the community accessed by a maintained gravel road. The landfill is located on a mountain past the rock quarry in an elevated area. It has been continuously permitted since 2000 and is fully fenced. It is a trench and fill landfill with a separately fenced and locked septage cell. In addition to septage, it accepts municipal waste and construction and demolition waste. There is also a functioning burn unit at the landfill. Inactive areas of the landfill had been covered and revegetated by the full-time operator. White goods have all fluids and CFCs removed and are staged in an inactive area of the landfill before disposal. Elim has a waste collection program; however, some residents self-haul to the landfill. It is approximately 515 feet from Norton Bay.

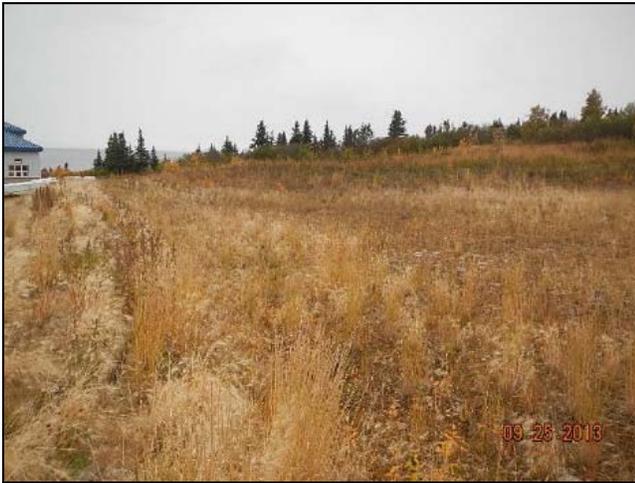
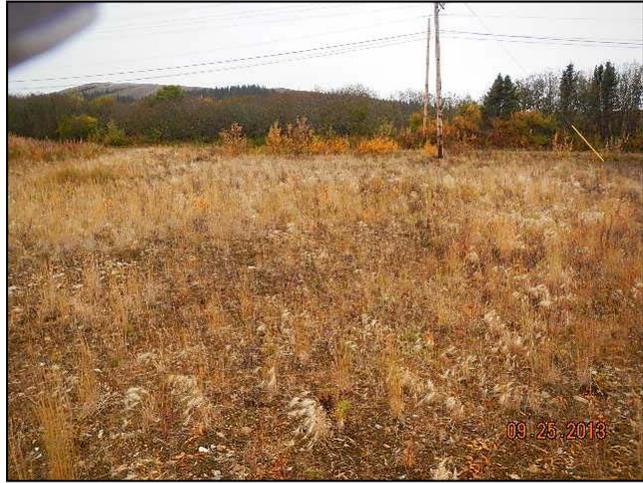
- **1970s Landfill, 64.616713/-162.266119 (Retired)** – This is a historic landfill that was operated until around 1980 when the current landfill was constructed. It is located between the runway and the school, west of the town on the outskirts of the community. It is presumed to contain municipal waste and construction and demolition debris. The area was well vegetated, and small berms around the site were the only indication the area was used as a landfill. It is located approximately 520 feet from Norton Bay.

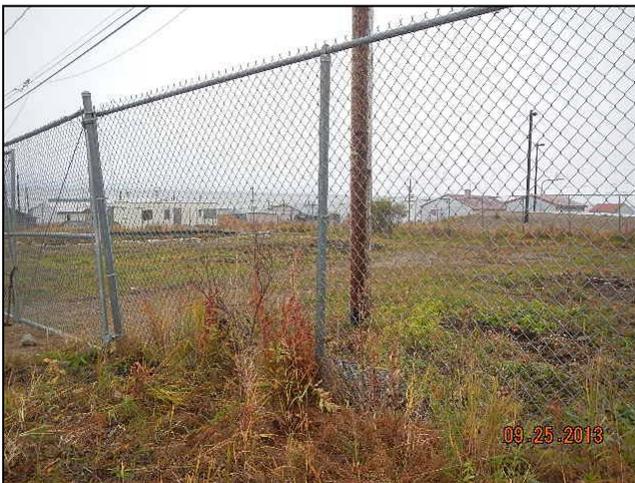
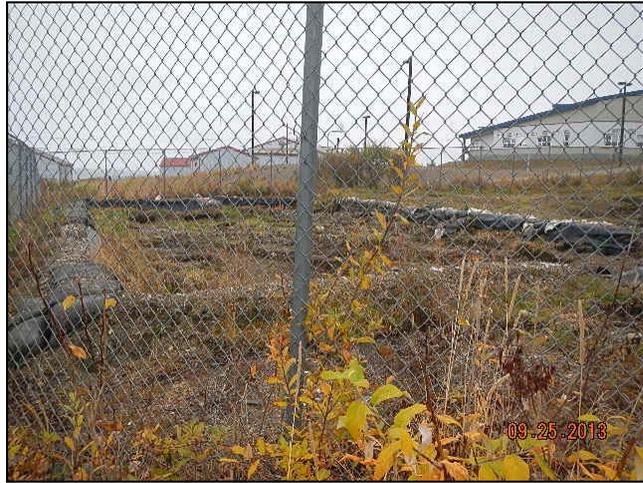
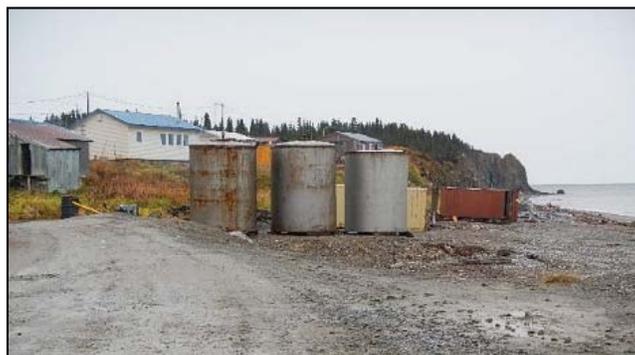
- **Old AVEC Tank Farm, 64.616556/-162.263100 (Active)** – This former tank farm and power generation site is an active Contaminated Site (File ID 600.57.001). It was in operation until 2002 when the new AVEC Tank Farm was completed. At the time of the inspection, the site was fully fenced, and the fuel tanks and all structures had been removed. Some tanks were stored along the shore for shipment out of the community and others had been cut up and taken to the landfill for disposal or reuse. It was reported the nine diesel tanks were removed the winter of 2012. No sampling has been conducted at this site to determine any levels of contamination. It is approximately 350 feet from Norton Bay.

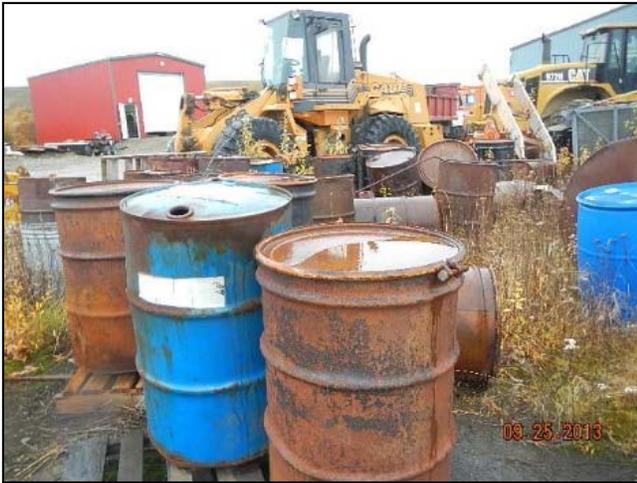
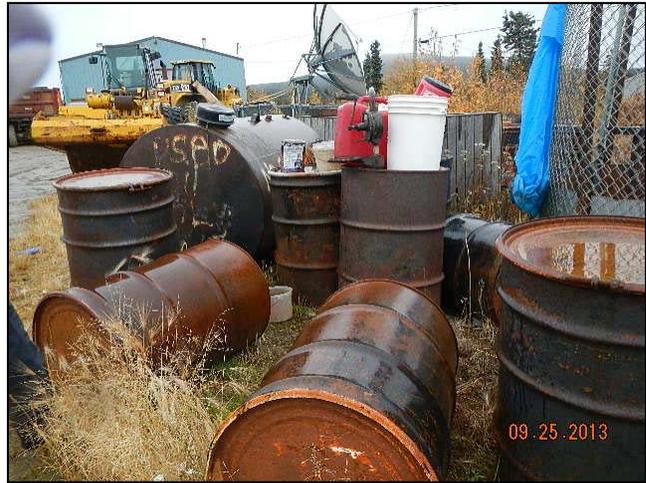
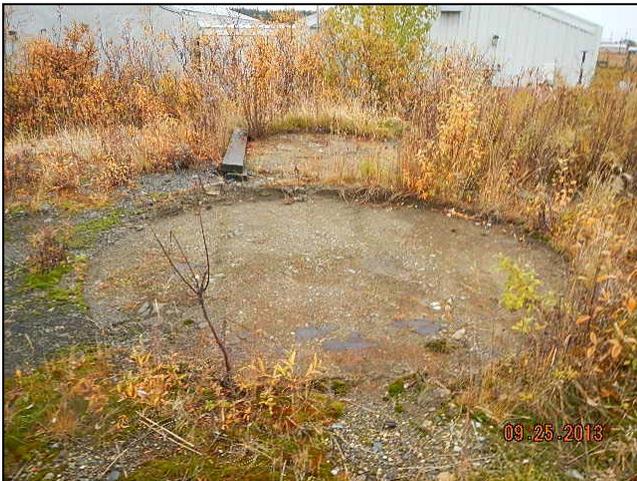
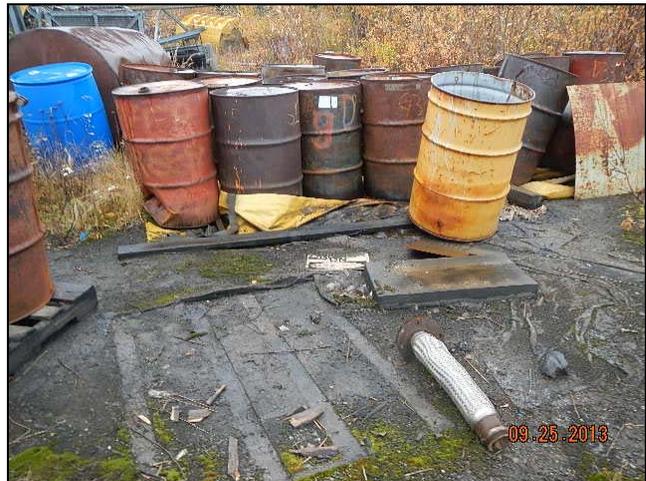
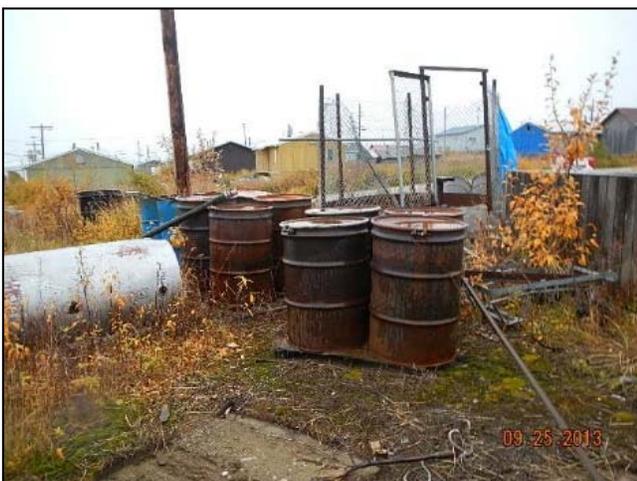
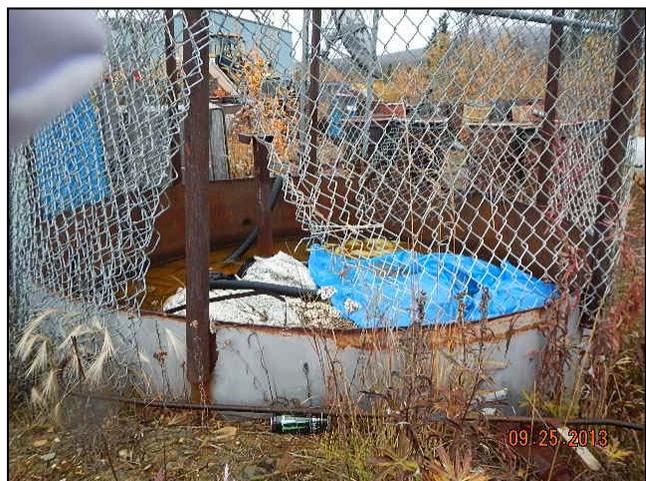
- **Old City Shop, 64.618112/-162.260603 (Active)** – The old city shop is located on the north end of the community, adjacent to the armory building. It is an active Brownfield site with the Contaminated Sites Program (File ID 600.57002). A *Property Assessment and Cleanup Plan* was completed in 2010. The site consists of a historic landfill that was closed in 1980, then it became the city's equipment shop and fire station. It currently functions as the city shop and storage and disposal area for broken equipment, vehicles, used oil, and lead acid batteries. The report states debris from mining cleanup activities were also left at this site. At the time of the inspection, two vertical fuel tanks had been removed from the southeast section of the site, leaving a heavily stained bermed area. Adjacent to this area were multiple 55-gallon drums with unknown contents and a small, green horizontal tank for used oil storage. It is approximately 790 feet from Norton Bay.

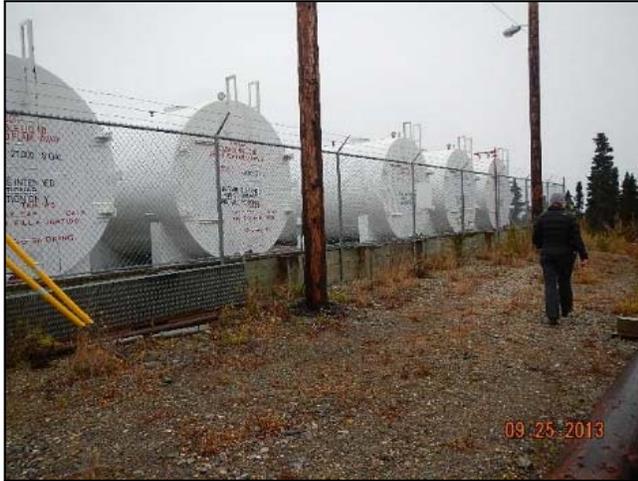
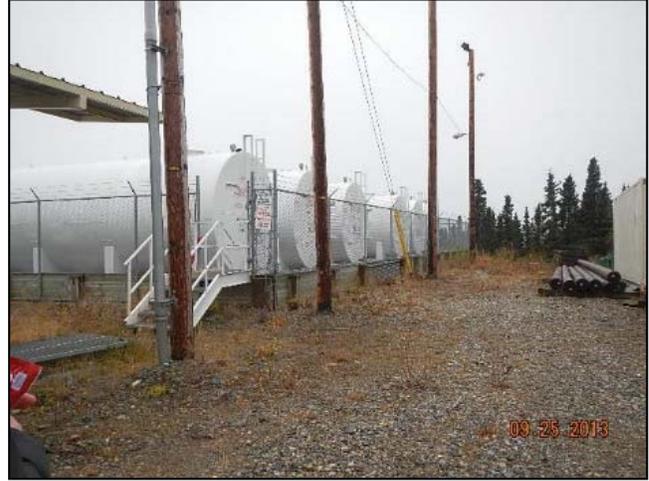
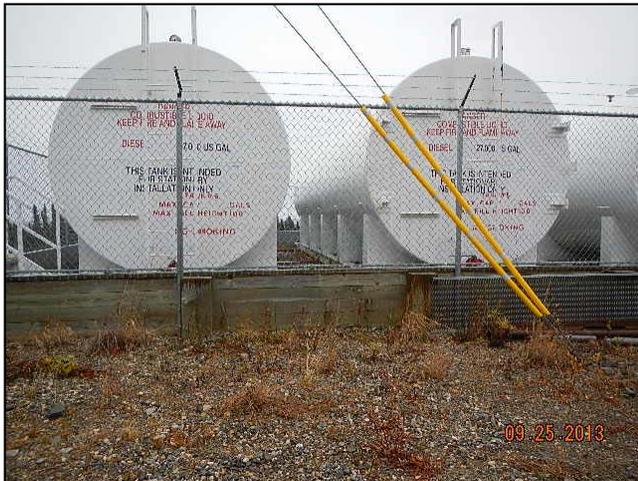
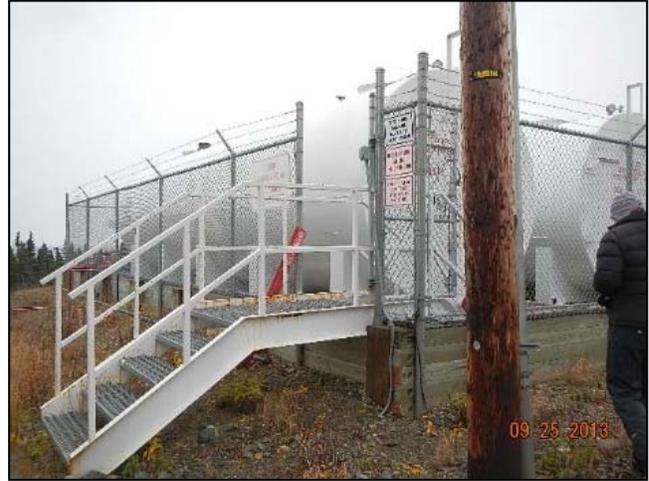
- **AVEC Tank Farm, 64.609825/-162.275044 (Active)** – This tank farm was constructed in 2002 through a Denali Commission project. It is owned and operated by AVEC. It consists of 6-27,000 gallon diesel tanks that are single-wall. They are located in a wooden, lined dike for secondary containment. The site is entirely fenced and locked. It is approximately 780 feet from Norton Bay on a large hill.
