Alaska Department of Environmental Conservation (ADEC) Solid Waste Program (Kitrina Persson and Elizabeth Stergiou) conducted a Coastal Impact Assistance Program (CIAP), Waste Erosion Assessment and Review (WEAR) site visit for the Village of Pilot Point on August 1<sup>st</sup>, 2012. Bruce Megarr, City Manager, helped coordinate our visit. The following narrative is a brief description of our findings during the inspection.

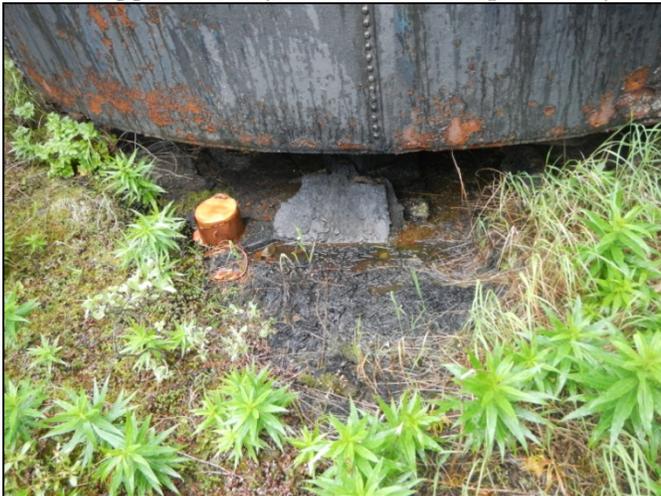
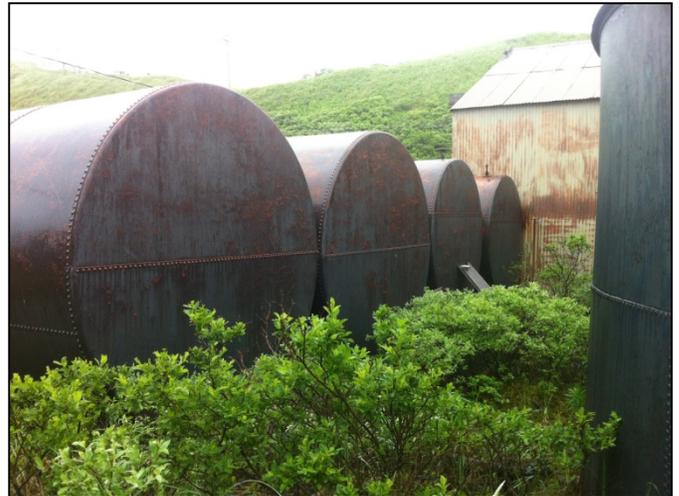
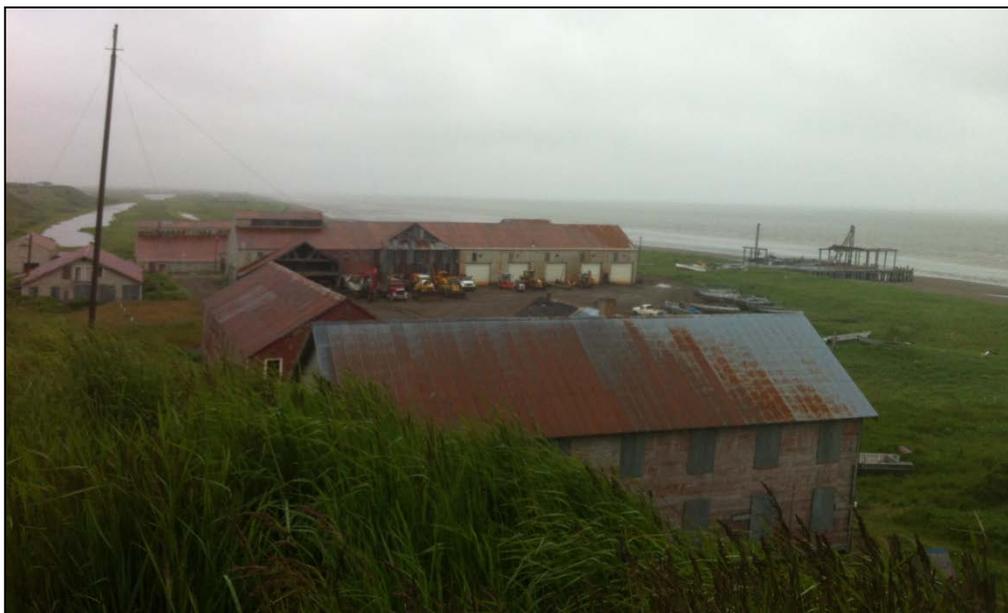
- **Alaska Packers Association Cannery, 57.562409/-157.582409 (Active)** – Alaska Packers Association (APA) Cannery circa 1891 was the recipient of a Brownfield Assessment in 2007 under the Contaminated Sites Program (File ID 2571.38.001). Assessment of the site included: release of fuels from the tank farm, asbestos containing materials and lead-based paint in several structures, and surface stains in the drum storage area. The tank farm shows signs of contamination under the middle tanks and at the outlet valve. The site is located approximately 300 feet from Ugashik Bay.

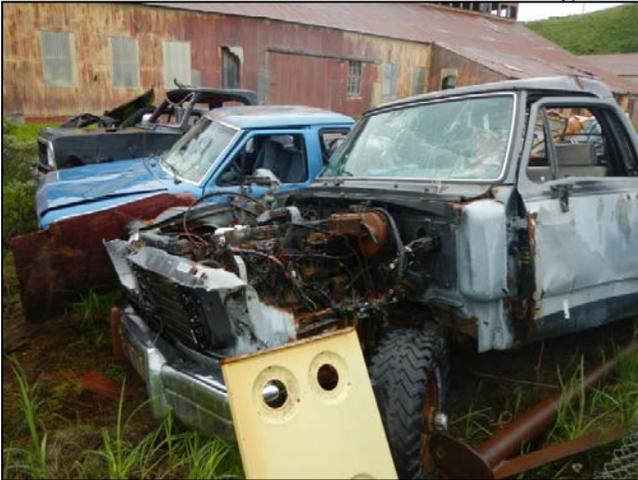
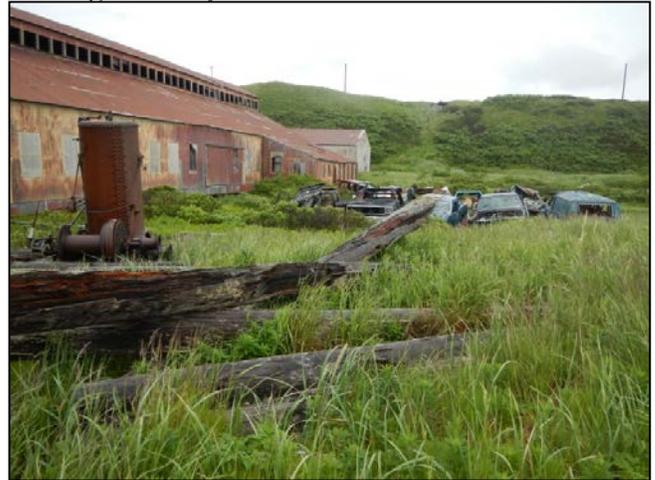
- **Vehicle Boneyard, 57.562083/-157.582100 (Active)** – There are about 15 automobiles next to the APA Cannery and petroleum odor is evident. The vehicles were placed on site without initial drainage of fluids or battery removal. There is noticeable oil in the site's sandy soil and petroleum sheen to the puddles. Batteries and engine parts are also resting on the ground. This site is about 200 feet from the high tide line of Ugashik Bay.

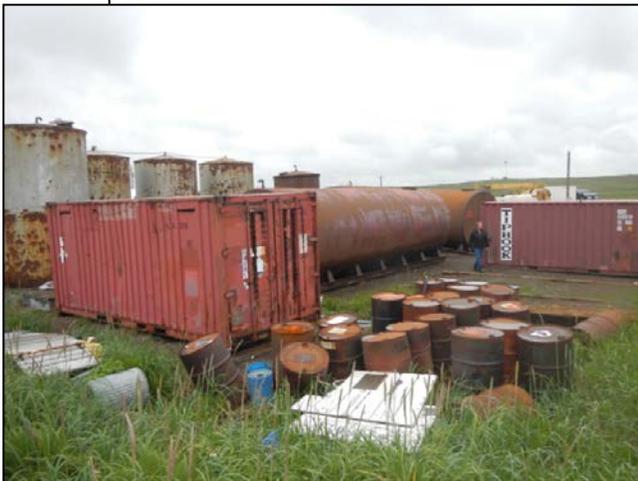
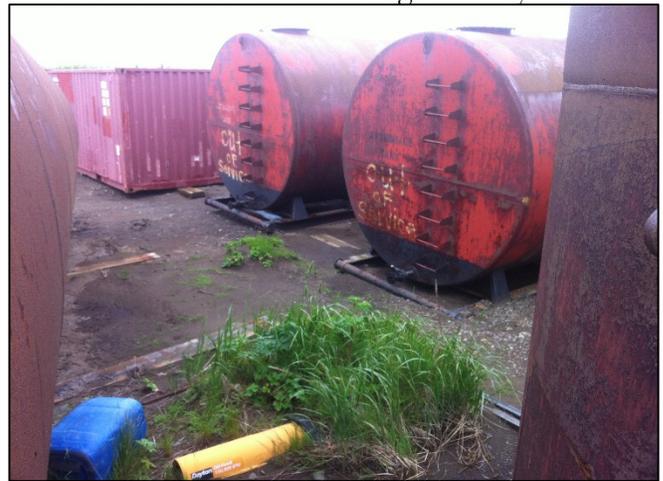
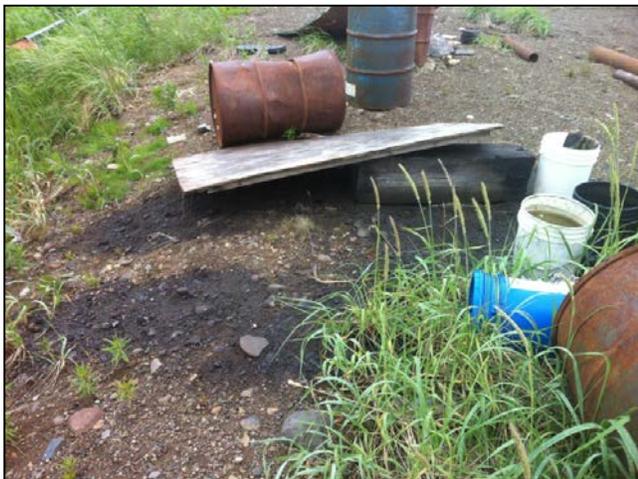
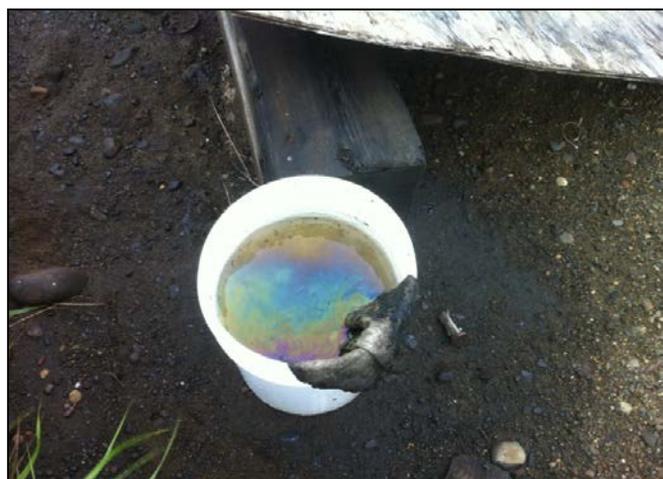
- **Old Tank Farm, 57.573821/-157.585191 (Inactive)** – This tank farm has not been in use since 2008 when the new tank farm was completed which is approximately 70 feet away. The area contains approximately 45 55-gallon drums (contents unknown) and 9 fuel tanks (6 vertical tanks and 3 horizontal tanks). The fuel tanks are empty and disconnected. Strong petroleum odor and stained soil was observed. The site is 190 feet from the Ugashik Bay.

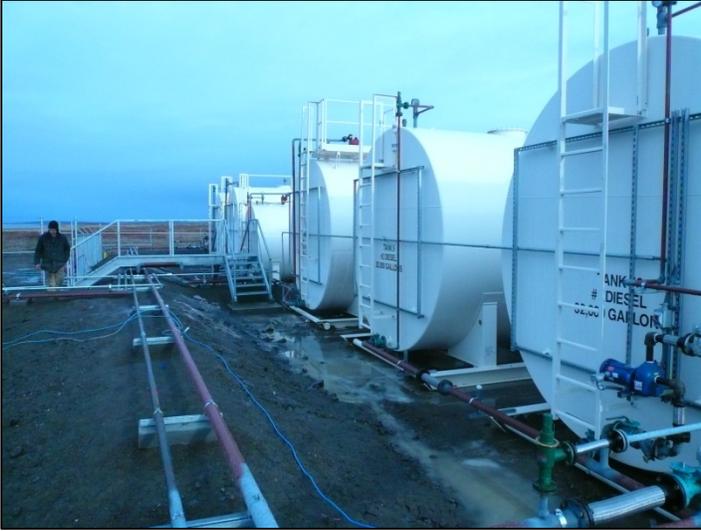
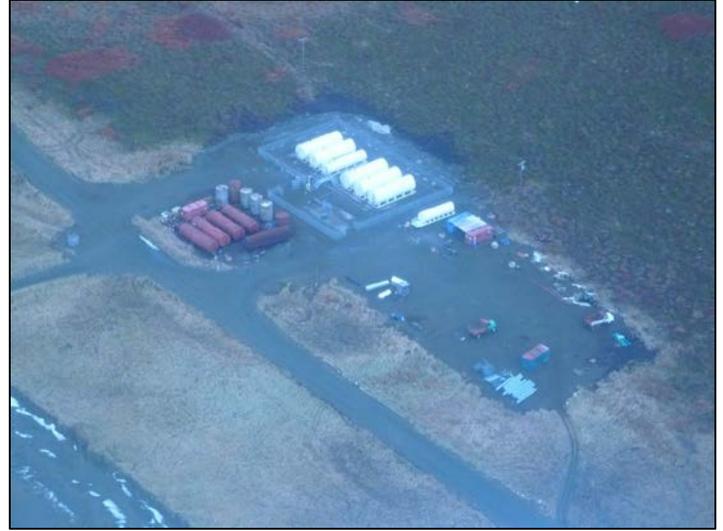
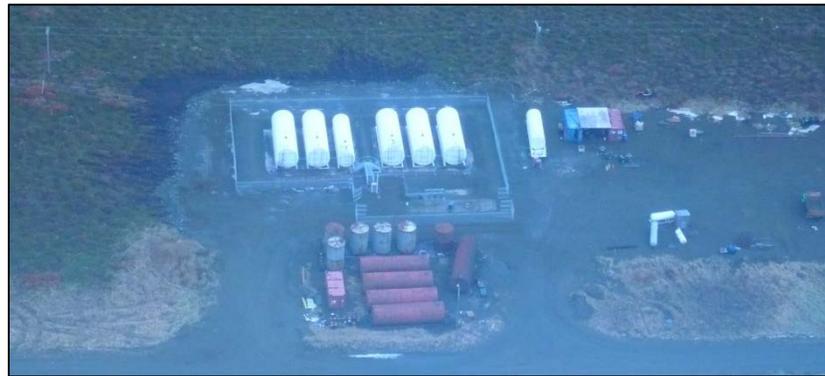
- **Tank Farm, 57.573870/-157.584445 (Active)** – This new bulk fuel facility was constructed in 2008 with Denali Commission and Alaska Energy Authority funding. It contains six horizontal fuel tanks within a fenced area. It is approximately 350 feet from Ugashik Bay.

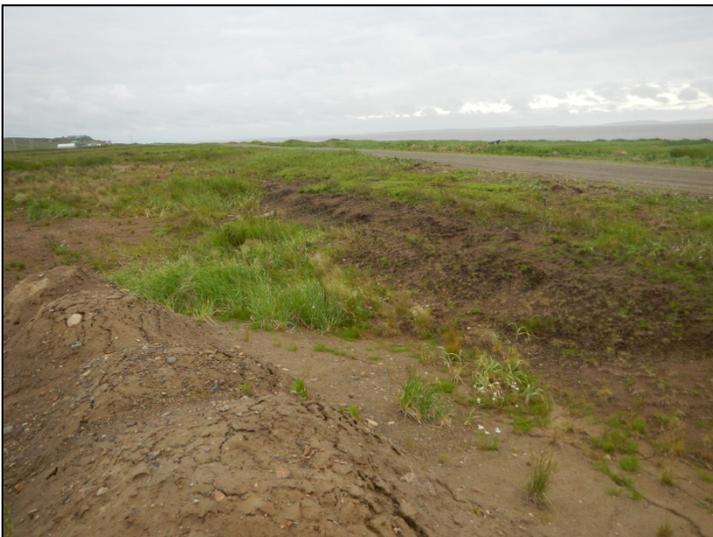
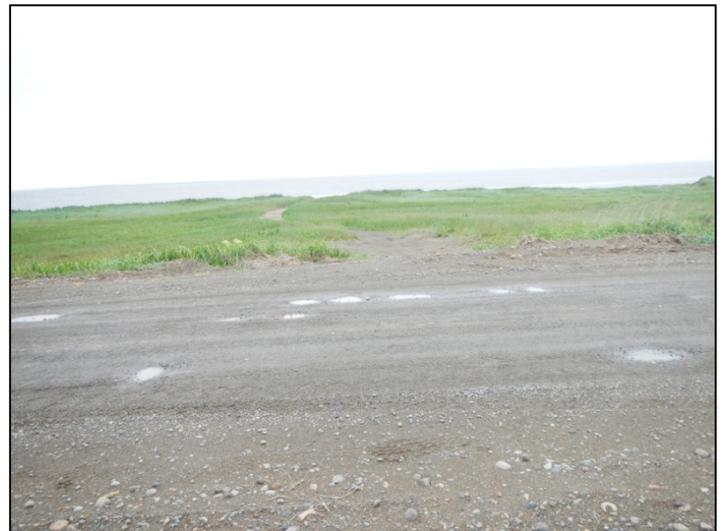
- **Dago Creek Road Landfill, 57.579137/-157.585568 (Closed)** – The site is located on the west side of Dago Creek Road between the end of the new runway and the beach. During the inspection evidence of this old landfill could not be physically found. It is suspected that mounds of dirt from the runway project were deposited on top of the landfill, completing the capping process. The landfill has been closed since 2001-2002. The landfill is approximately 350 feet from Ugashik Bay based on review of older imagery.

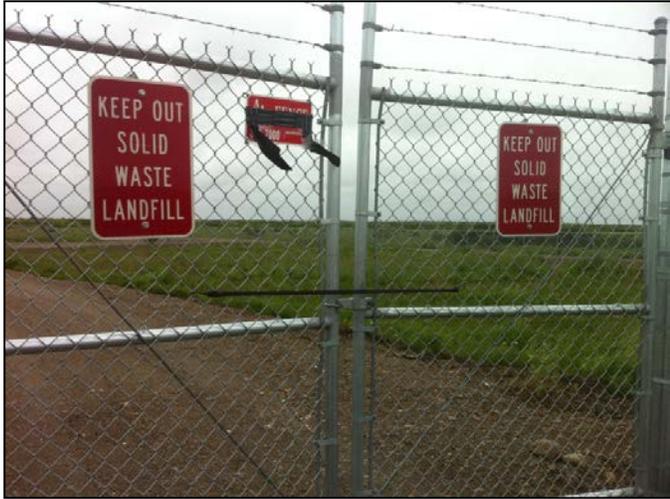
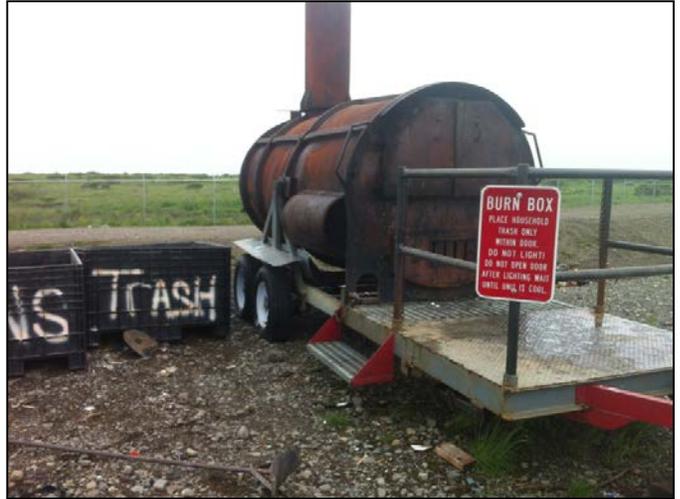
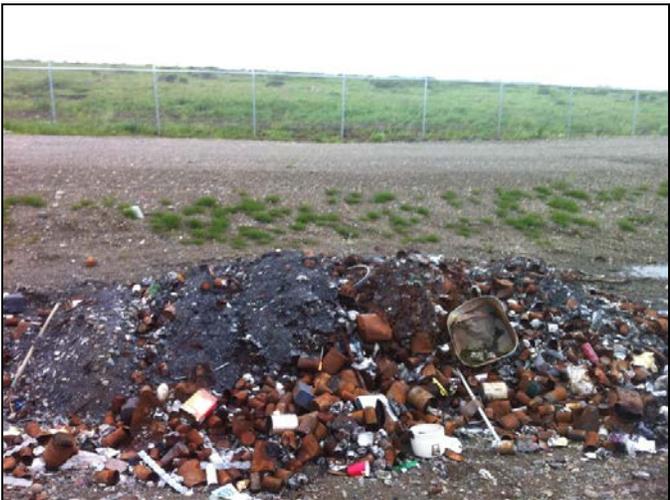
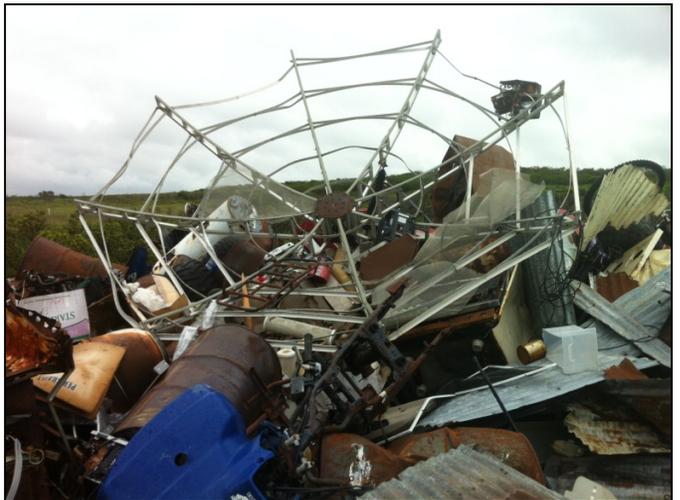
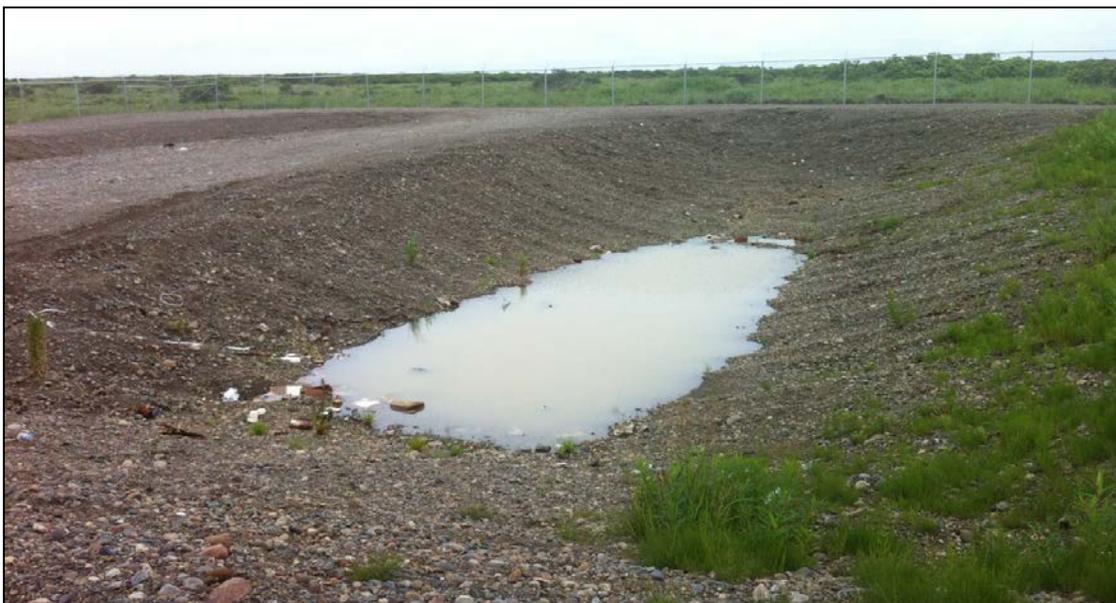
- **Northeast Landfill, 57.589871/-157.501524 (Active)** – This fenced, permitted landfill was constructed in 2001-2002. The City provides a waste hauling service for the community. A Tok Burn Box is used to reduce volume and reduce vector attraction. It is a trench-and-fill design. Water was observed in an unused landfill cell about 5 feet below ground surface. It is located 3 miles inland from Ugashik Bay.
